CONTRACT No. 19-513

**WIGHTMAN MANSION REHABILITATION
LENOIR PRESERVE YONKERS, NY**

HISTORIC REPORT

30% SUBMISSION

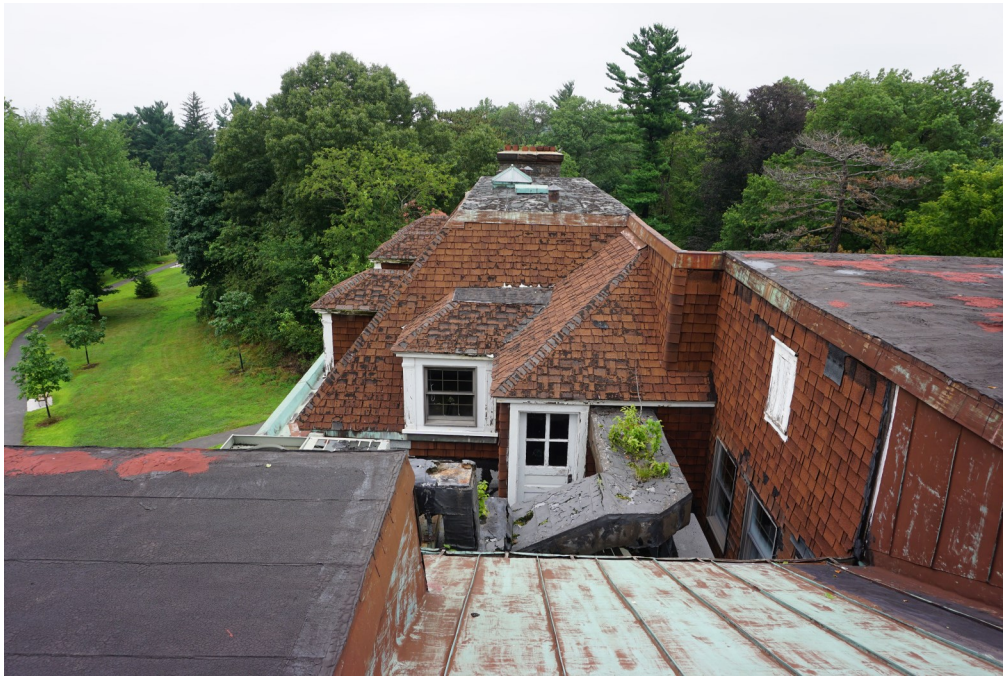
In the 1980's the slate roofs were replaced with asphalt shingles and overtime the canvas flat roofs have been replaced with built-up roofing. All current roofing materials (including gutters) have exceeded their serviceable life and are failing or have already substantially failed. Water is penetrating the building at multiple locations.

WIGHTMAN MANSION ROOF TODAY

- Remove all current roofing materials and flashings.
- Replace mansard roofs with 'unfading red slate'. During a roof survey we discovered a sample of this (1907) slate on the north mansard roof.

- Alternate: Architectural grade asphalt/fiberglass shingle in color to match original slate.
- Replace flat built-up roofs with modified bitumen or EPDM roofing membrane.
- Replace tin roofs at original building dormers with flat seam copper.
- Remove existing tin built-in gutters and replace with copper. Provide new copper leaders.

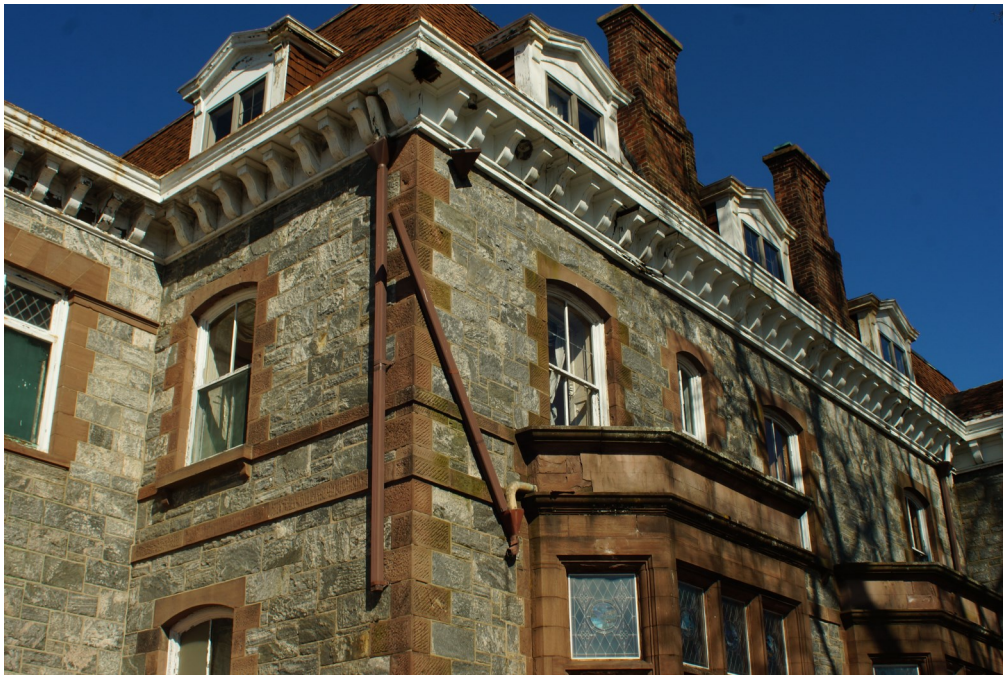
The granite walls are generally in good condition but require repointing. The building brownstone has delaminated and deteriorated in multiple areas and will require composite repairs to stabilize the stone and prevent further deterioration. All brick masonry chimneys require repointing and cap replacement.

WIGHTMAN MANSION NORTHWEST CORNER TODAY

- Remove damaged and exfoliated areas of brownstone units to adjacent joints. Perform composite repairs on deteriorated areas of stone. Tint repairs to match existing stone and adjacent areas.
