MERESTEAD

HISTORIC STRUCTURE REPORT

Prepared by
Harboe **A**rchitects, PC

AUGUST 2017

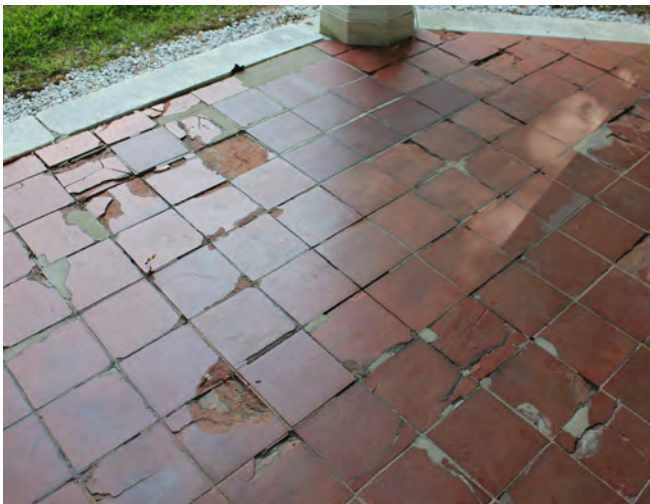
Figure II-128. Deteriorated clay tile at porch. (HA, 2015)

Carefully remove and salvage existing tiles and replace setting bed. Provide new custom clay tiles that match the size and color of the originals but have better weathering characteristics than the original tile. Re-grout all of the tile paving.

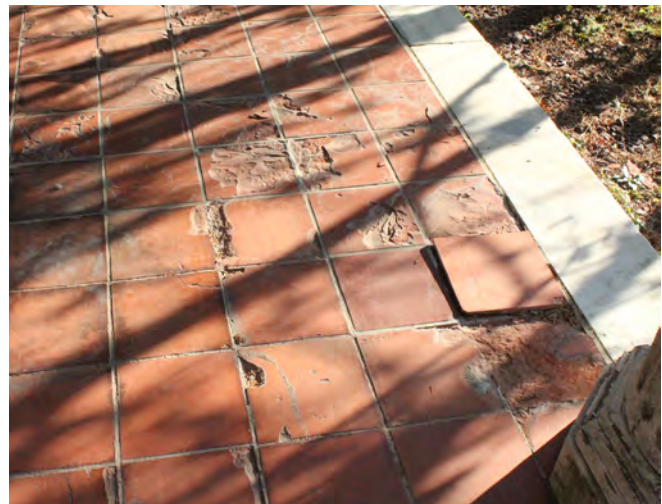
Figure II-129. Deteriorated clay tile at porch. (HA, 2015)

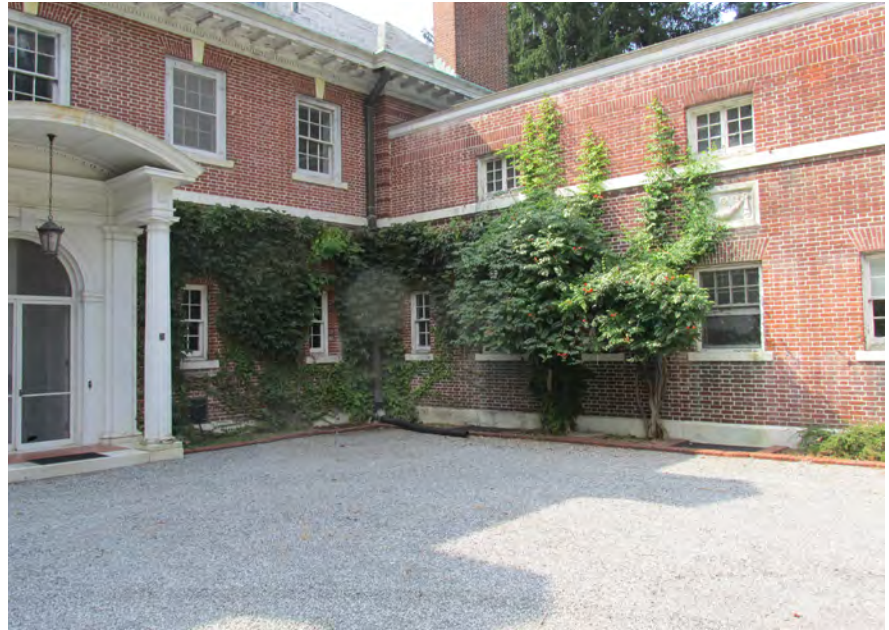
Figure II-137. Extensive vines at intersection of main house and servant's wing. (HA, 2015)

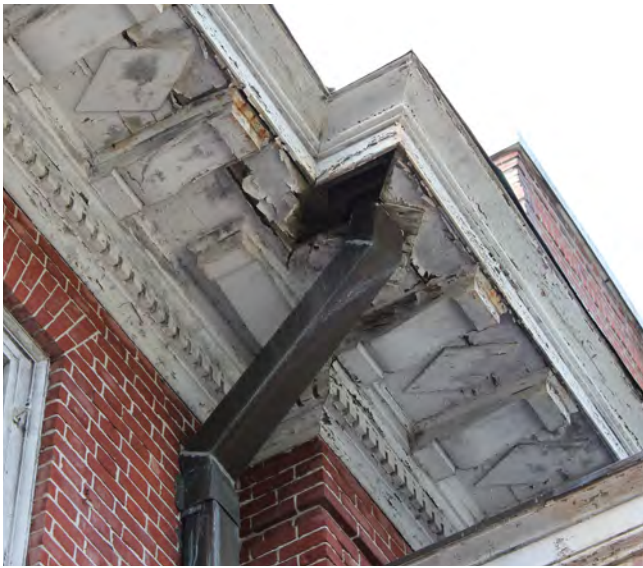
The projecting cornice is typically in fair to good condition with the wood elements being sound although there is some loose trim. The cornice soffit at the areas of the downspouts and the southern half of the west elevation cornice soffit are in poor condition. At these areas the soffit panels are rotted and sections have holes and missing elements. This damage is likely related to leaks in the built in gutters that are concealed in the cornice. The advanced deteriorated conditions at these areas suggest that the concealed framing and decking for the gutters may also be rotted and damaged at these locations.

Figure II-138. Rotted wood soffit at downspout. (HA, 2015)

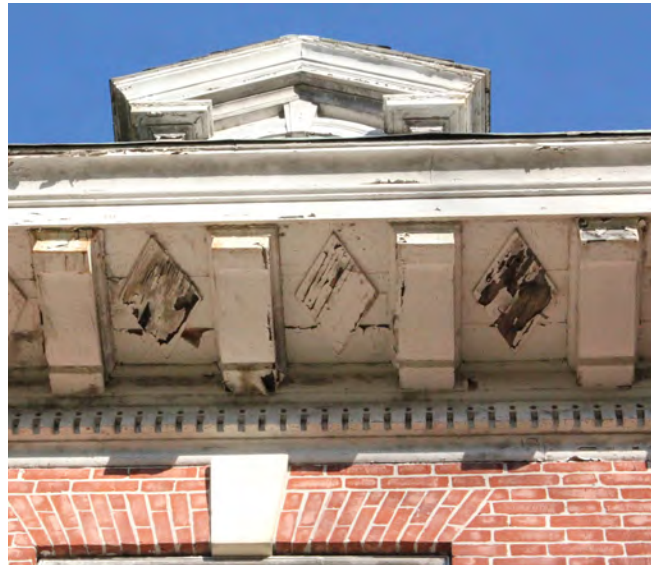
Figure II-139. Paint failure and rotted wood soffit elements. (HA, 2015)

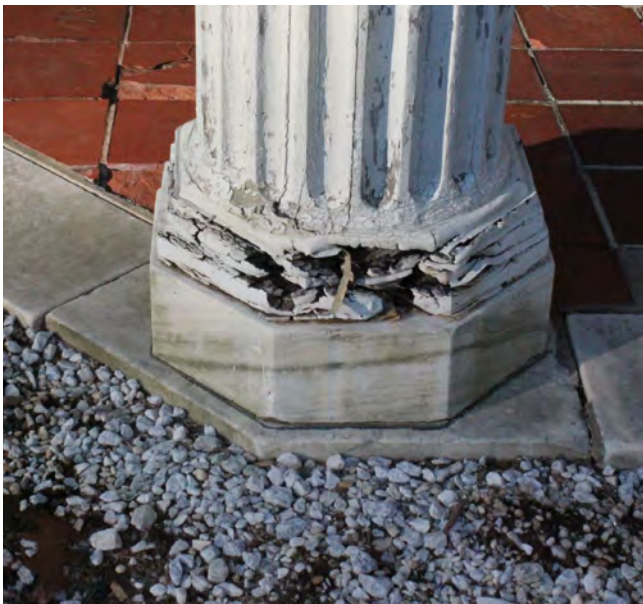
Figure II-140. Non-original octagonal wood column base at south porch. (HA, 2015)

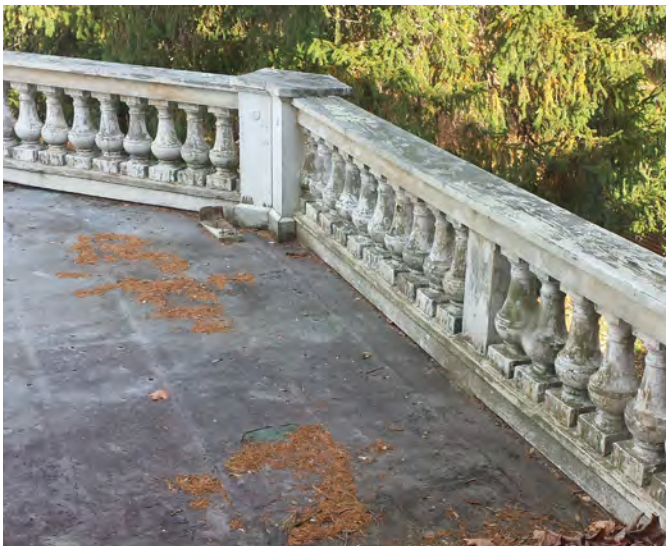
The baluster railings at the roofs of the north and south porches are in poor condition. It is believed that the corner columns as well as the top and bottom rails were replaced in 19xx (per tom.....). The top rail is severely rotted and the bottom rail is slightly to moderately rotted. The turned balusters are believed to be original and are in good to fair condition. They have some weathering and UV damage, but appear to be sound.

Figure II-142. Baluster railing at north porch. (HA, 2015)

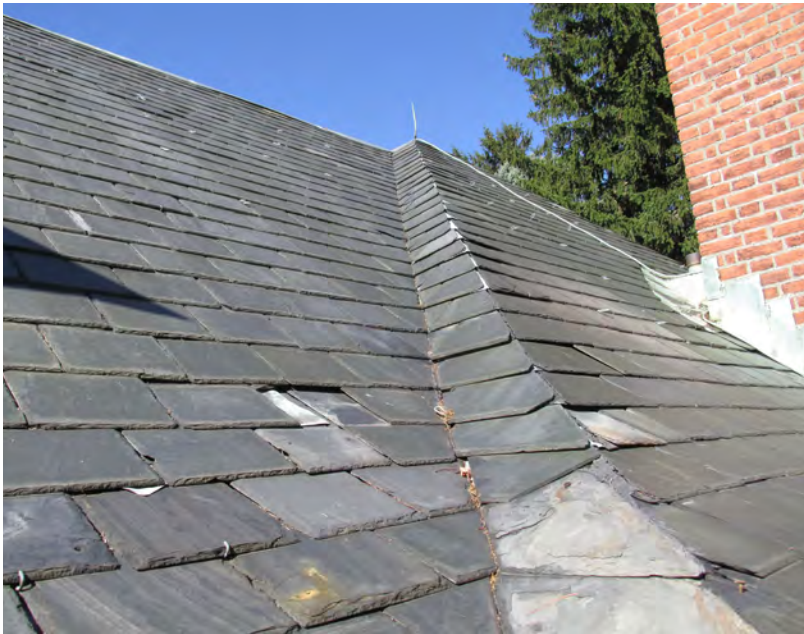
Figure II-148. Slate roof showing eroded and missing tiles. (HA, 2015)

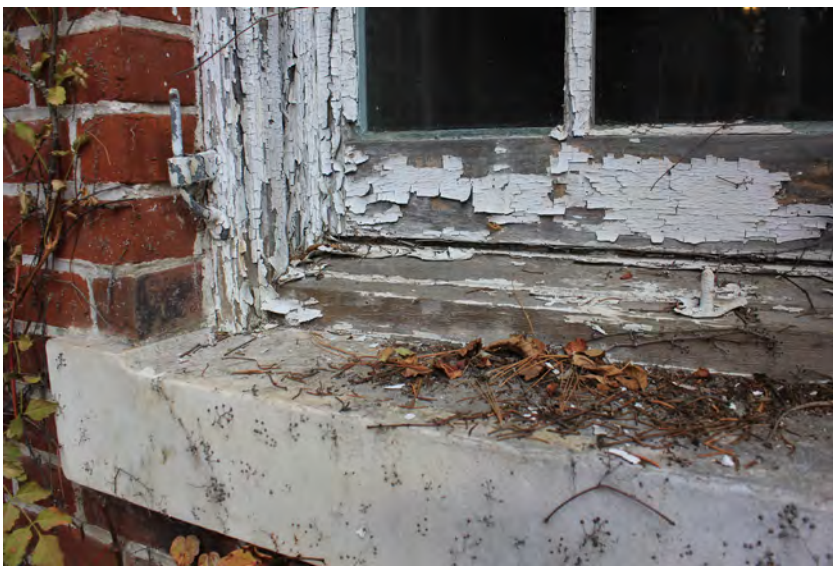
Figure II-173. Paint failure at windows. (HA, 2015)

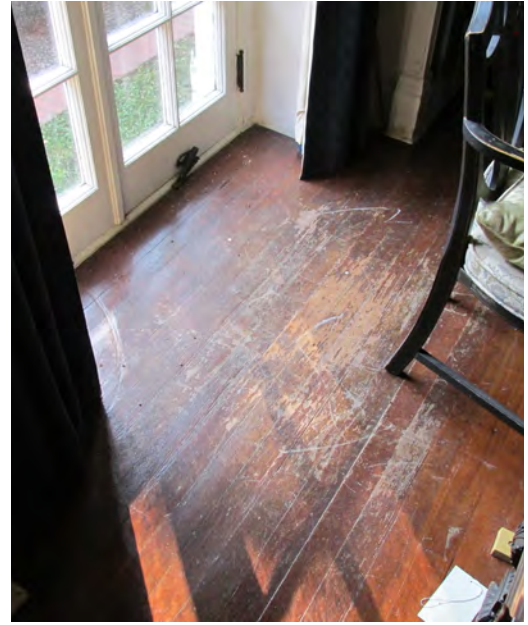
Figure II-208. UV damage and scratches at Library (105) floor (HA, 2015)

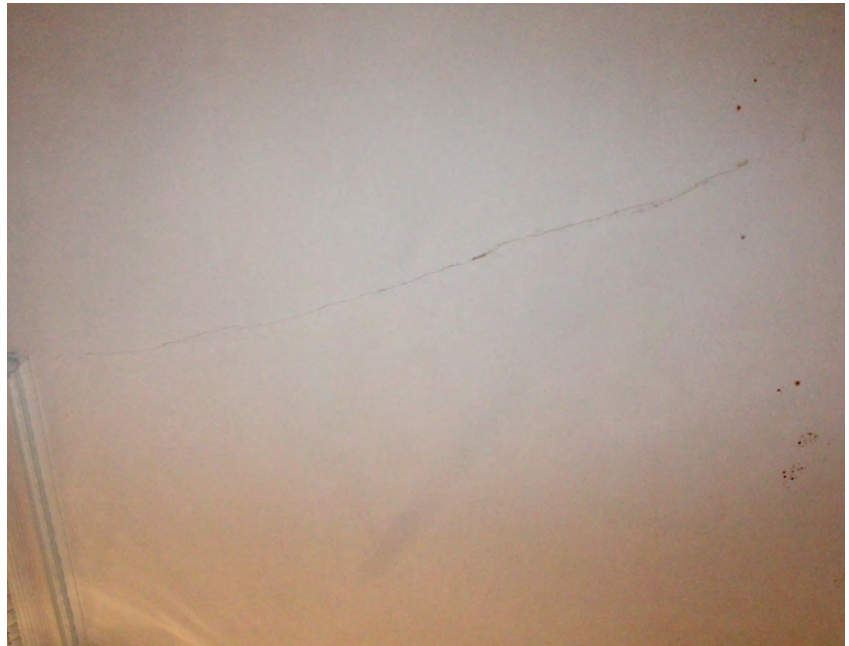
Figure II-222. Ceiling crack in the Living Room (106) ceiling (HA, 2015)

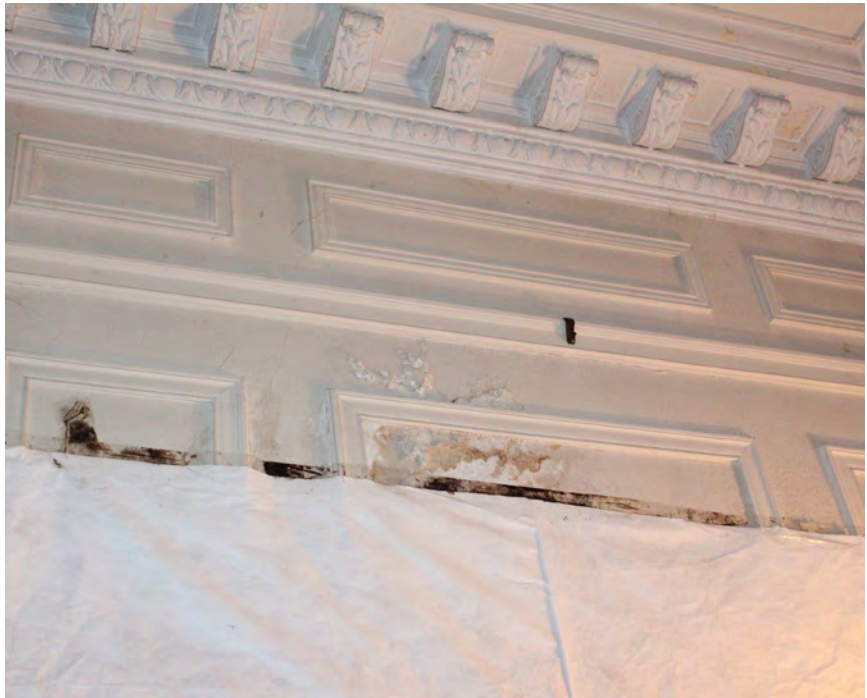
Figure II-224. Water damaged plaster in Dining Room (108). (HA, 2015)

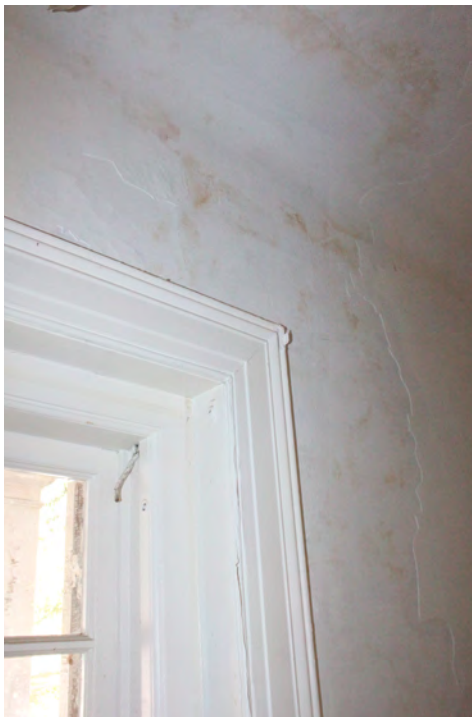
Figure II-226. Chipped paint and water staining at exterior wall in Servant's Corridor (115). (HA, 2015)

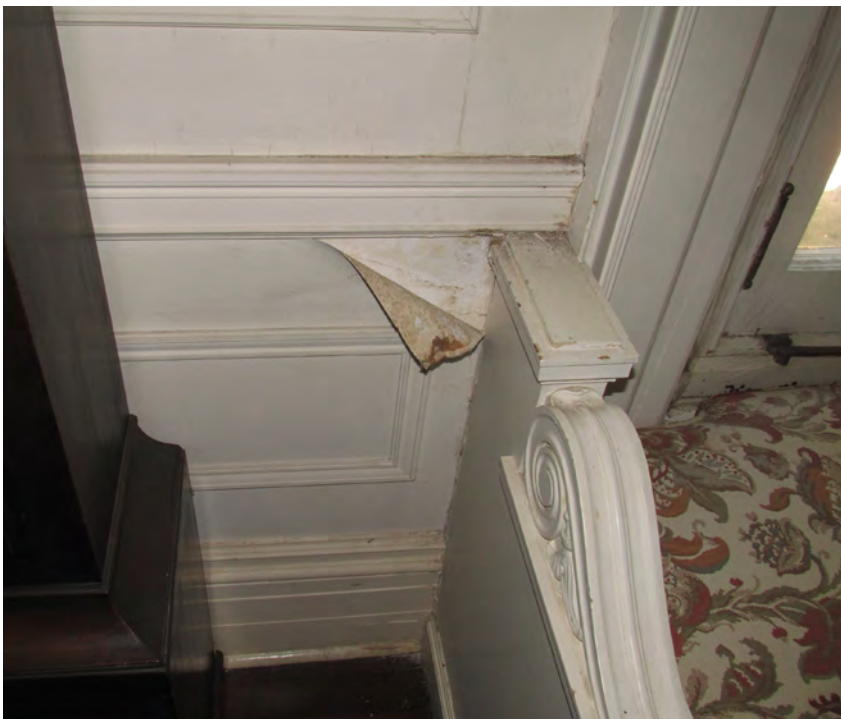
Figure II-228. Peeling canvas in main stair landing (201). (HA, 2015)

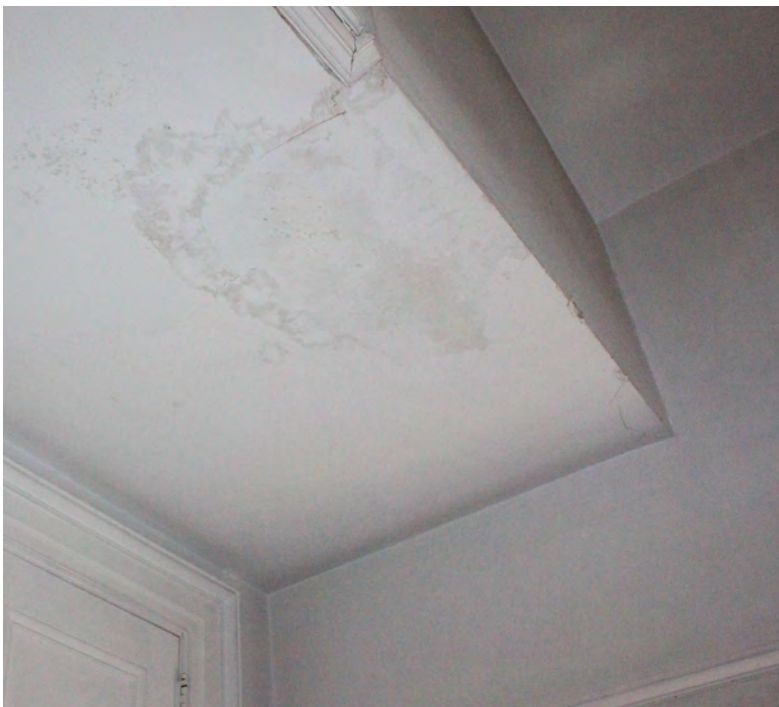
Figure II-230. Water staining at third floor Stair (204) ceiling. (HA, 2015)

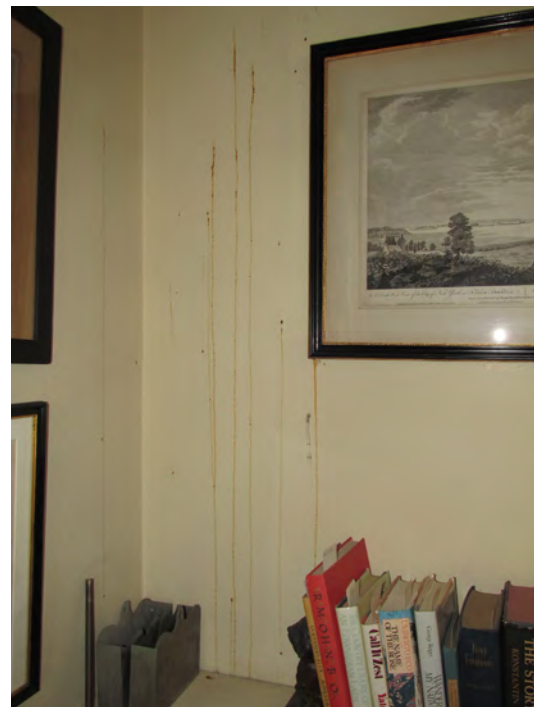
Figure II-231. Staining/drip marks on Bedroom 1 (216) wall. (HA, 2015)

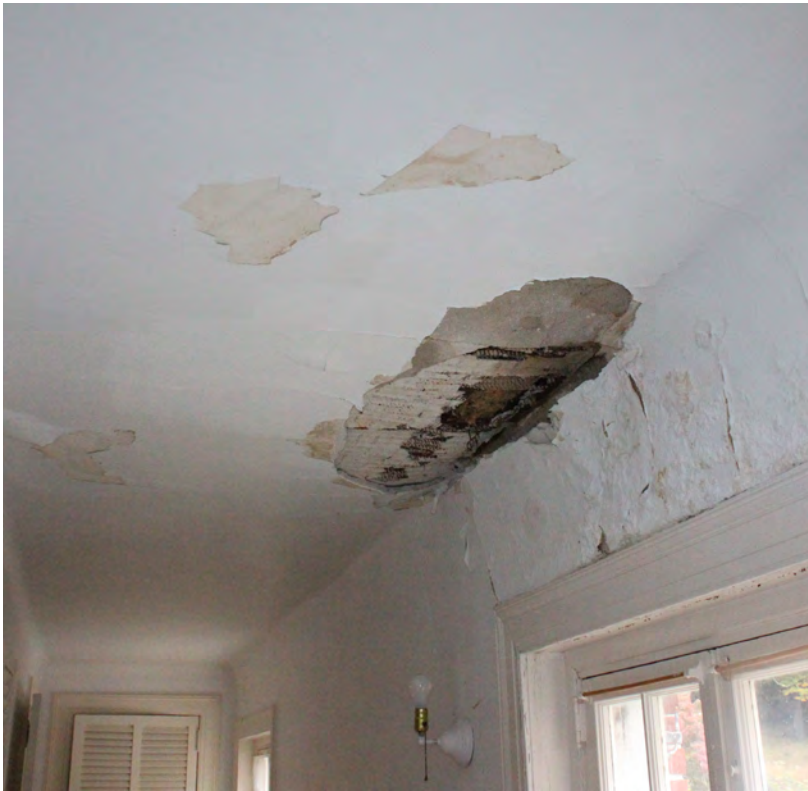
Figure II-232. Plaster and paint failure due to water infiltration in Servant's Corridor (224). (HA, 2015)

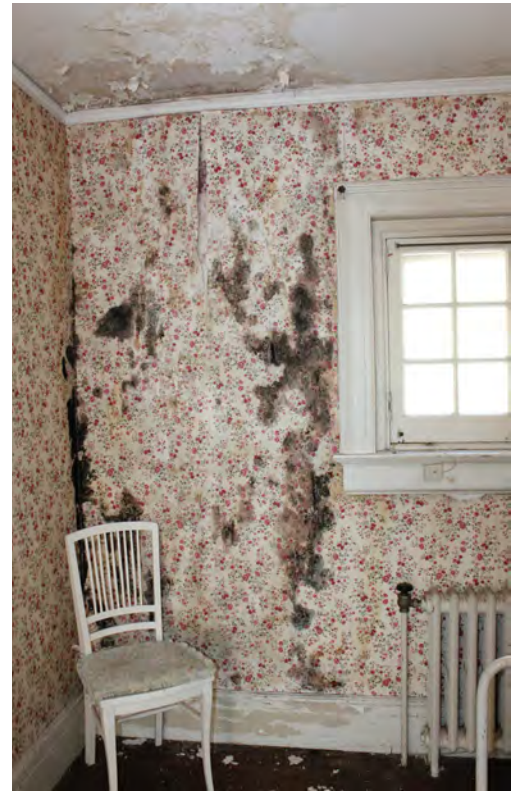
Figure II-233. Mold growth, water staining and peeling paint and wallpaper in Servant's Bedroom D (222). (HA, 2015)

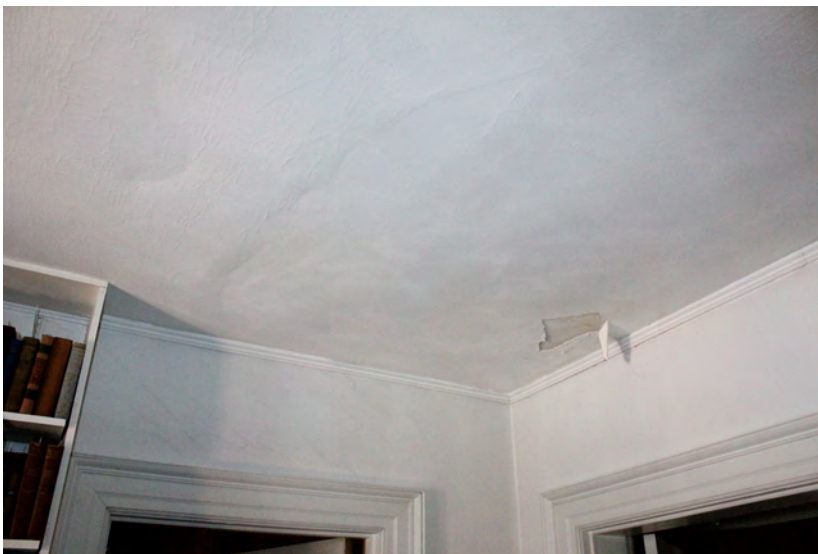
Figure II-234. Crazed and peeling paint at third floor Hall (301) ceiling. (HA, 2015)

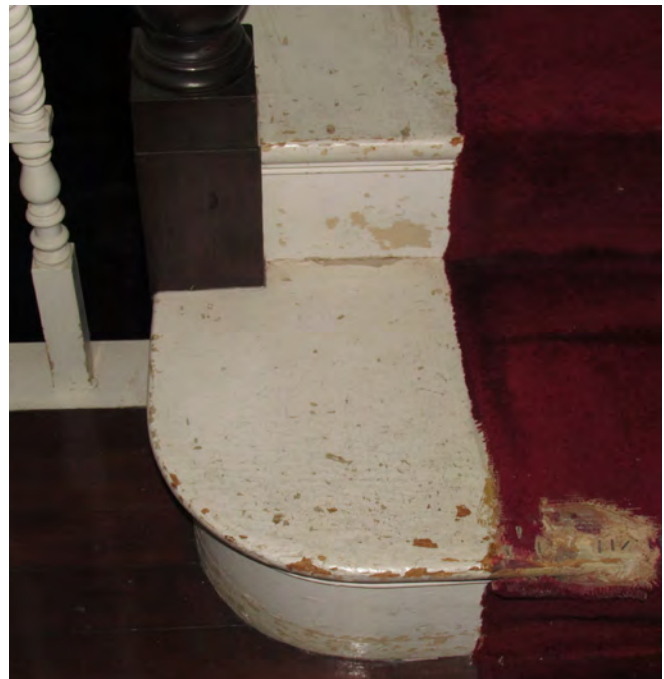
Figure II-240. Scratches and nicks at main stair painted treads and risers. (HA, 2015)

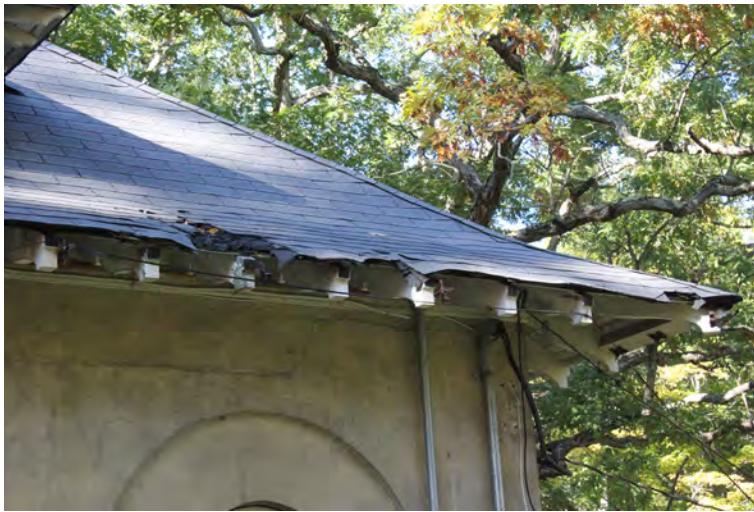
Figure III-51. Impact damage to asphalt shingles. (HA, 2015)

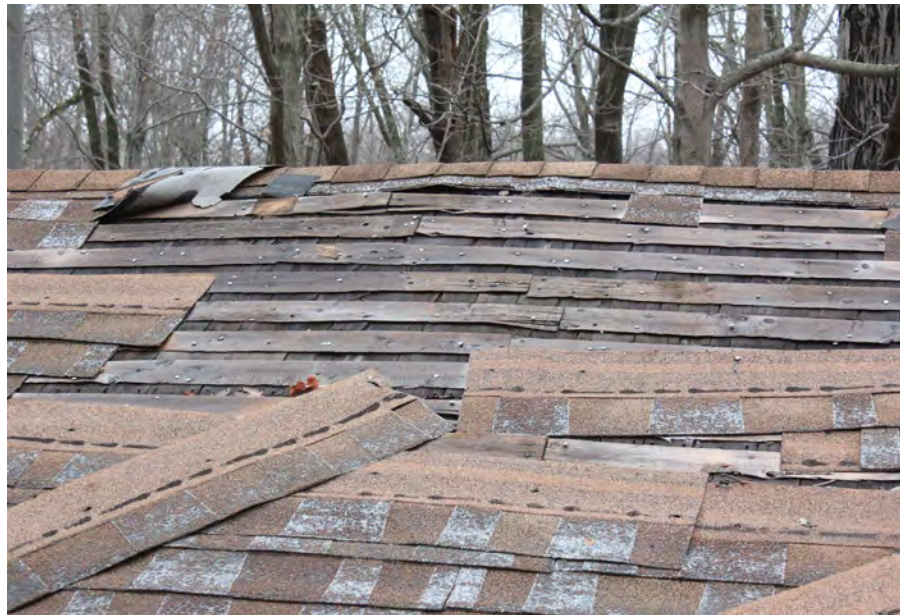
Figure III-135. Missing and loose asphalt shingles. (HA, 2015)

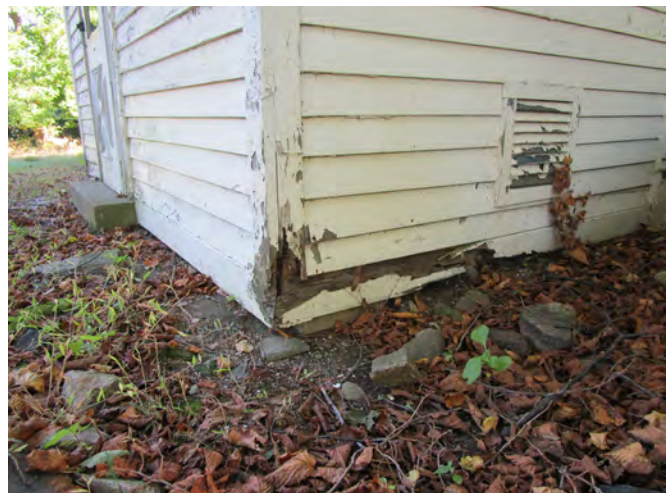
Figure IV-29. Rotted and loose clapboard siding. (HA, 2015)

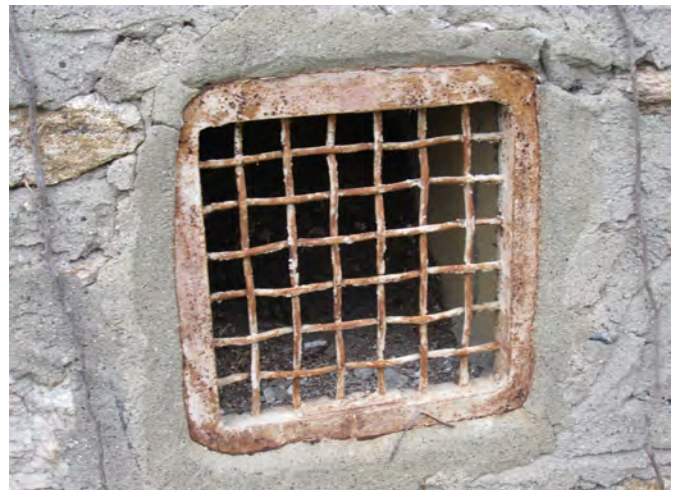
Figure IV-104. Corroded metal vent in fieldstone walls. (HA, 2015)

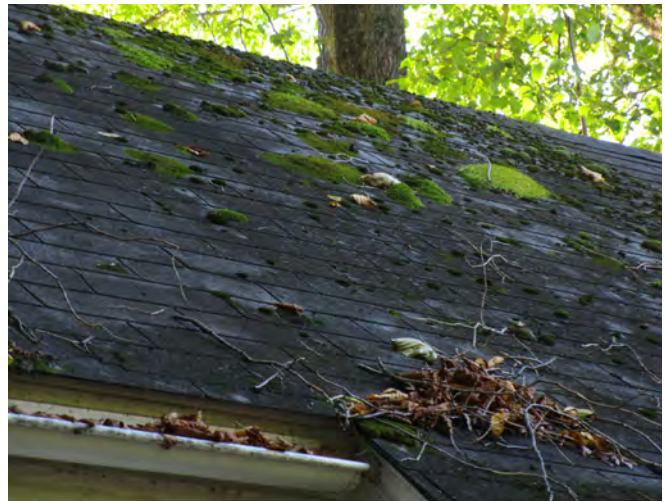
Figure IV-163. Worn shingles and biological growth and debris on roof. (HA, 2015)

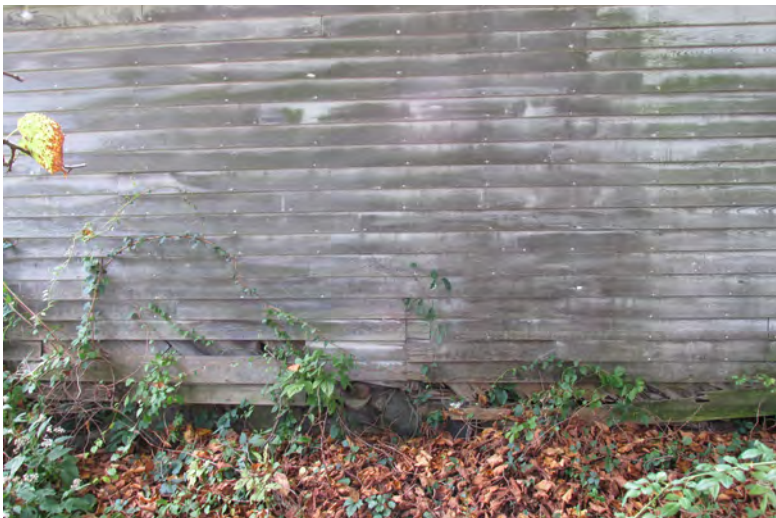
Figure IV-170. Worn paint finishes and damaged clapboard siding. (HA, 2015)

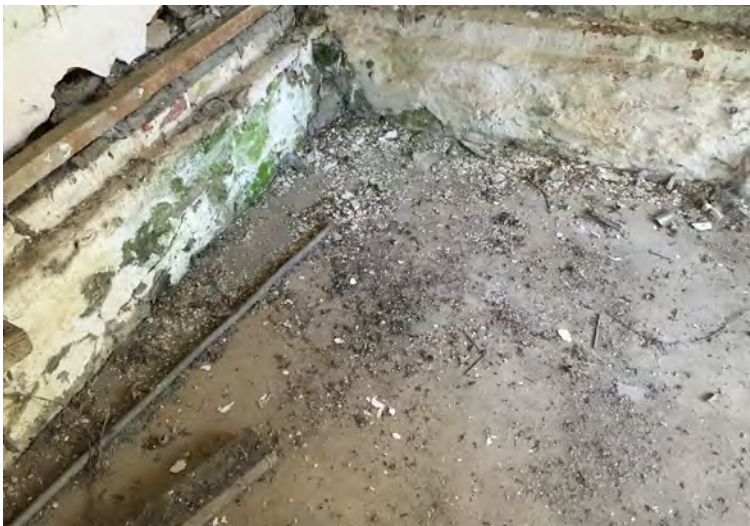
Figure IV-191. Debris on concrete floor. (HA, 2015)

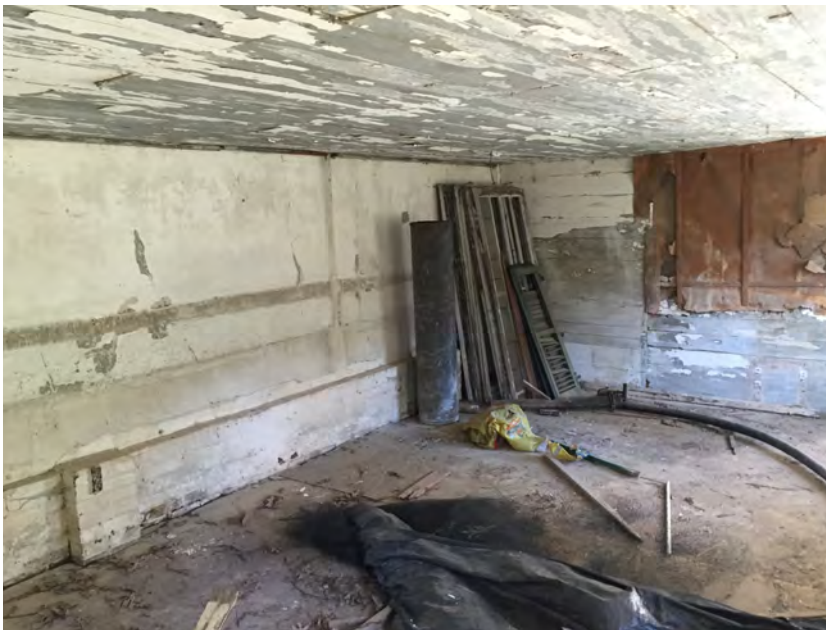
Figure IV-193. Peeling paint at walls and ceiling. (HA, 2015)
