### INSPECTION REPORT FORM WESTCHESTER COUNTY DEPARTMENT OF PARKS, RECREATION, AND CONSERVATION (DPRC) WOODLANDS LAKE DAM

INSPECTION COMPLETED BY: JF DATE OF INSPECTION: 9/9/21

GDAM NAME: Woodlands Lake Dam

NYSDEC # 214-0235

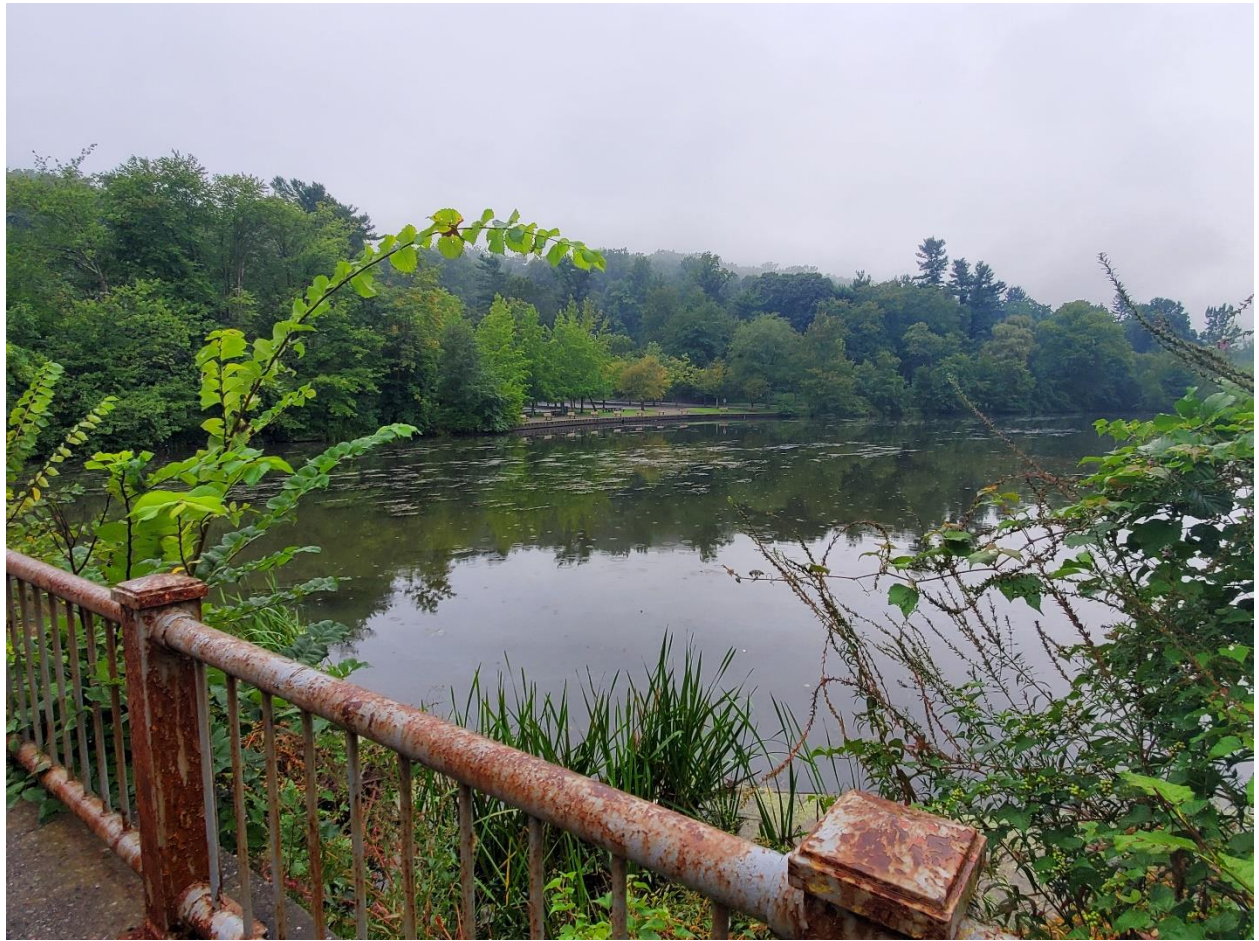
AREA INSPECTED	ITEM NO.	CONDITION	OBSERVATIONS	MONITOR	INVESTIGATE	REPAIR
Crest	1	Surface conditions	Deteriorated walk	x		
	2	Horizontal alignment	ok	x		
	3	Vertical alignment	ok	x		
	4	Unusual movements	none	x		
Upstream face	5	Surface condition/ misaligned stones	ok	x		
	6	Condition of joints	weathered	x		
	7	Unusual movement	none	x		
	8	Abutment-dam contacts	ok	x		
Downstream face	9	Surface condition/misaligned stones	Unable to access	x		
	10	Condition of joints	“	x		
	11	Unusual movement	“	x		
	12	Abutment-dam contacts	ok	x		
	13	Seepage	some	x

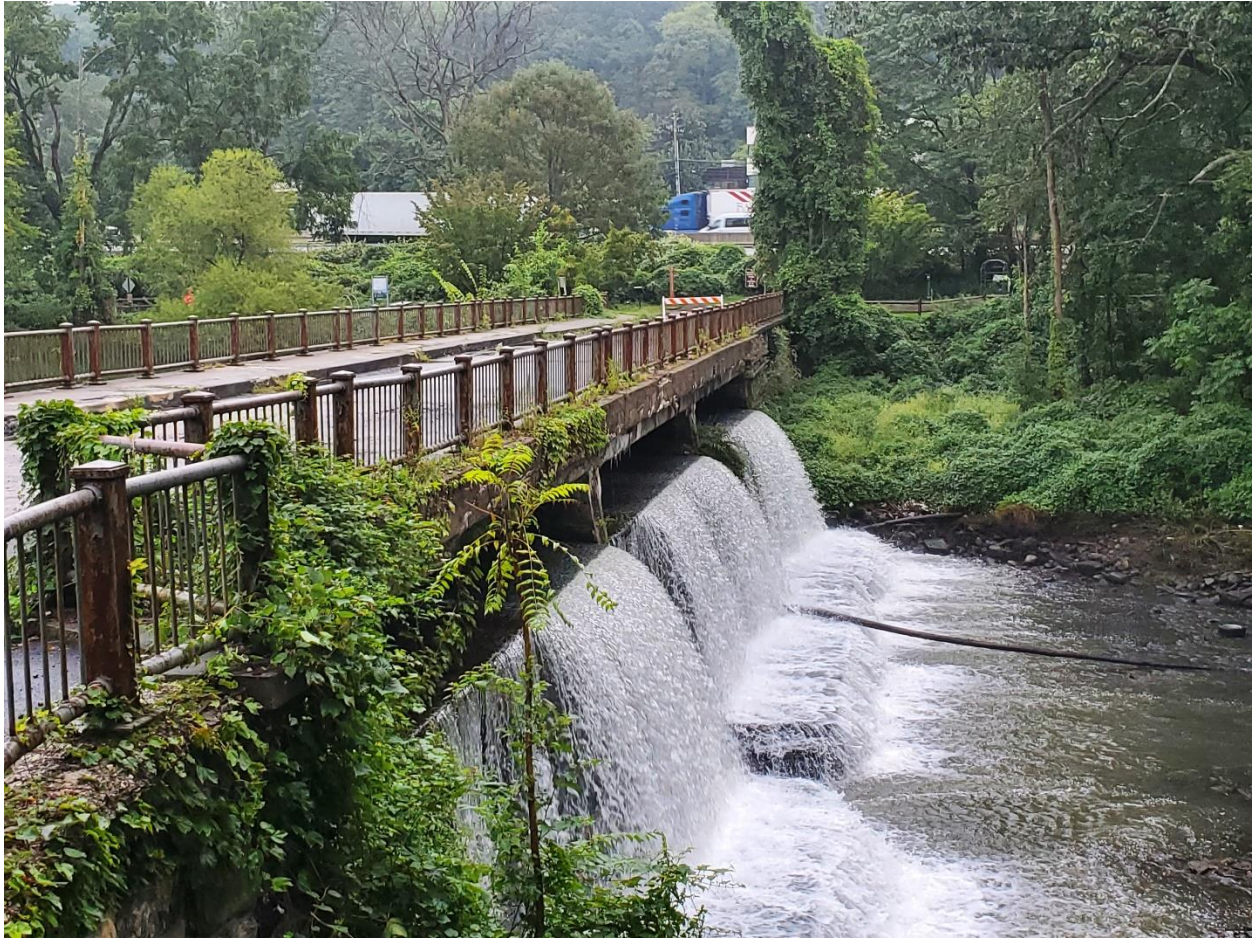
AREA INSPECTED	ITEM NO.	CONDITION	OBSERVATIONS	MONITOR	INVESTIGATE	REPAIR
Spillway	14	Sidewalls	ok	x		
	15	Channel floor	ok	x		
	16	Unusual movement	none	x		
	17	Approach area	ok	x		
	18	Spillway obstructions	debris /limbs	x		
	19	Discharge channel <sup>(1)</sup>	ok	x

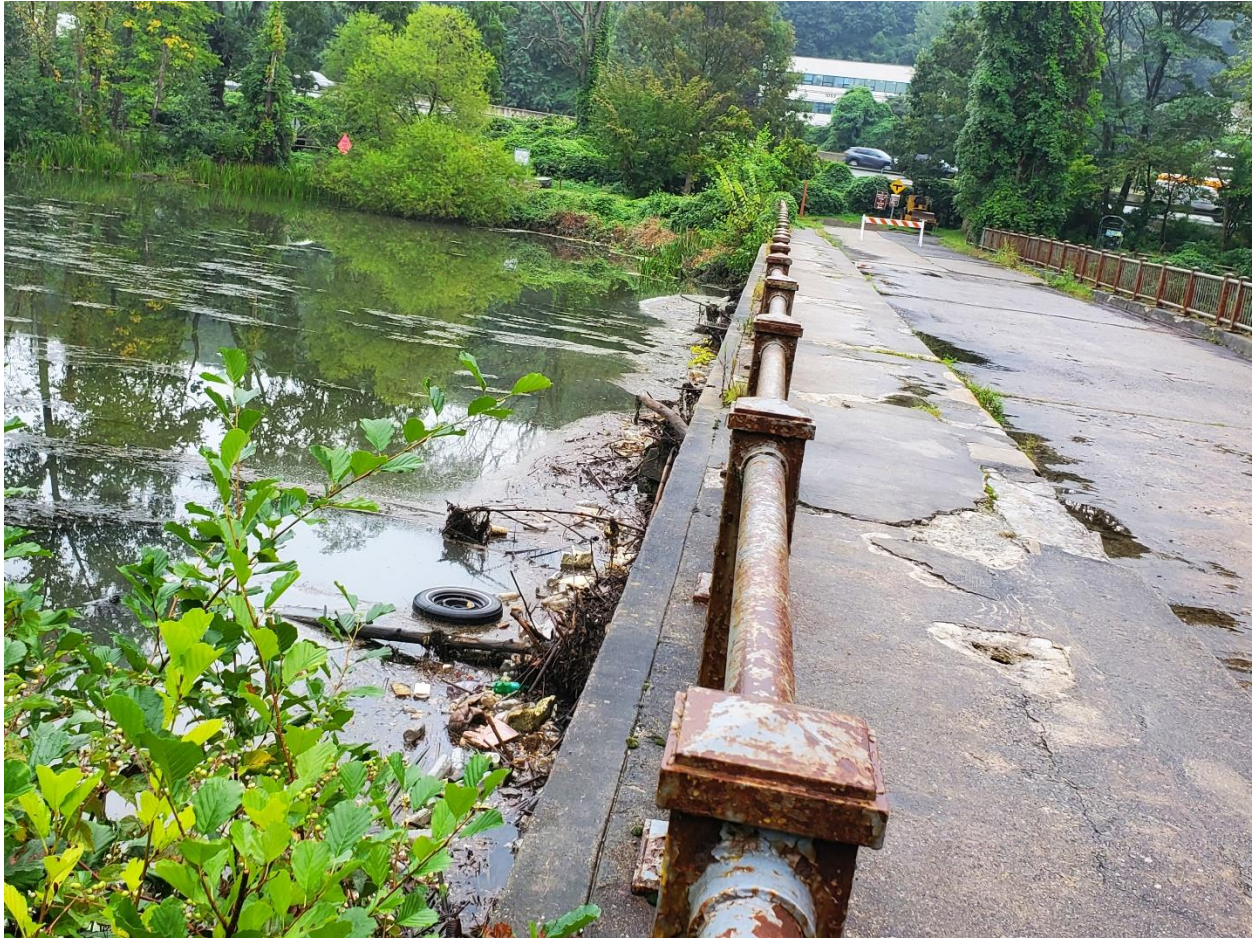
## DEBRIS AT SPILLWAY
