APPENDIX
INSPECTION REPORT FORM
WESTCHESTER COUNTY DEPARTMENT OF PARKS,
RECREATION AND CONSERVATION (DPRC)
PINE LAKE DAM AND CAUSEWAY

INSPECTION REPORT FORM

TIBBETTS LAKE DAM #1

INSPECTION REPORT FORM
PELHAM LAKE DAM

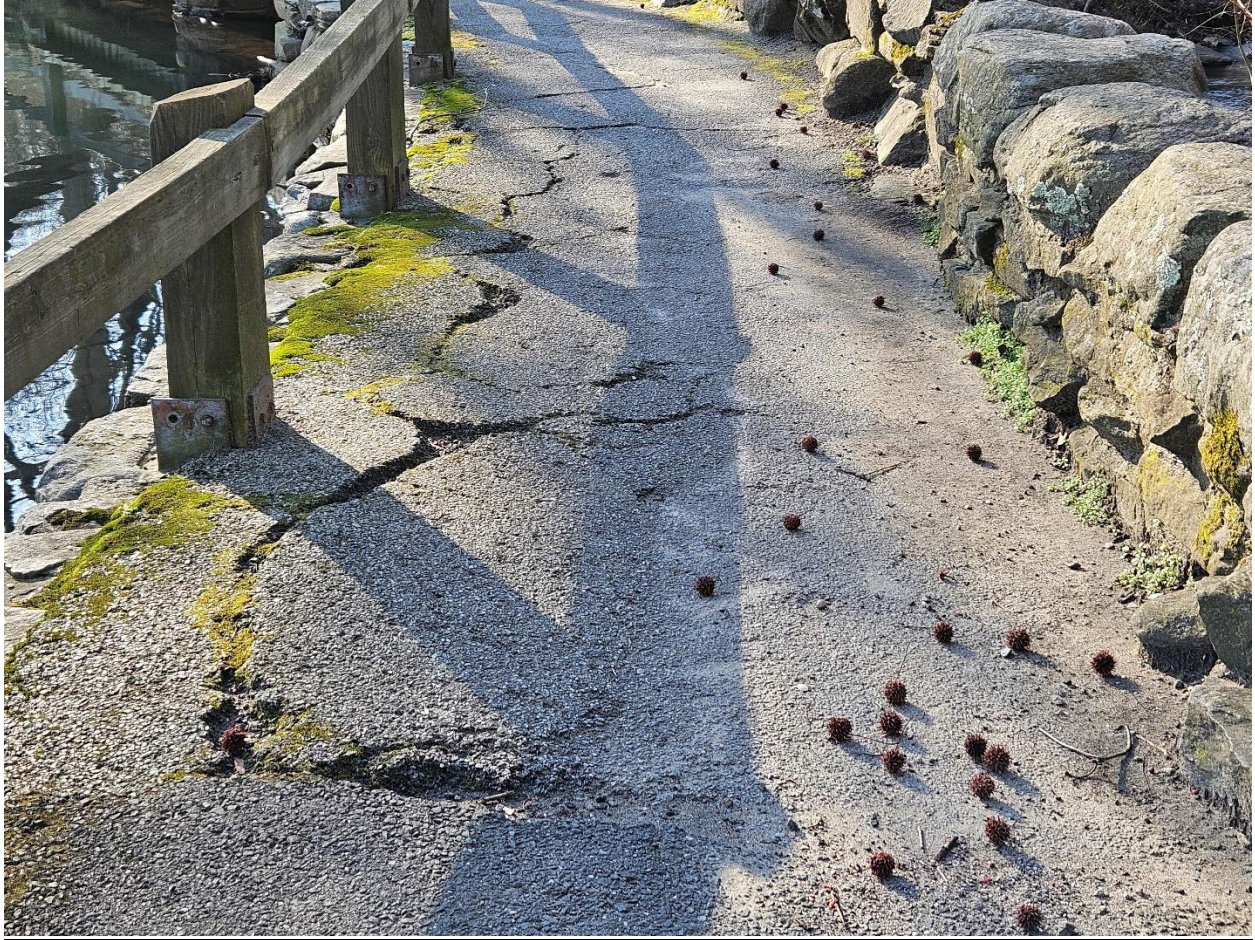
Signs of stress on asphalt walkway see photo below
