PHASE IB ARCHAEOLOGICAL SURVEY

PROPOSED IMPROVEMENTS LASDON PARK AND ARBORETUM

TOWN OF SOMERS
WESTCHESTER COUNTY, NEW YORK

SEPTEMBER 20, 2021

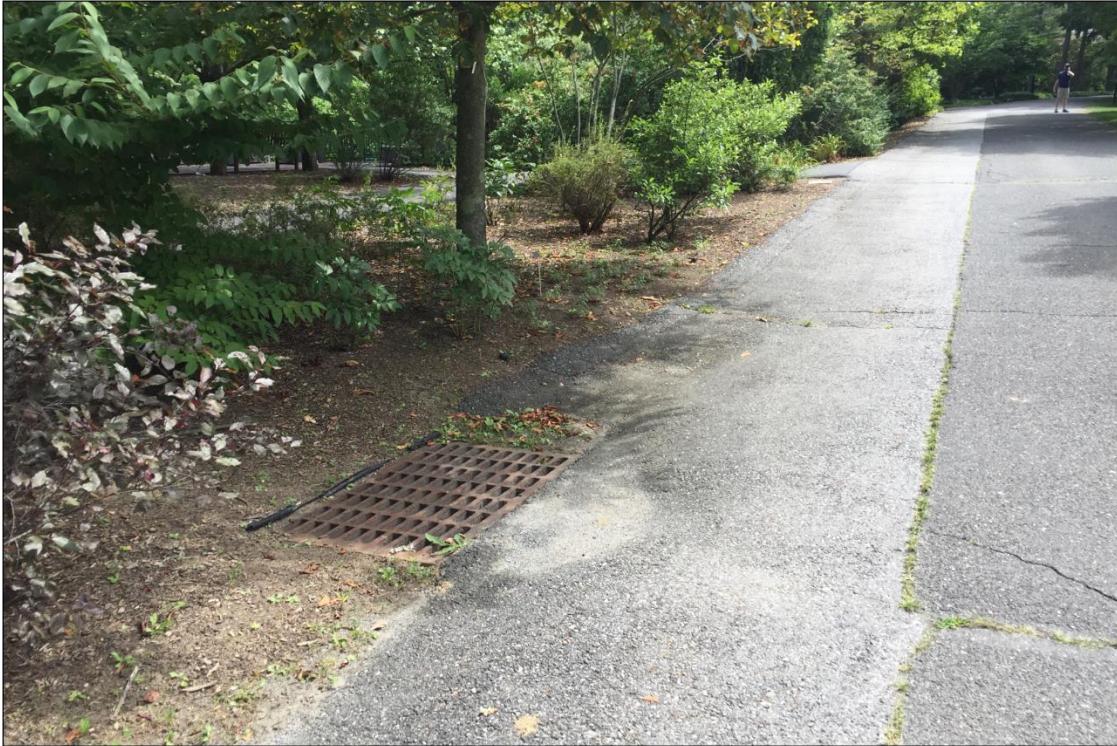
Photograph 1. Central Drive just West of the Fountain, showing Existing Storm Drainage Installed in Shoulder, View Southeast

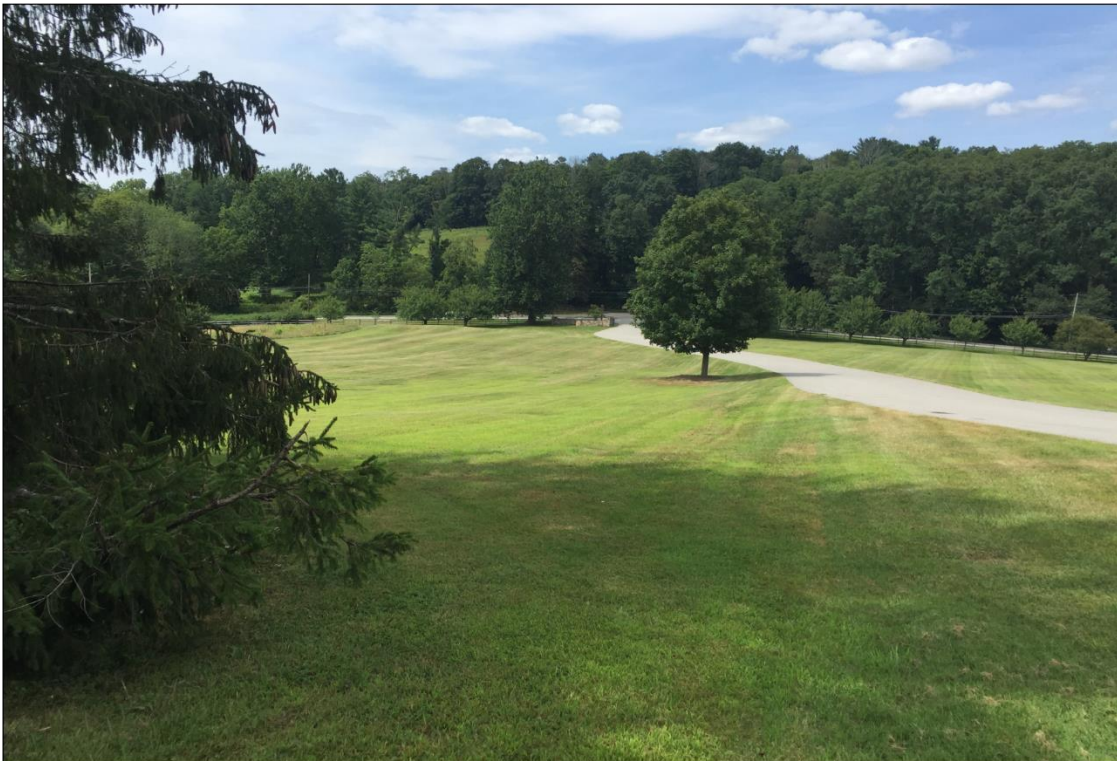
Photograph 2. Proposed Septic Field Location North of the Arboretum Fence, with Amawalk Road in the Background, View North.

Transect F (F1 to F6) was excavated in the proposed septic field area adjacent to the main entrance drive (see Figure 2, Photograph 2). Shovel test profiles in this portion of the project area were consistent, with a dark grayish brown (10YR 4/3) silt loam topsoil overlying a yellowish brown (10YR 5/6) silt loam subsoil. The topsoil stratum ranged from 29 to 36 centimeters (1.0 to 1.2 feet) in thickness. Gravels and cobbles were common throughout the soil profile. No artifacts were recovered from Transect F.

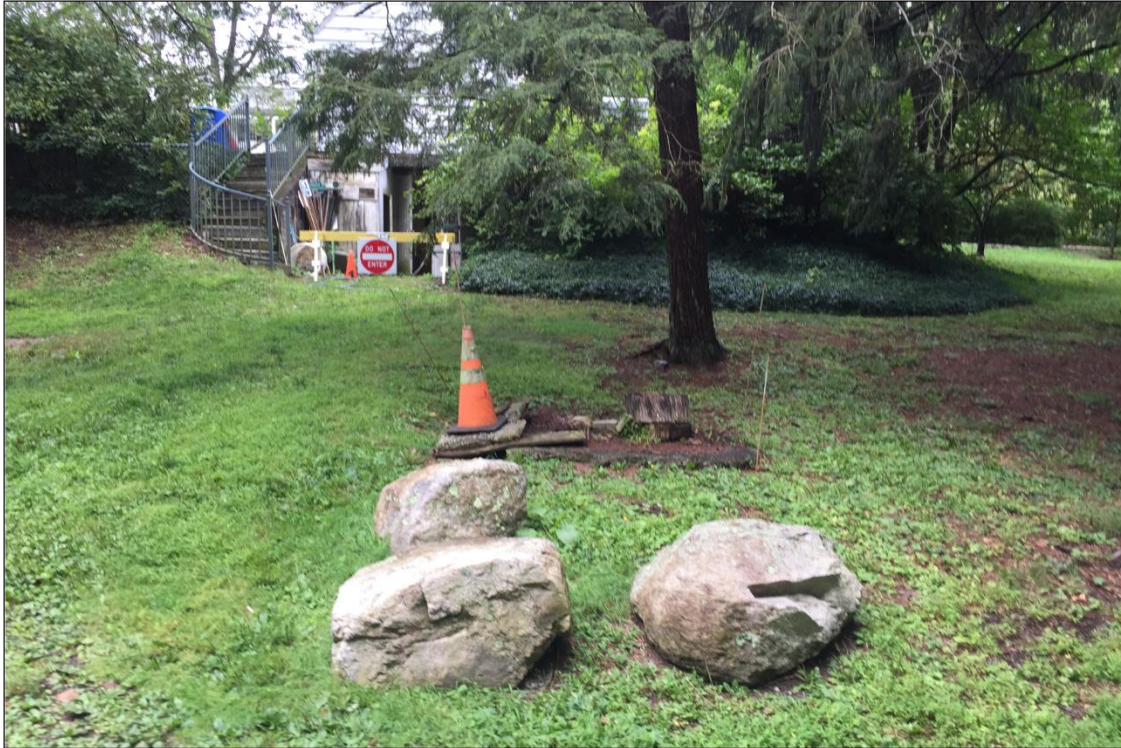
Photograph 3. Proposed Sewerline Location East of the Gift Shop and Restrooms, View West

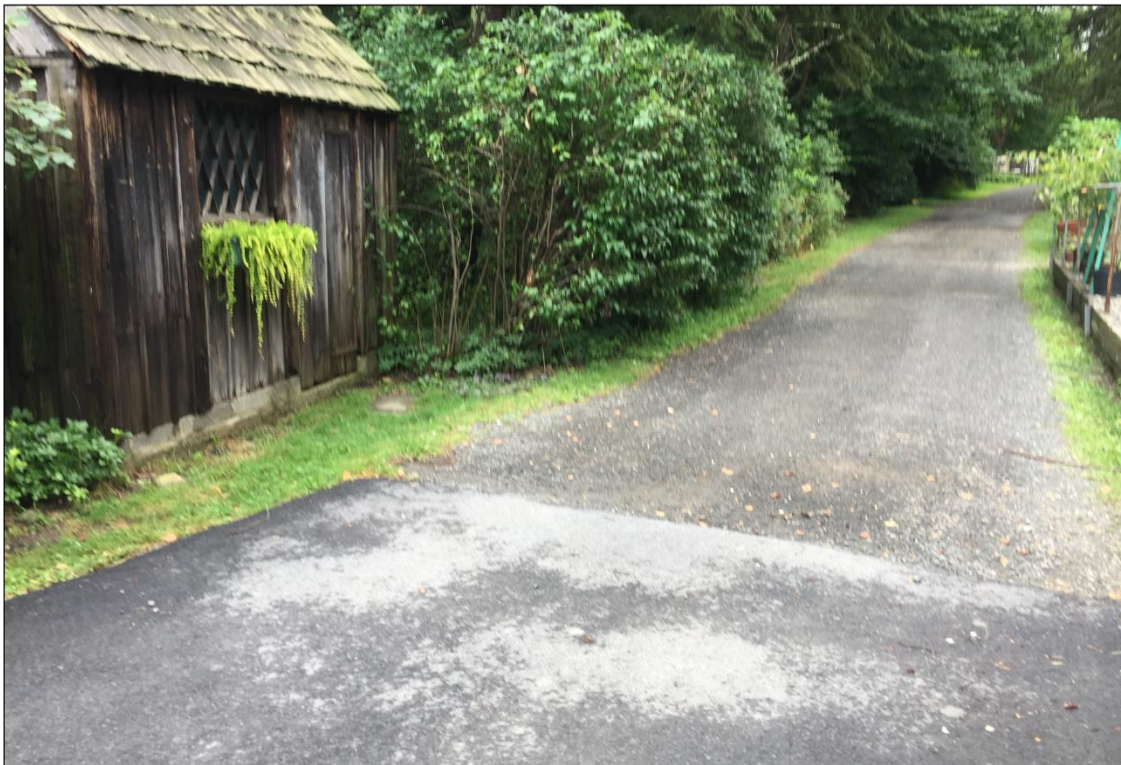
Photograph 4. Proposed Sewerline Location along Gravel Maintenance Road, East Side of APE, View South

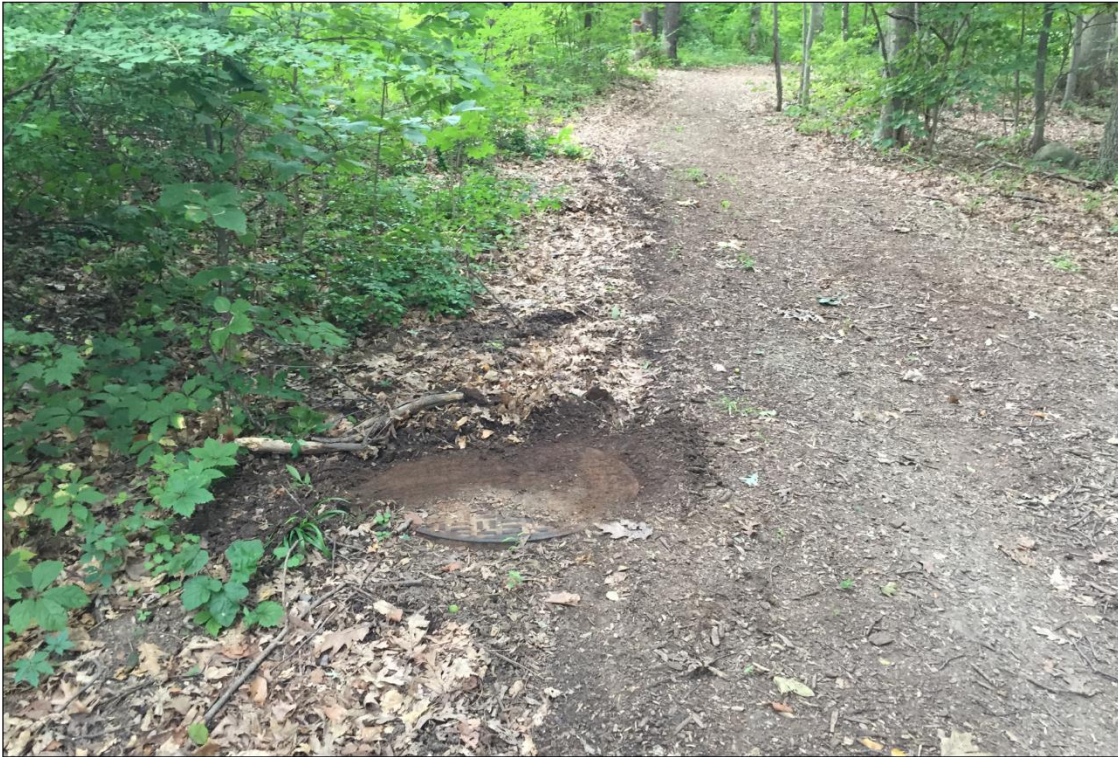
Photograph 5. Earthen Pathway along Western Side of APE (Transect W), with Buried Utility Line near Main House and Office, View South.

In addition to the septic improvements, the project includes the widening and/or resurfacing of most of the pathways in the arboretum proper (see Photographs 5-10, Figure 2). Existing pathways will be widened to a standard width of five feet (1.5 meters) and upgraded to pavement or other hard surface (see Photographs 5 and 6). Some existing pathways are already paved, but are too narrow, and some paths are already five feet in width, but need upgraded surfaces. A new pathway will be installed in a loop from the gift shop and conservatory south across the yard and then looping back around to the north to the Main House and Office (see Photographs 7 and 8, Figure 2).

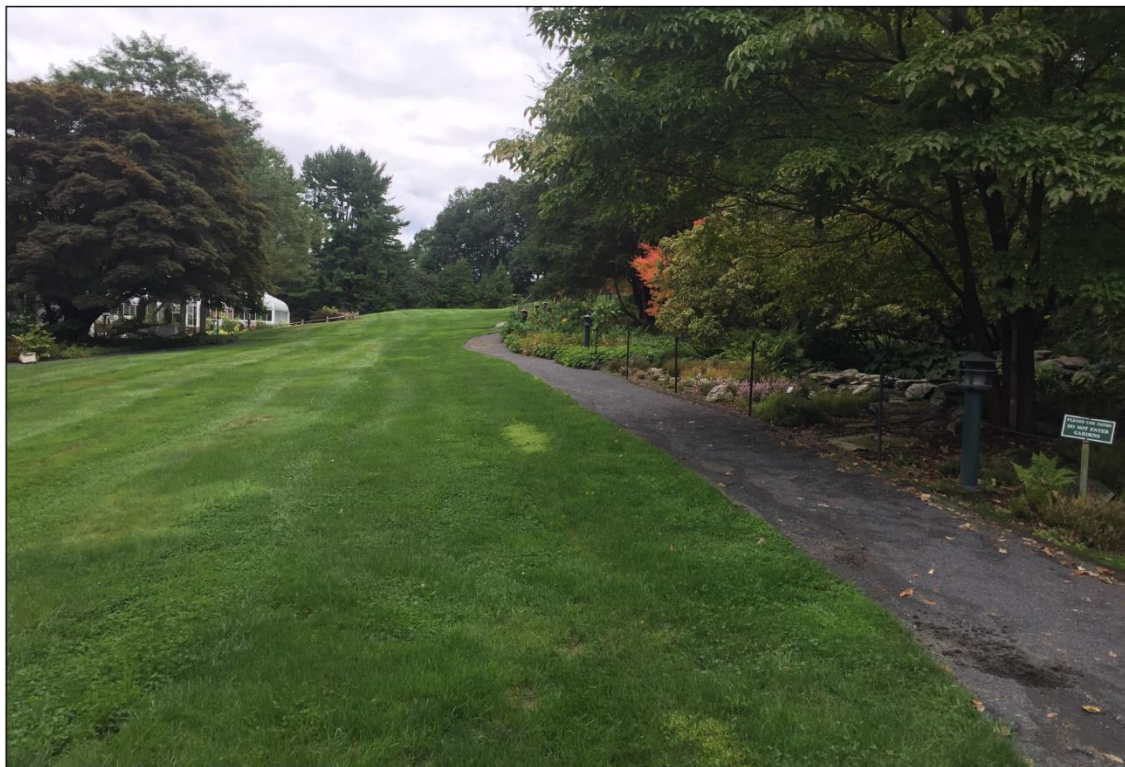
Photograph 6. Stone Dust Pathway along Sewerline Alignment (Transect S), View South

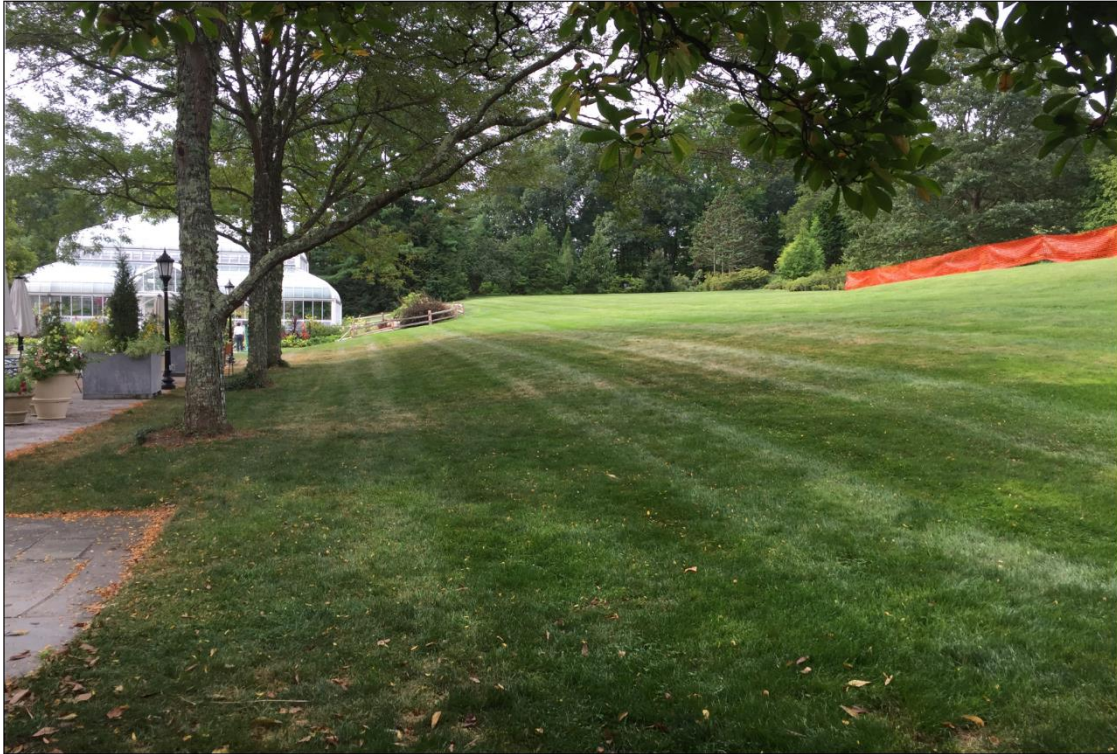
Photograph 7. Overview of Central Lawn Between Main House to the West and Conservatory to the East, View South

Shovel tests C1 to C18 were excavated in the flat-lying yard area immediately east of the main house (see Photographs 7 and 8, Figure 2). Shovel Tests in Transect C were excavated at 7.5-meter (25-foot) intervals due to proximity to the former residence, and possibly the original residence that burned and was replaced in the twentieth century. The location of the original structure is not clearly known, especially due to the extensive landscaping in the project area but is presumed to have been near the existing Main House. Generally, shovel test profiles were consistent with the soils observed along the paths downslope, with a thin topsoil capping a yellowish-brown gravelly silt loam B horizon. No artifacts were recovered from Transect C.

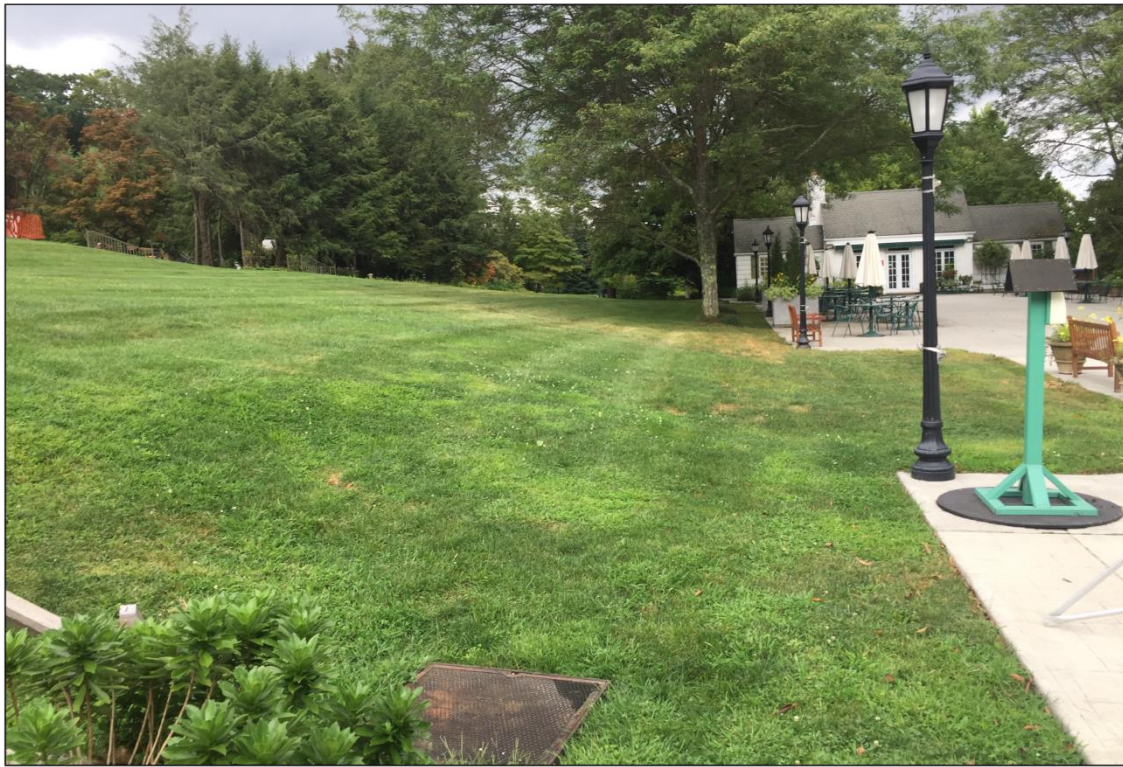
Photograph 8. Proposed Location of New Pathway from Gift Shop to the East and Continuing West along Sloping Yard to the Main House, View North

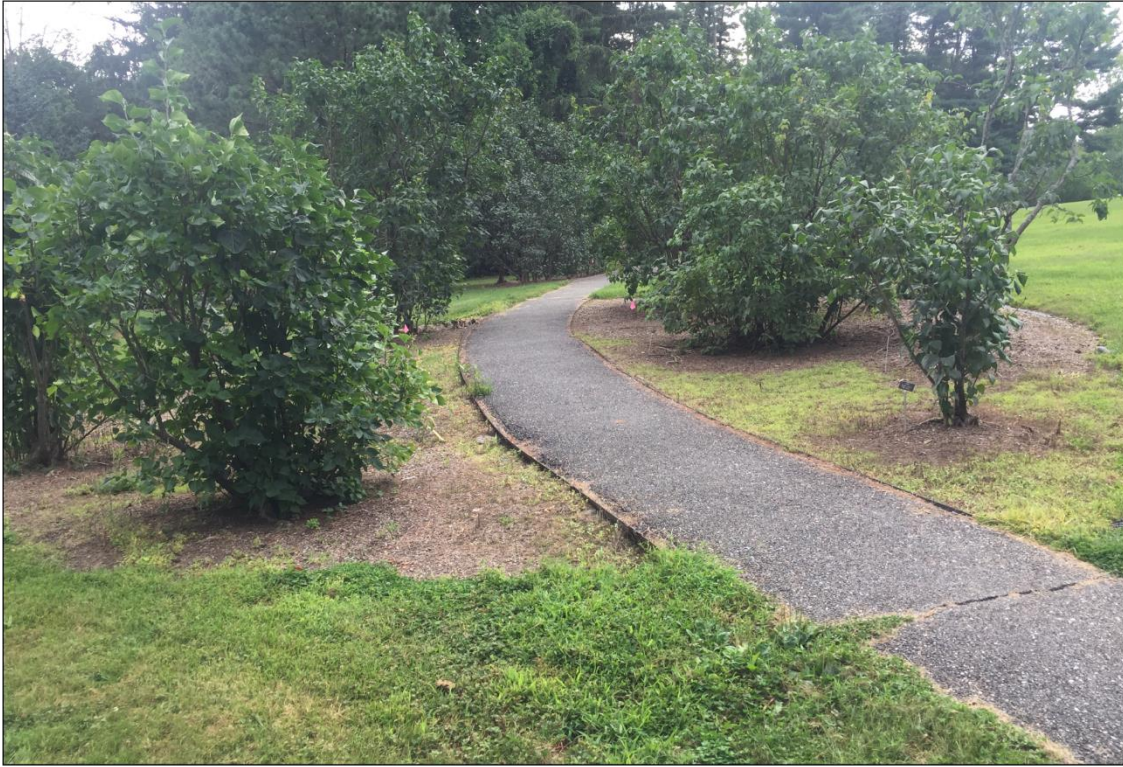
Photograph 9. Overview of Transect L, Showing Planting Beds along Proposed Path Widening, View Southeast

Shovel tests L1 to L30 were along the pathway which loop around the sloping hilltop at the center of the arboretum (see Photograph 9, Figure 2). This pathway winds around the shoulder slope of the hilltop, and is relatively flat, though a portion in the northwest segment of the path was greater than 12 percent slope. Shovel test profiles were consistent with the soil profiles throughout Transects F and L, with a dark grayish brown gravelly silt loam overlying a yellowish-brown gravelly loam B horizon (see Appendix A). As with Transect S, shovel tests in

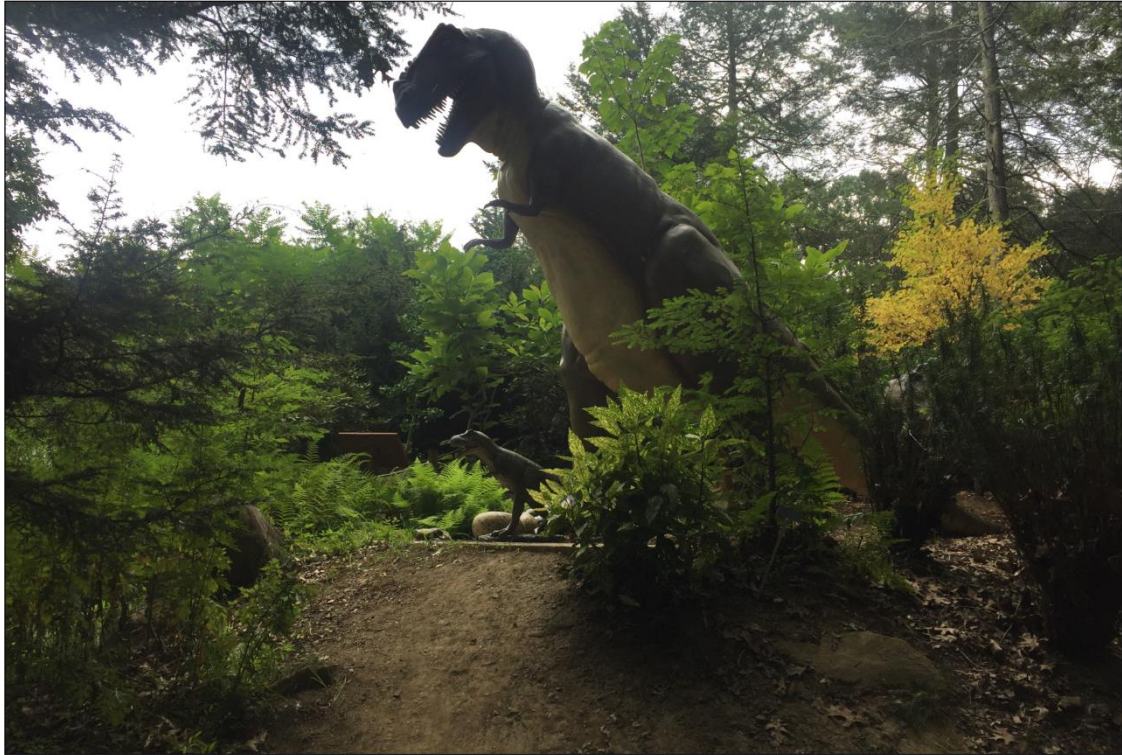
Photograph 10. Overview of Dinosaur Exhibit Adjacent to Transect W, showing Steep Slope in Foreground, View East

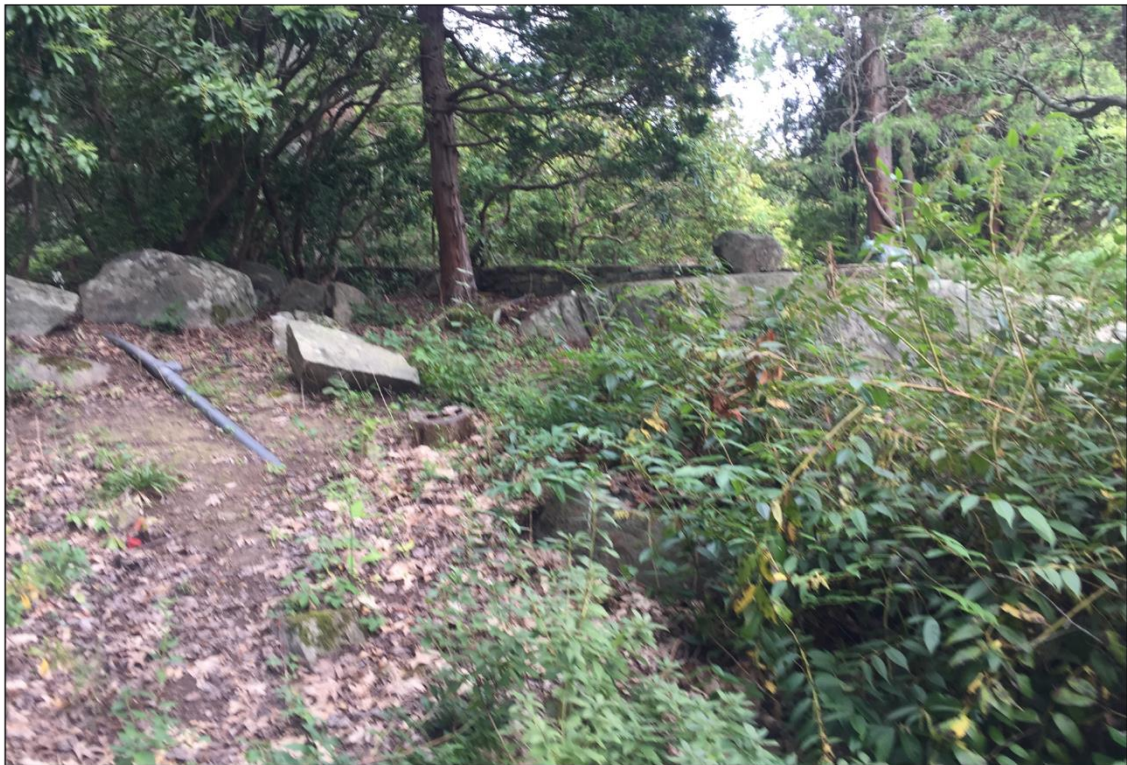
Photograph 11. Overview of South End of APE near Transect W, showing Shallow Bedrock and Partially Buried Subsurface Water Lines, View Southwest

horizon. Three shovel tests in this transect (W3, W8, and W11) encountered rock at less than 20 centimeters (0.6 feet) and were abandoned due to the impasse. Soil colors were consistent with Transects L and C. No artifacts were recovered from Transect W.

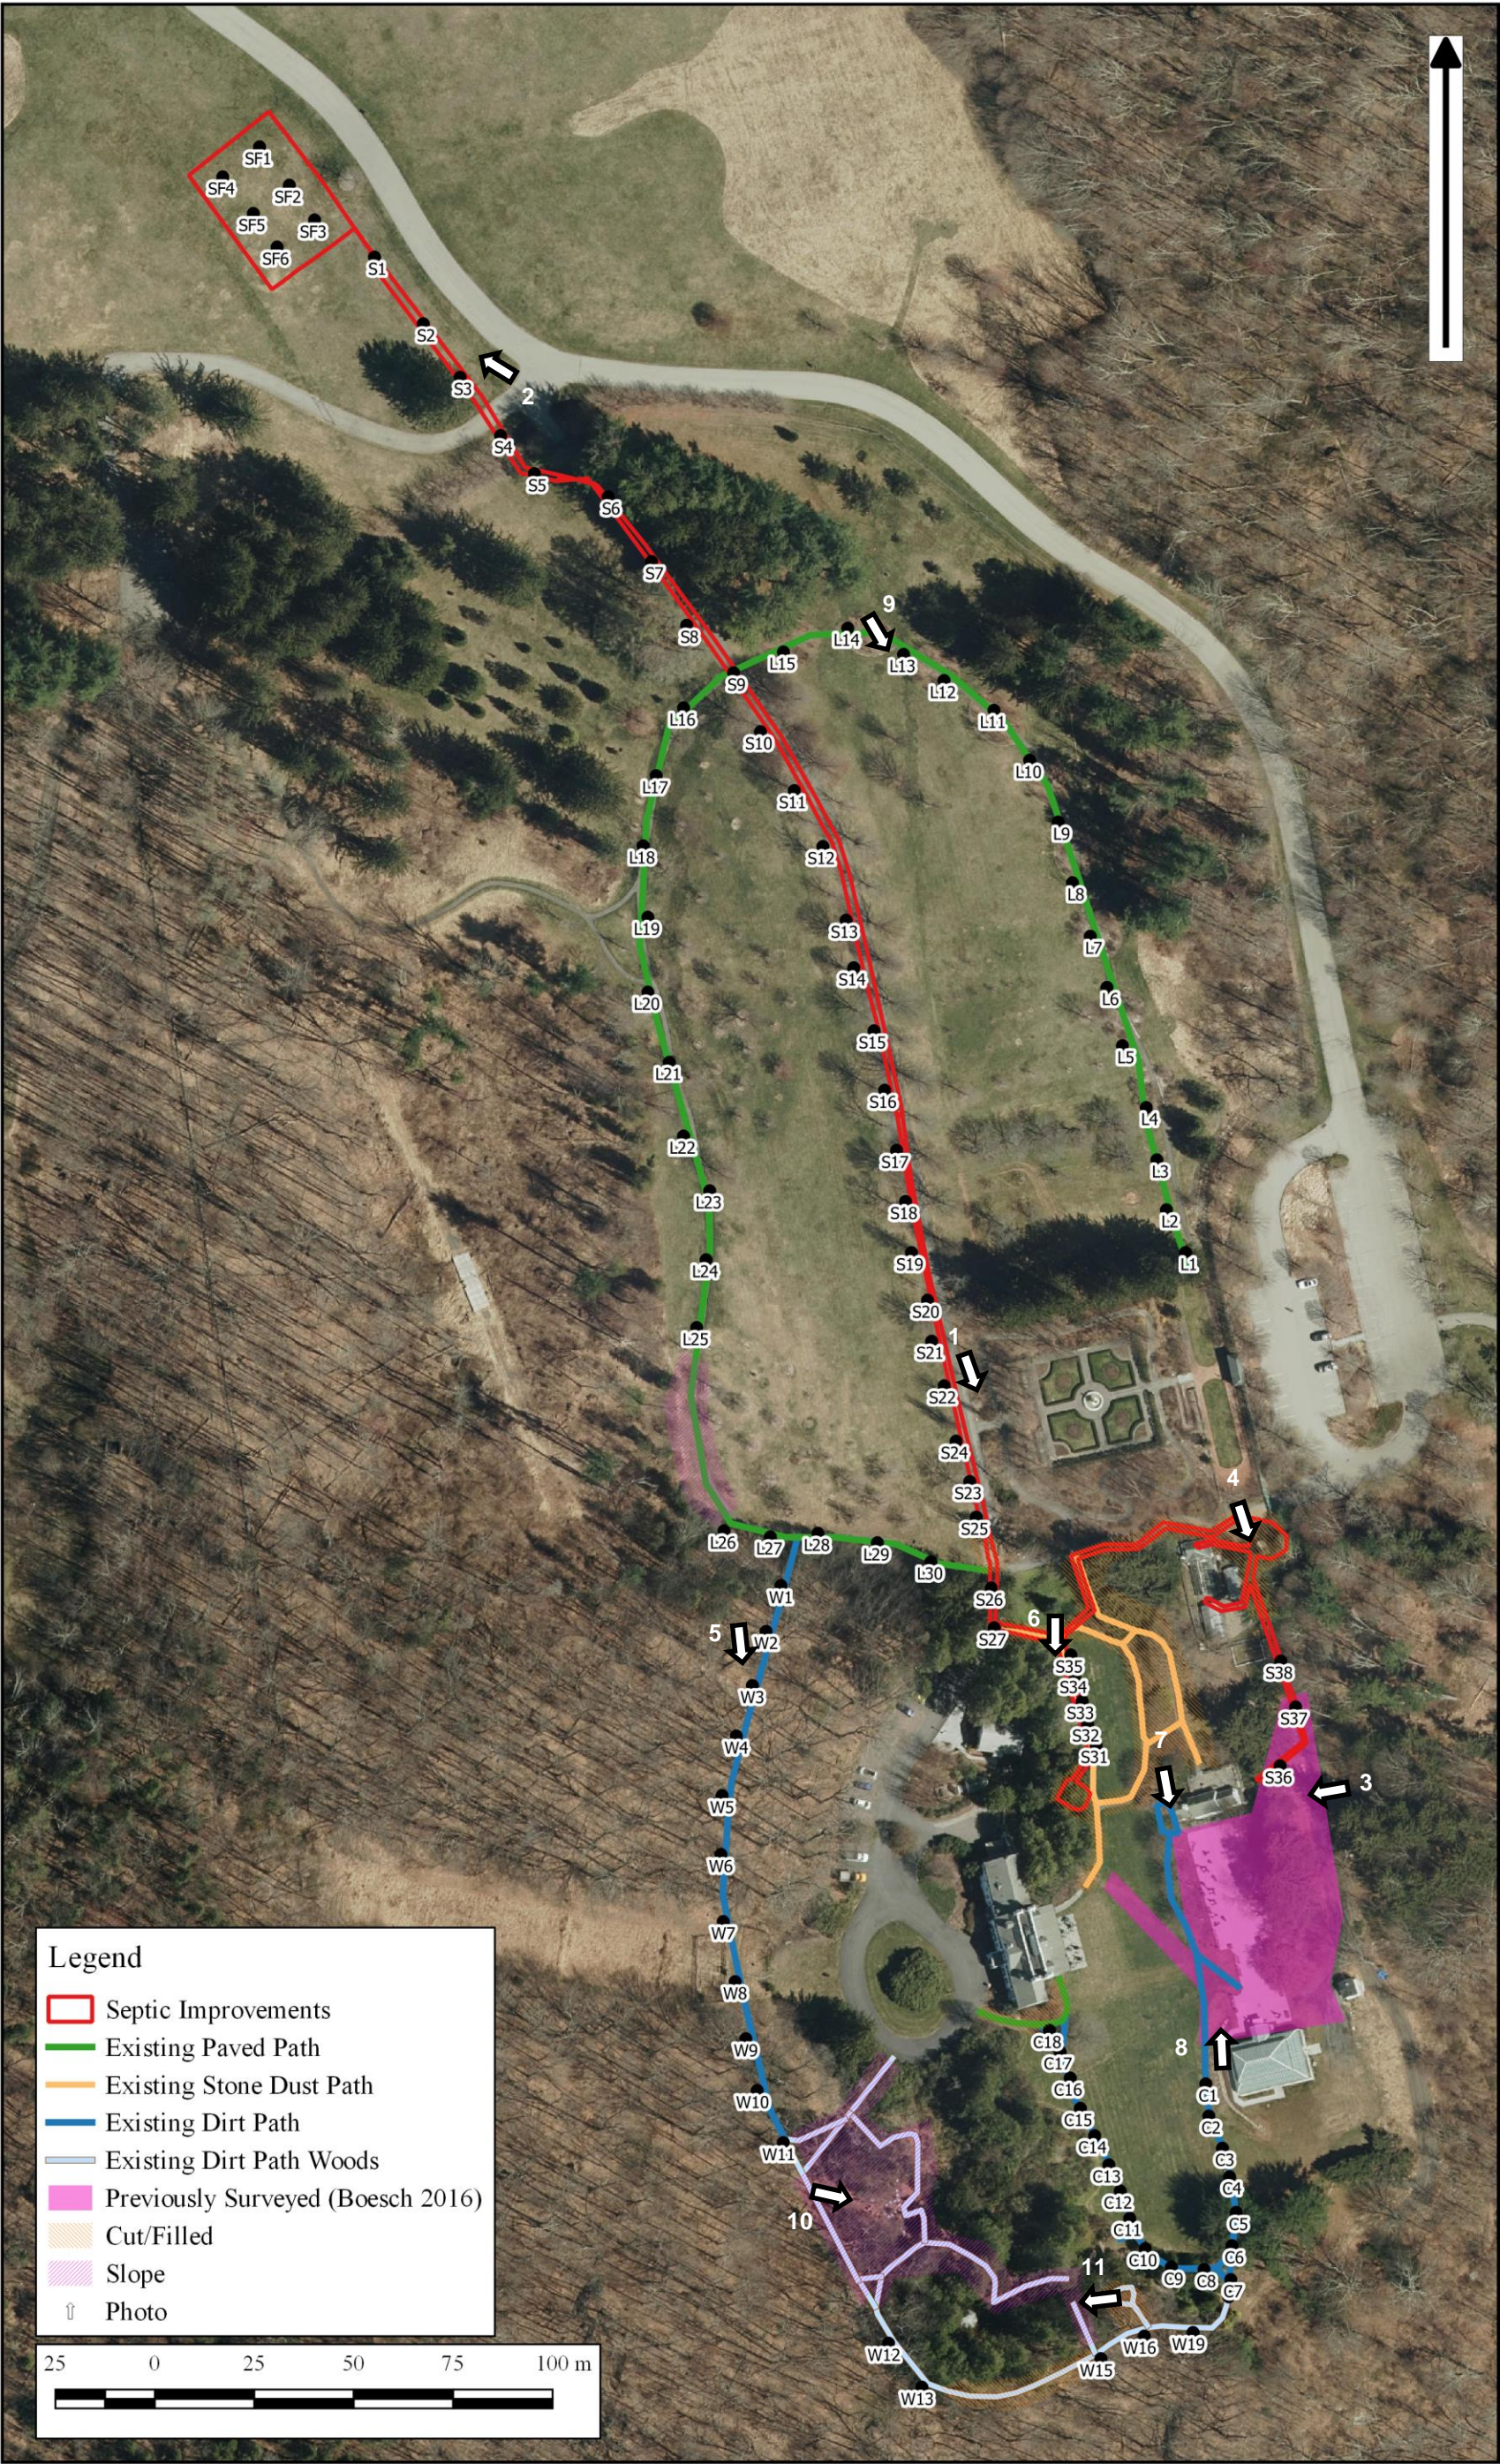
Figure 2. Aerial View of the Project Area and Subsurface Testing

The project will entail the resurfacing and/or widening of existing paths. Some existing paths will be widened from 0.9 meters (3-foot) wide to five feet. Figure 2 shows the paths that will be improved. The existing 0.9 meter (3-foot) wide path will be widened to 1.5 meter (5-foot) and paved with asphalt; the existing stone dust path will be paved with asphalt as will the existing dirt paths shown in Figure 2. The existing dirt path shown within the southern wooded area will be upgraded to hard surface material.

The subsurface investigation consisted of the excavation of 103 shovel tests (see Figure 2). Shovel tests were excavated in 15-meter (50-foot) interval transects along the proposed linear disturbances, with a small 15-meter interval grid excavated in the proposed septic field location. A 7.5-meter (25-foot) interval was utilized in the central lawn area, due to proximity to the Main House and Office (a former residence). Shovel tests measured a minimum of 40 centimeters (16 inches) in diameter and were excavated into culturally sterile subsoil, except where an impenetrable obstacle (e.g. rock) was encountered. Soils were screened using 0.64-centimeter (0.25-inch) mesh hardware cloth and recorded using standardized SCA forms and Munsell soil color charts. Testing locations were recorded in planview on the project map. Digital photography was used to document the field investigation, ground conditions, project topography and disturbances. All shovel tests were backfilled, and the surfaces restored to the best extent possible. Shovel tests were assigned alpha-numeric shovel test designations (Appendix A). Shovel tests ranged from 14 to 78 centimeters (0.5 to 2.3 feet) in depth.
