TIBBETTS POND RESTORATION AND MANAGEMENT PLAN

CITY OF YONKERS, WESTCHESTER COUNTY, NEW YORK

MAY 2021

PRINCETON HYDRO, LLC
1108 OLD YORK ROAD
RINGOES, NJ 08551
WWW.PRINCETONHYDRO.COM

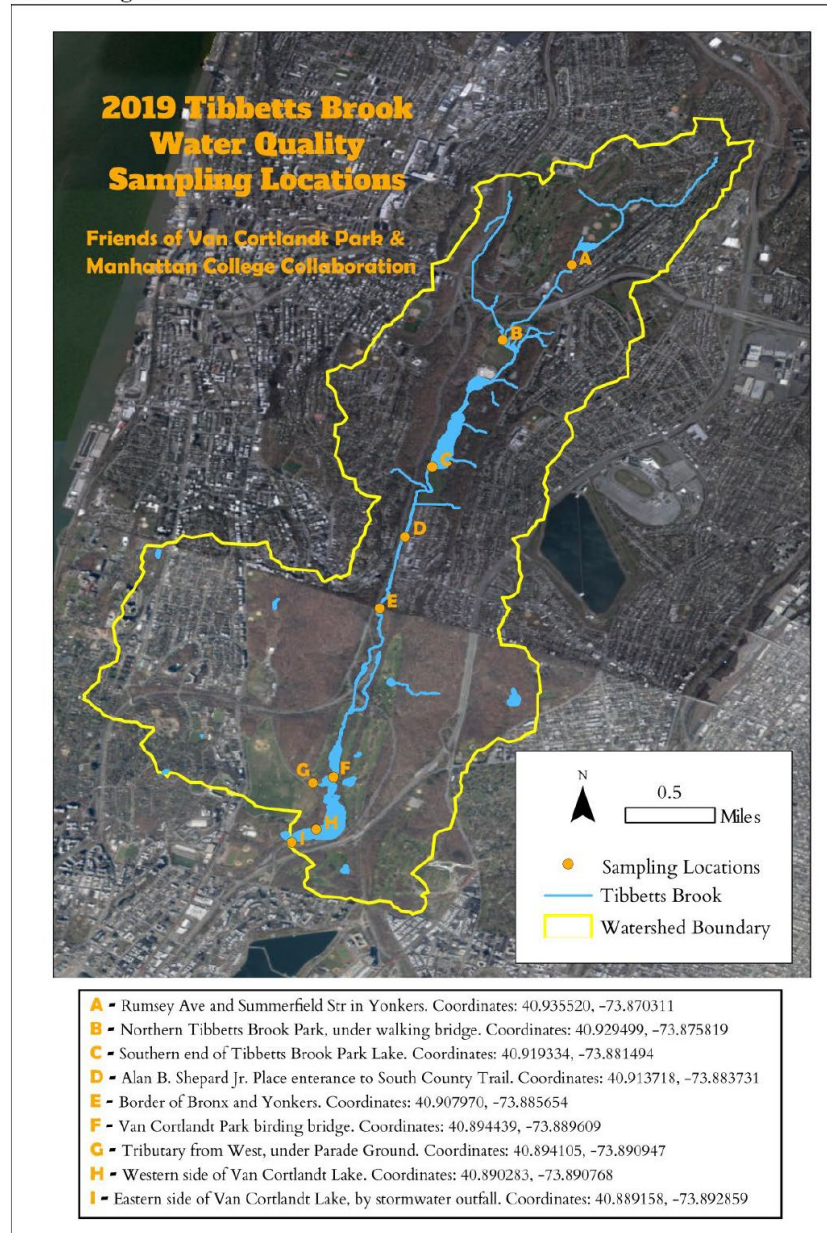
Figure 1. Sampling locations along Tibbetts Brook sampled during a study by friends of Van Cortlandt Park

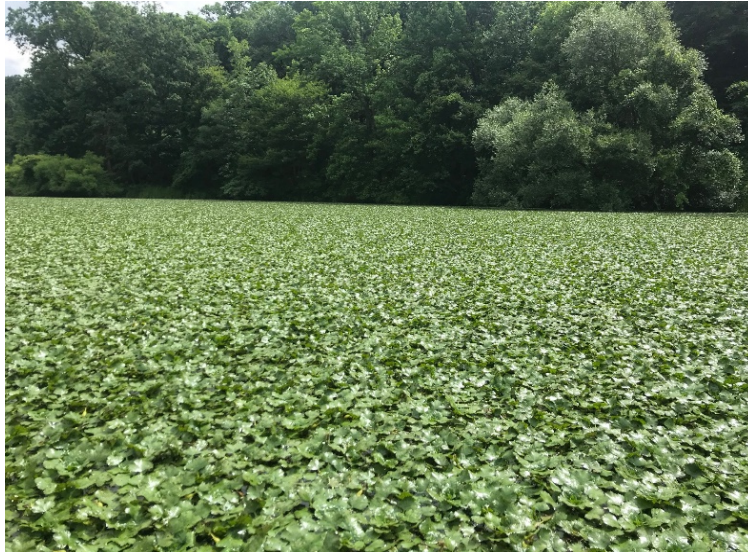
Figure 2. Water Chestnut Densities on 30 June 2020

During the 28 May sampling event, curly-leaf pondweed (*Potamogeton crispus*) was present throughout the southern portion of the waterbody, while water chestnut (*Trapa natans*) was present throughout many of the shallower areas. Also present along the shoreline is the invasive ornamental yellow flag iris (*Iris pseudacorus*). Filamentous algae (*Spirogyra*) was also observed on the lake bottom in the northern portion of the lower basin. By the 30 June event, approximately 75-80% of the waterbody's surface was covered with water chestnut (Figure 1), and the northern-most sampling point on the lower basin was moved approximately 100' south due to difficulty accessing the northern portion of the waterbody. Additionally, curly-leaf pondweed was still present throughout the waterbody, however these plants were senescing. Additionally, duckweed (*Lemna* sp. and *Spirodela* sp.) was observed throughout the waterbody between water chestnut rosettes and coontail (*Ceratophyllum demersum*) was observed in the mid-lake sampling location in the lower basin.

By the July sampling, water chestnut still comprised approximately 50% of the surface area in the main basin, dominating the North station. Duckweed was present at both sampling stations, and some trace curly-leaf pondweed was noted at the North station. Water chestnut harvesting took place during the 5 August sampling, including both hand-pulling and mechanical harvesting. The bulk of this invasive was removed from the middle of the waterbody. By the final sampling event, water chestnut was not observed.

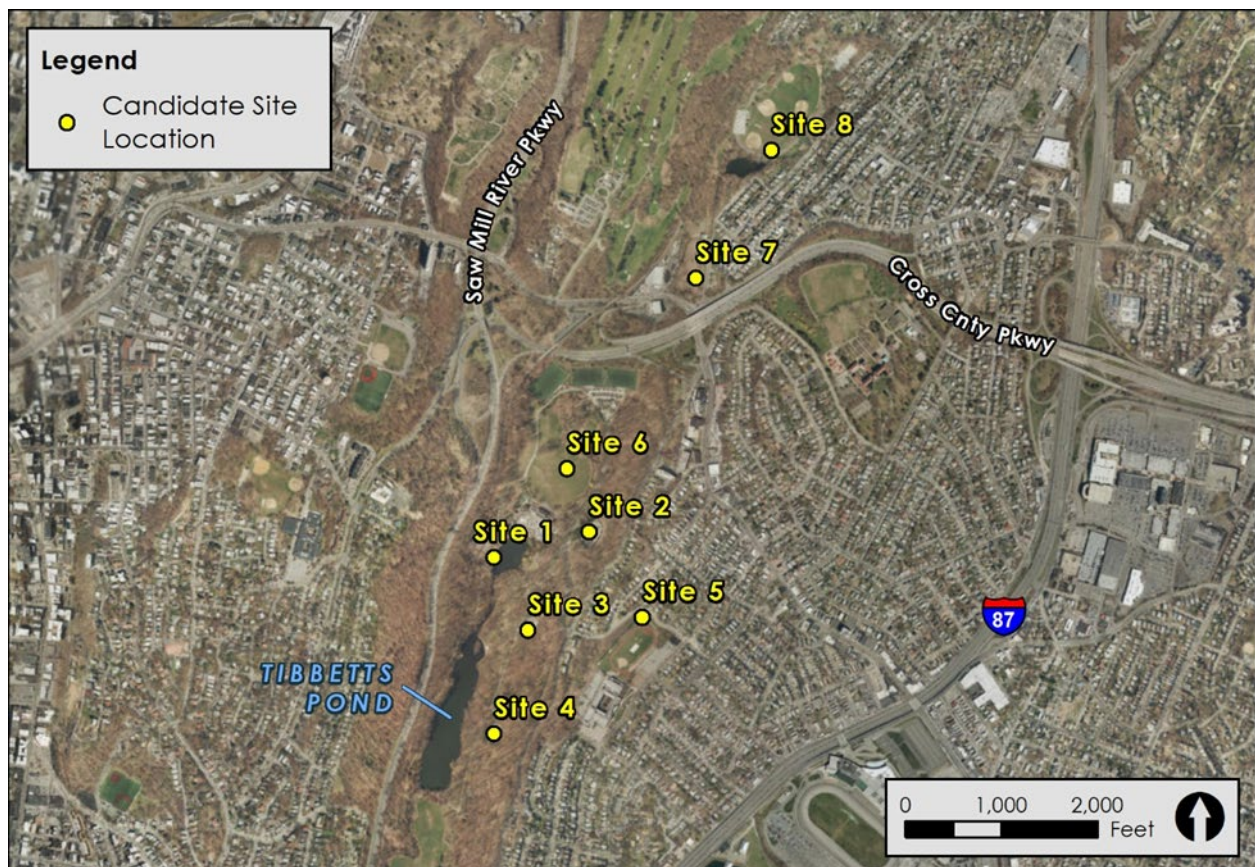
Figure 16. Site Overview of Tibbetts Pond Area.

Princeton Hydro evaluated and identified sites within the watersheds of the upper and lower basins of Tibbetts Pond. Figure 16 below depicts recommended site locations within the watershed; these will be described in more detail in the subsequent sections. Table 19 presents a list of the proposed Best Management Practice (BMP), the amount of TSS removed, and an estimated price. *Please note, the numbering of the recommended project site is in order of priority.*

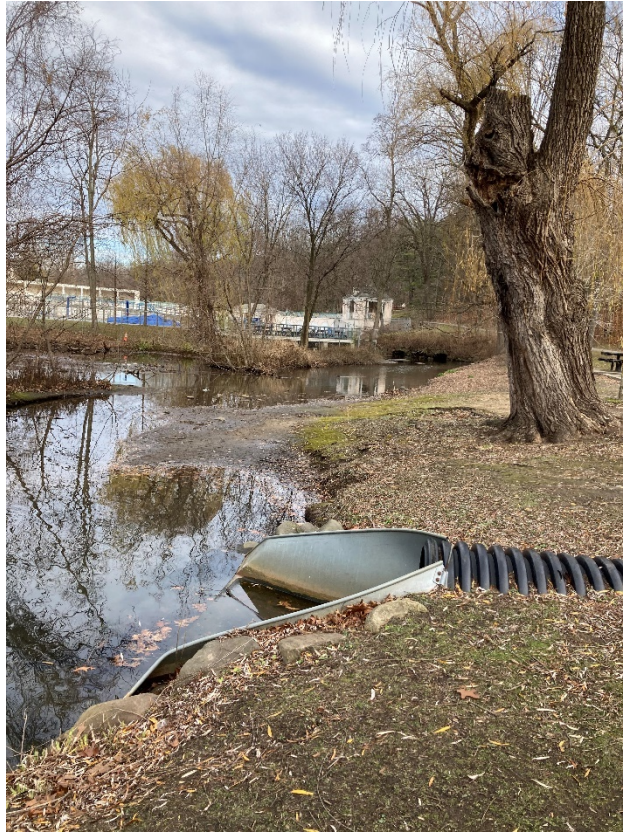
Photo 1: Area of Bank Stabilization and Riparian Improvements, Facing Towards Recreation Center

Recommendation Site 1B: To compliment the sediment forebay construction, riparian plantings and bank stabilization would be introduced to the site at this location. As shown in Photo 2 below, this location contains a rock embankment with a grassed area and dirt walkway near the Tibbetts Brook Park recreation building. Since this area is not highly vegetated along the upper basin banks, stormwater runoff from the surrounding grass and paved areas gets conveyed directly into the pond. Without a stabilized bank or riparian area, this location contributes many additional pollutants and sediment into the upper basin area here. Riparian plantings and bank stabilization would address that issue by creating a buffer between the unfiltered stormwater runoff and the pond itself. This buffer would be able to lower the amount of sediment entering the lake at this location, as well as filter any unwanted nutrients with the vegetated riparian area.

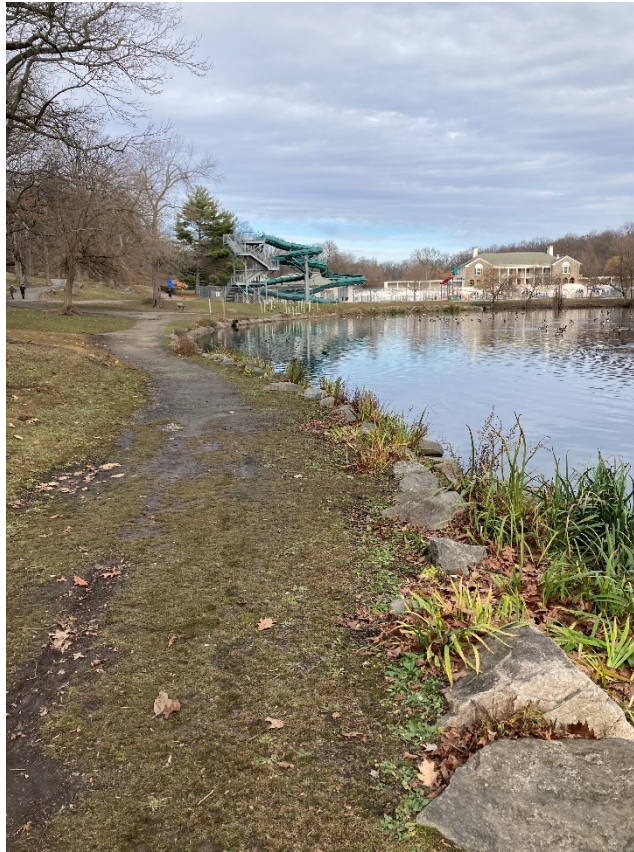
Photo 2: Tibbetts Brook Discharge Location Into the upper basin

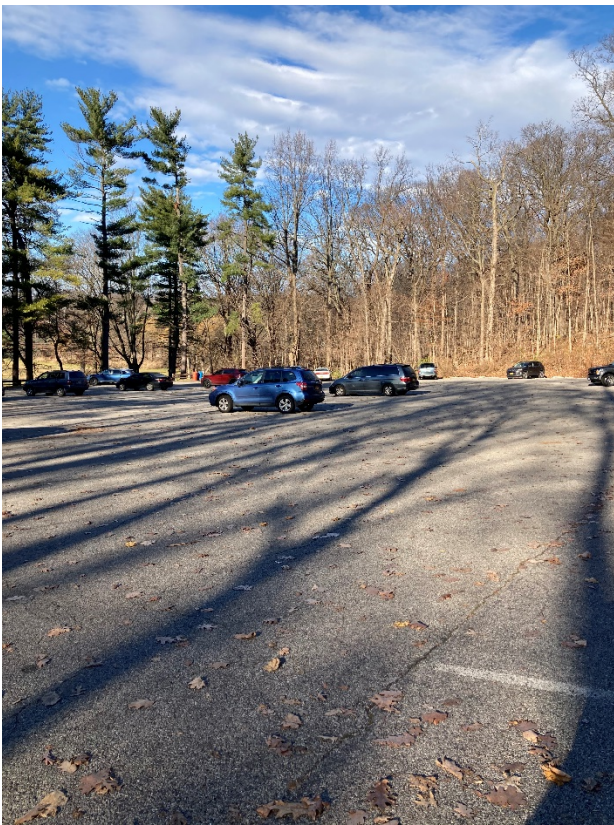
Photo 3: Parking Lot Area for Site 2

Located at the entrance to the park area is Site 2, the parking lot for the Tibbetts Pond Recreation Center. This parking lot is located directly to the east of the recreation center and is paved with impervious asphalt. A drainage swale has been constructed around the sides of the lot. Photo 3 shows the conditions of the parking lot, and Photo 4 shows the drainage swale itself to the right. The swale borders the entire parking lot at a lower elevation, with the parking lot runoff draining into it. This swale contains a small asphalt bottom, with grass or exposed soil along the side of it. The swale drains to a catch basin along the edge of County Park Road, which in turn connects to Tibbetts Pond Brook. In addition to the parking lot drainage, much of the surrounding forested area drains to this parking lot swale. The forested area has limited understory growth and many sections of bare soil. The impervious area of the parking lot itself combined with the surrounding drainage of the forested area add excess sediment and nutrients to the swale area, which does not filter them from the stormwater runoff before conveying these excess pollutants into the upper basin.

Recommendation Site 2: The recommended Best Management Practice (BMP) for this site is to convert the asphalt and dirt swale around the edges of the parking lot to a stabilized vegetated conveyance system. Instead of containing an asphalt bottom, the conveyance system would contain various plants and vegetation to help filter nutrients from the stormwater passing through it. Additionally, this would serve as a buffer between the surface runoff from the parking lot and the conveyance system to Tibbetts Pond Brook, reducing the initial influx of polluted rainwater to Tibbetts Pond during the “first flush” of a storm event. The first flush runoff produces the most pollution in bodies of water from surface runoff. Reducing the first flush volume of water during storm events and filtering any rainwater in the conveyance system with vegetation will greatly reduce the amount of TSS and pollutants entering Tibbetts Pond. To provide additional pollutant and sediment removal, the catch basin at the end of the swale can be retrofitted to provide a sump or other sediment trapping device and replacing the

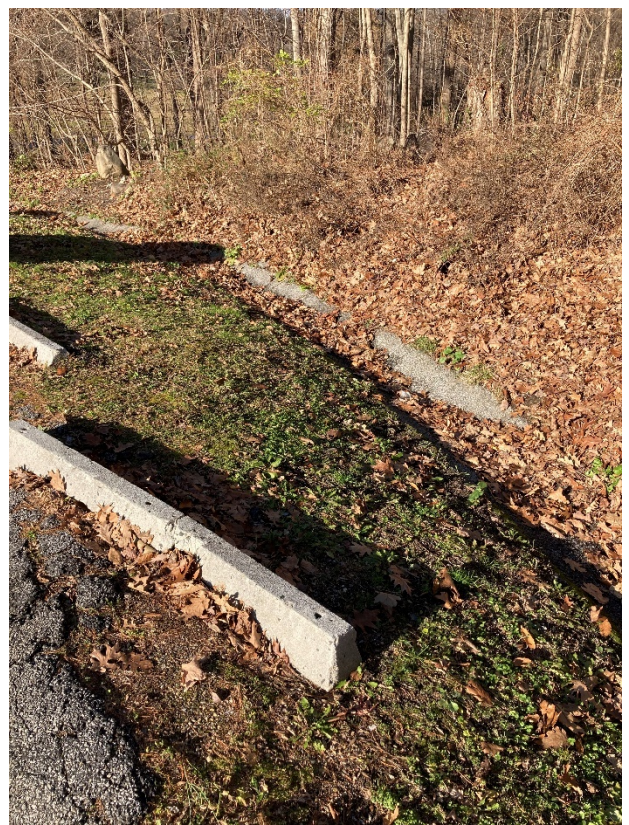
Photo 4: Asphalt Drain Ditch on Side of Parking Lot

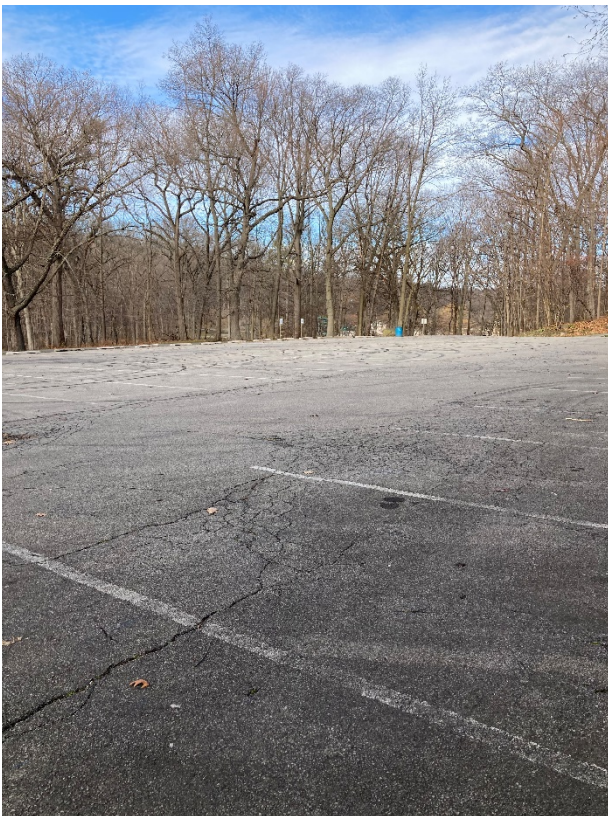
Photo 5: Parking Lot Area For Site 3

The lower basin of Tibbetts Pond is home to two parking lots on the eastern side of the pond area. Site 3 refers to the northern parking lot out of those two, shown in Photo 5. This parking lot is one of two main parking lots used by Tibbetts Pond visitors to access the pond and playground area. Similar to Site 2, this parking lot also contains a grassed swale area around the perimeter, which collects much of the impervious parking lot runoff. The parking lot area also has various natural swales extending from it, providing multiple paths for stormwater to drain from the parking lot and travel to Tibbetts Pond. In addition to the impervious parking area, this sites drainage area also consists of the surrounding wooded areas bordering the parking lot, which collect stormwater in the swale as well. The forested area has limited understory growth and many sections of bare soil. Once the runoff is collected in the swale, it discharges to the park pathway area shown in Photo 6. From there its travels down the side of the path and eventually makes its way into the lower basin. Due to the impervious area of the parking lot and lack of filtration of runoff before discharging, this site will contribute a high amount of sediment and pollutants into the lower basin during storm events.

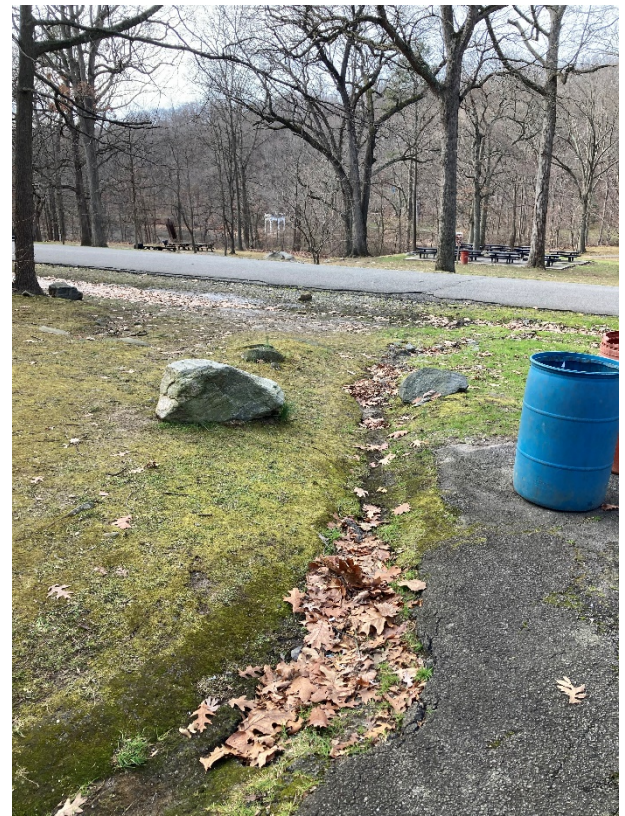
Photo 6: Site 3 Swale Discharge Location

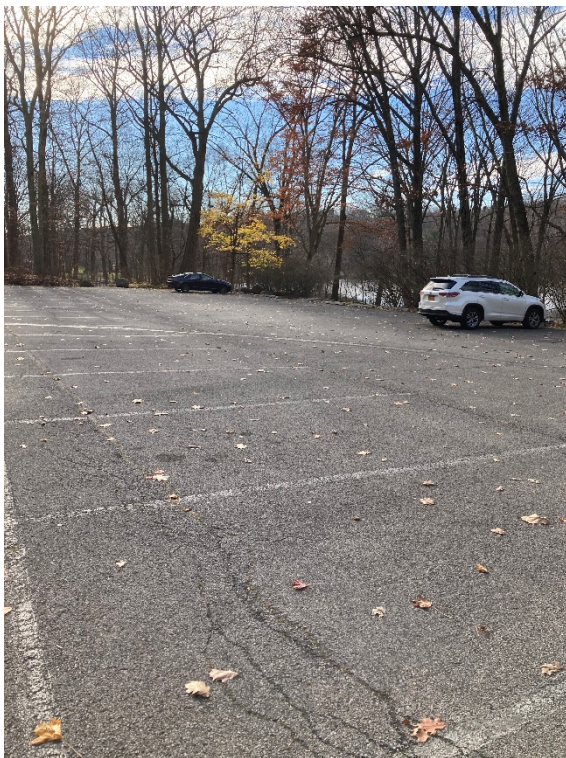
Photo 7: Parking Lot Area for Site 4

Site 4 is the southern parking lot on the east side of the lower basin of Tibbetts Pond. Like Site 3, this site is one of two parking lots that serve the Tibbetts Pond recreation area. This asphalt parking lot contains parking spots for park attendees to use and contains a similar grassed swale configuration as Site 2 and Site 3 to handle the drainage. Photo 7 depicts the current condition of the parking lot. The forested area surrounding this parking lot, combined with the impermeable parking lot, make up the drainage area for this site. The stormwater runoff is then conveyed through a series of naturally made swales bordering the lot until it discharges into the lower basin. The swale system exiting the parking lot can be shown in Photo 8. Due to the large impervious area provided by the parking lot combined with a wooded drainage area with limited understory growth and exposed soil, this site will contribute excess sediment and nutrients into the lower basin.

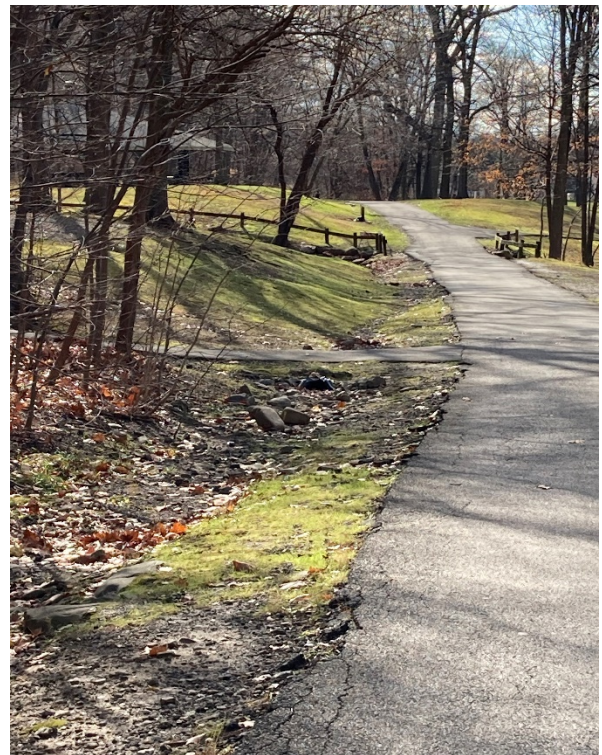
Photo 8: Natural Drainage Swale Which Drains From Parking Lot to Tibbetts Pond

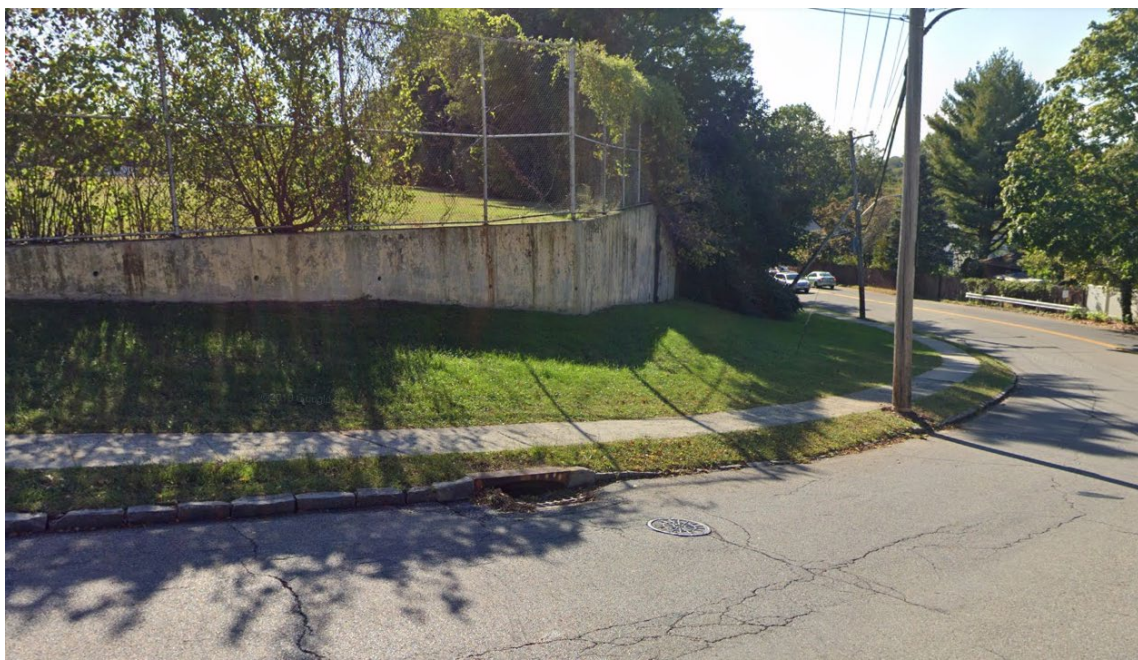
Photo 9: Grassed Area Off of Teresa Avenue, With Underdrains Stemming from the Wall Area

Site 5 is located at the intersection of Borghild Avenue and Teresa Avenue, next to Lincoln High School. At the intersection, there is a grassed area next to the sidewalk that contains the discharge points for several underdrains stemming from Lincoln High School. These underdrains service the Lincoln High School track and field area and can be shown in Photo 9. As shown, these underdrains convey excess water from the high school field and discharge them on to this grass area. Additionally, there is an inlet at this location that captures runoff from Teresa Avenue. The underdrains and inlet both convey stormwater to a piped stormwater conveyance system that runs down the center of Teresa Avenue, eventually discharging to Tibbetts Pond. The drainage area for the underdrain and stormwater conveyance system consists of the field area of Lincoln High School, Teresa Avenue, as well as the surrounding streets of Borghild Avenue, Patricia Place, and Frum Avenue. The high amount of impervious asphalt contained in this drainage area results in a high amount of sediment and pollutants discharged into the stormwater from this location. The underdrain system under the field complex can contain undesirable pollutants from fertilization, that directly impacts the water quality of a receiving body of water.

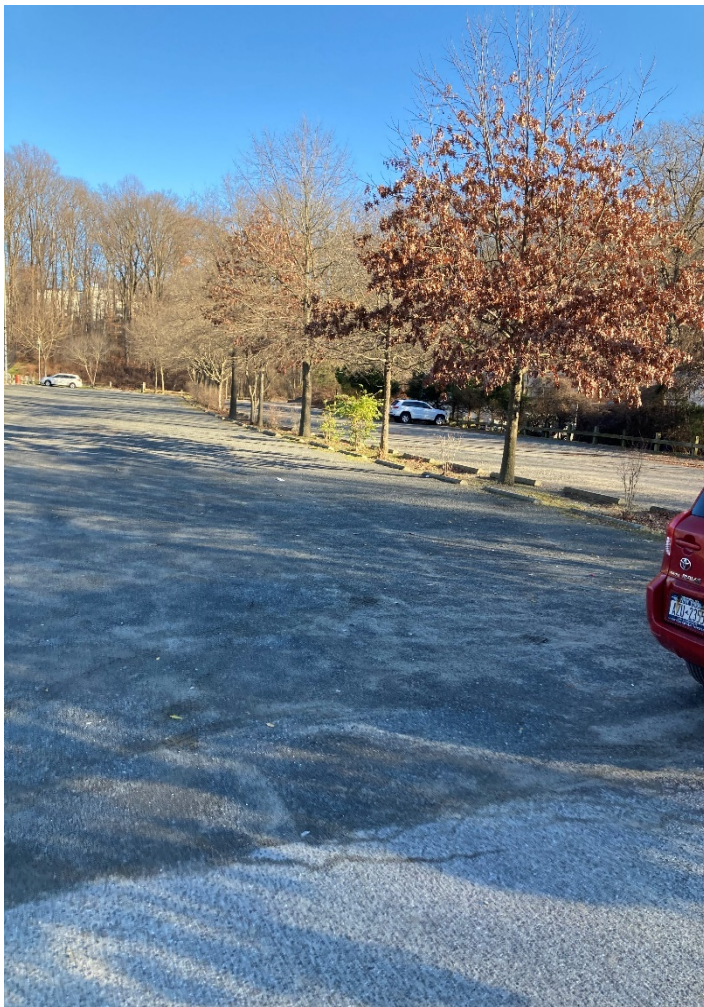
PHOTO 10: GRAVEL PARKING LOT ON NORTHERN SIDE OF SITE 6

To add to the stream stabilization and wetland BMP's above, the gravel parking lot located on the north portion of the site will also be modified. This modification will include the conversion of the center area of the parking lot, shown in Photo 10, into a rain garden. This parking lot is graded so that all stormwater runoff will drain to the middle Branch of Tibbetts Brook in the Site 6 wetland system. Adding a rain garden in this location will give the gravel parking lot an area to drain and filter all stormwater runoff before the runoff reaches the mouth of the tributary stream. Rain gardens work by collecting stormwater within their surface system, and filtering it through their soil, plant, and stone filter systems before discharging. Gravel parking lots contain a high amount of sediment and pollutants from parked cars, so treating this area with a rain garden before conveying the stormwater to the wetland system and beyond will improve water quality further downstream at Tibbetts Pond. **Estimated Costs**

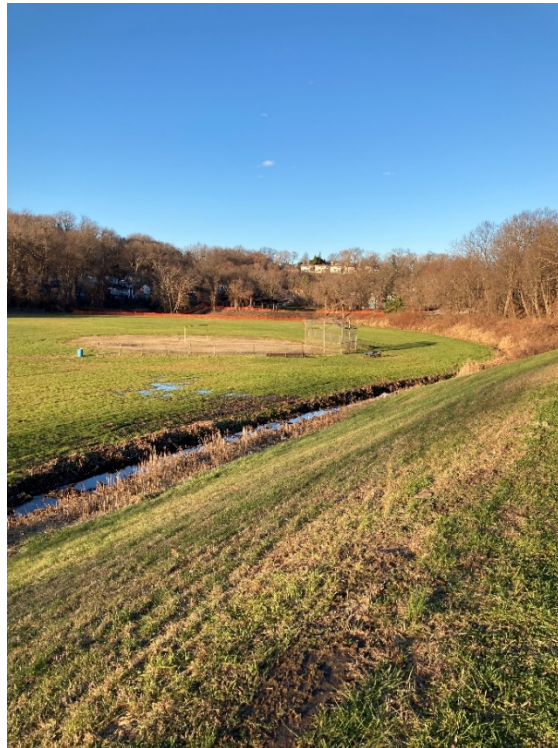
Photo 11: Tibbetts Brook Flowing Through HF Redman Memorial Park

Located north of Site 7, and to the east of the Dunwoodie golf course, is Site 8. This site is HF Redmond Jr. Memorial Park, which contains various recreational facilities and grassed baseball fields used by park-goers. Tibbetts Pond Brook passes through this site on its way south towards Site 7 and Tibbetts Pond. The location of the brook within the site can be shown in Photo 11. This sites drainage area is comprised of the grassed field areas from the park itself, as well as a large number of residential areas and roadways, which drain into Tibbetts Pond Brook further north of the site. The portion of the brook passing through Site 8 contains no buffer area between the grassed slopes and the brook itself. Because of this, stormwater runoff from the surrounding impervious and grassed areas can flow directly into the brook, adding unnecessary pollutants into the brook from this location.

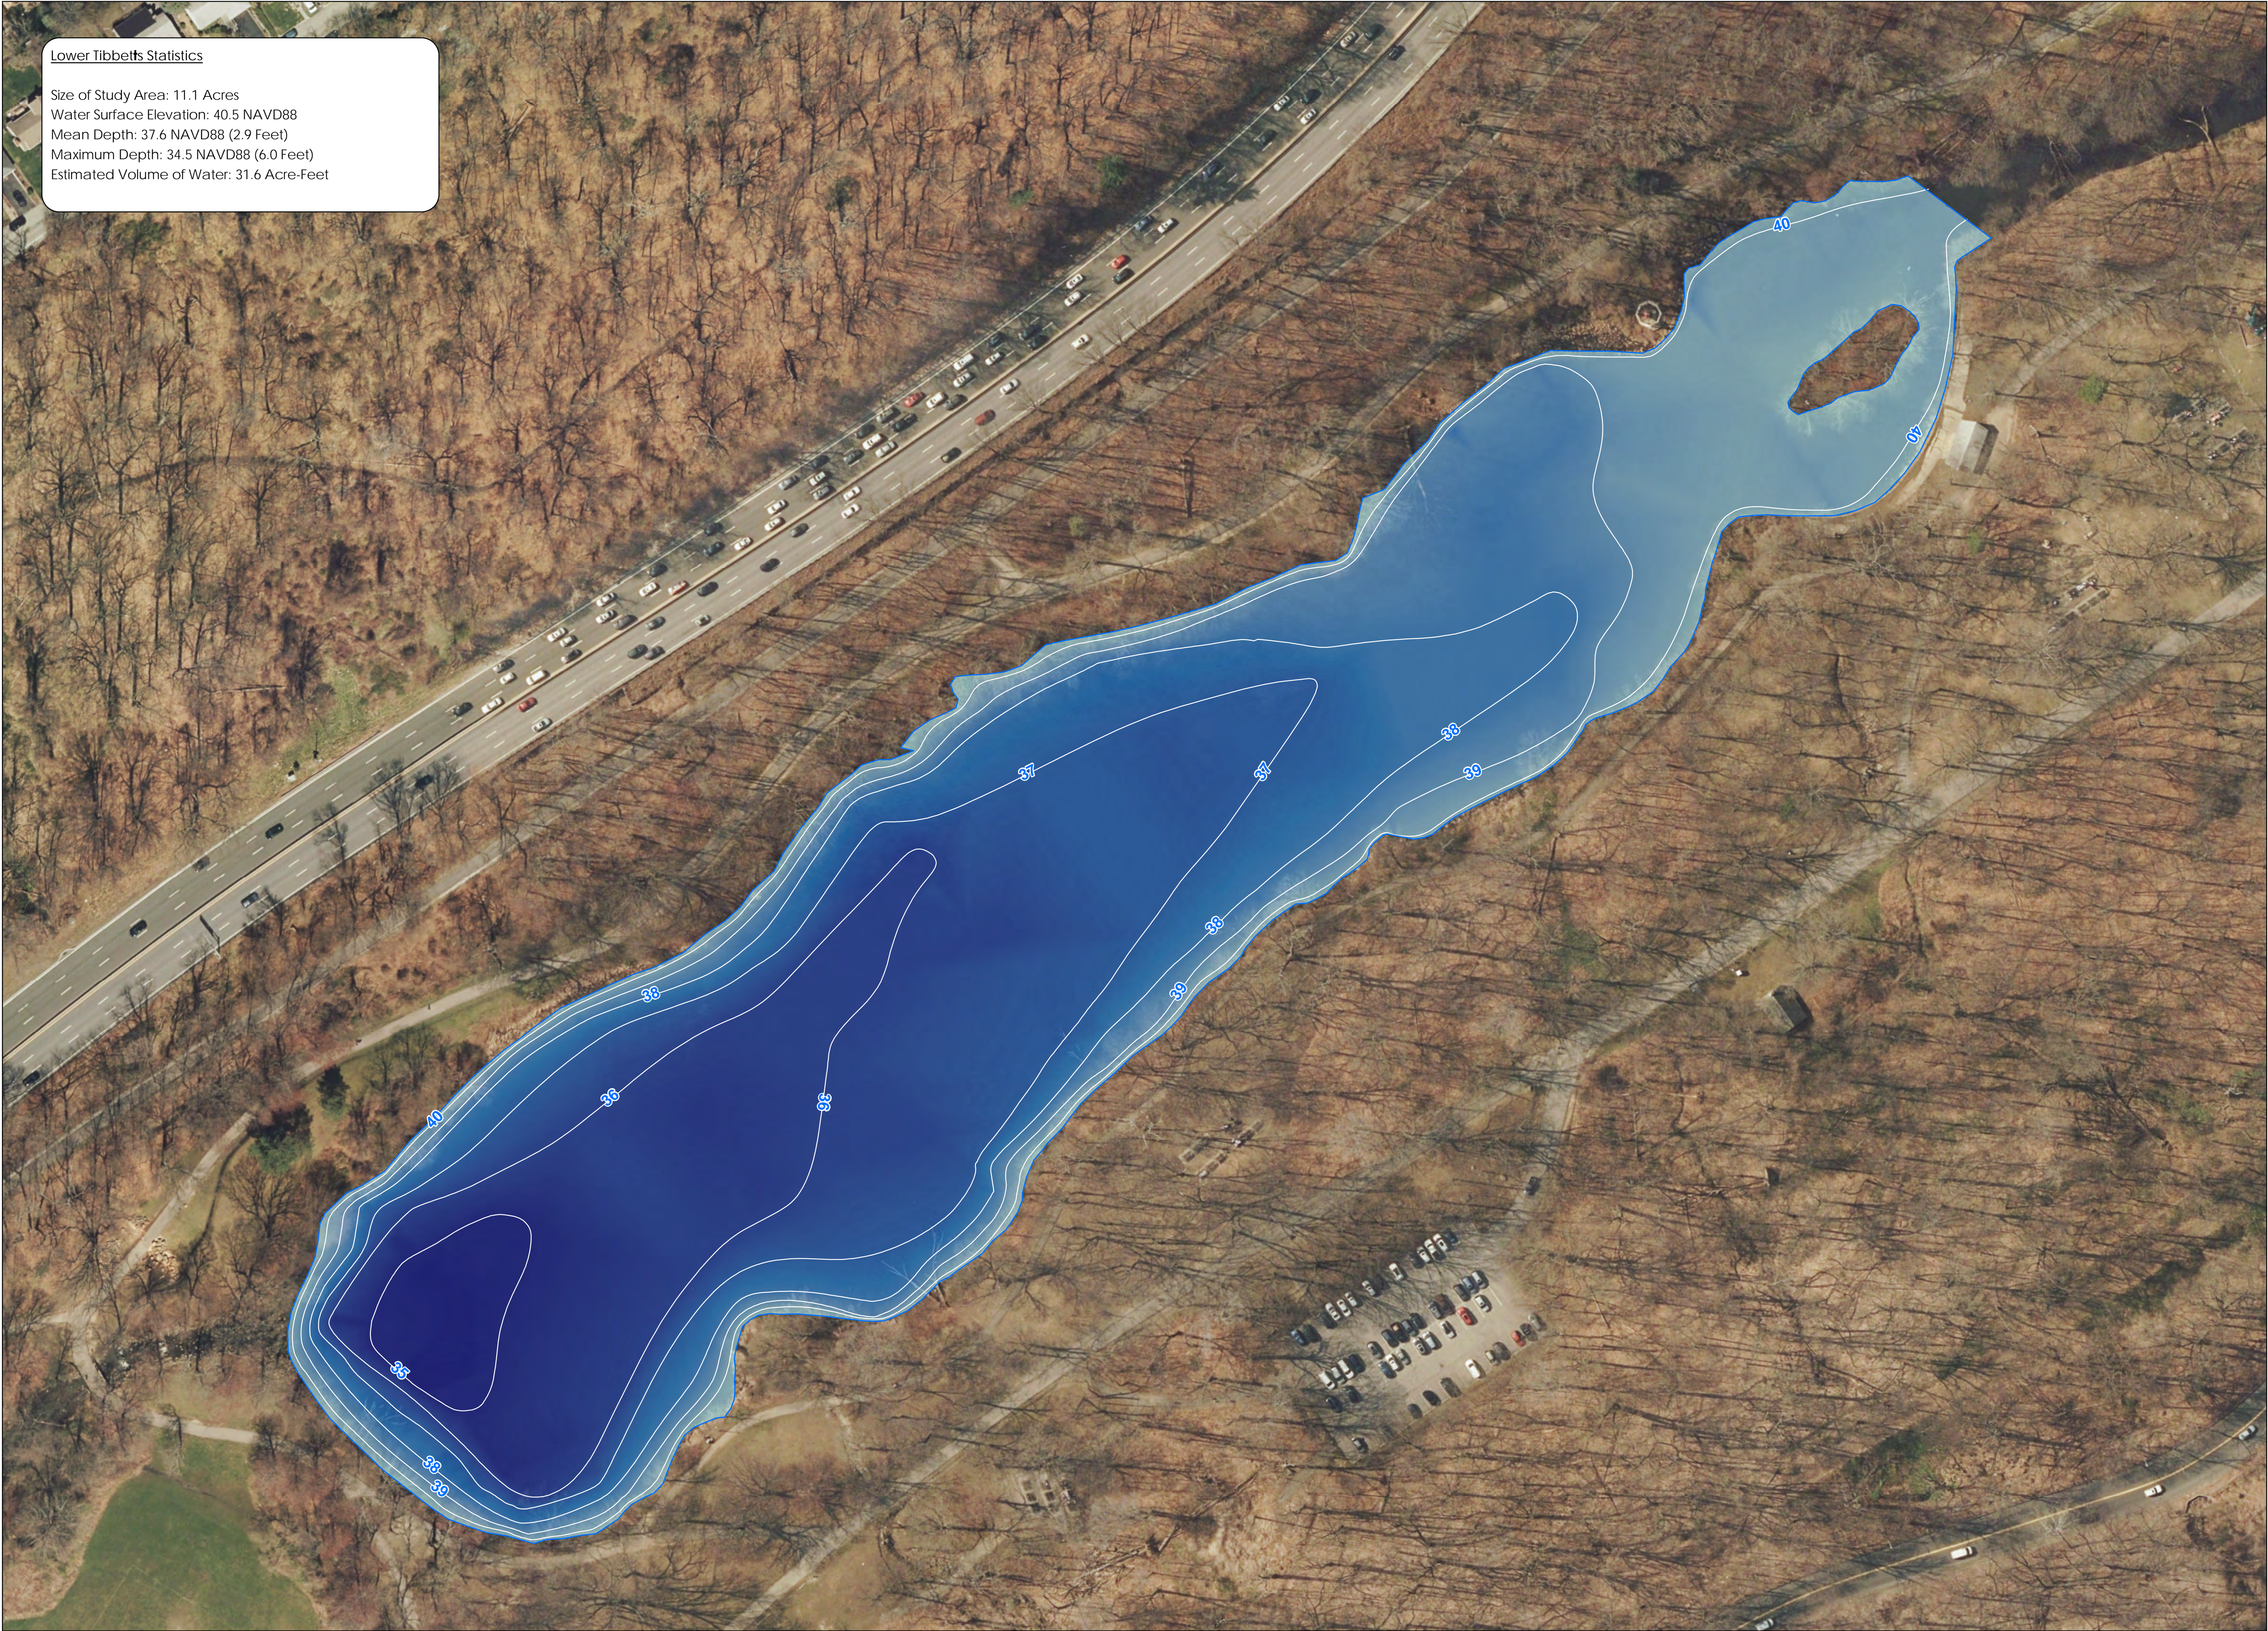
Lower Tibbetts Statistics

Size of Study Area: 11.1 Acres
Water Surface Elevation: 40.5 NAVD88
Mean Depth: 37.6 NAVD88 (2.9 Feet)
Maximum Depth: 34.5 NAVD88 (6.0 Feet)
Estimated Volume of Water: 31.6 Acre-Feet

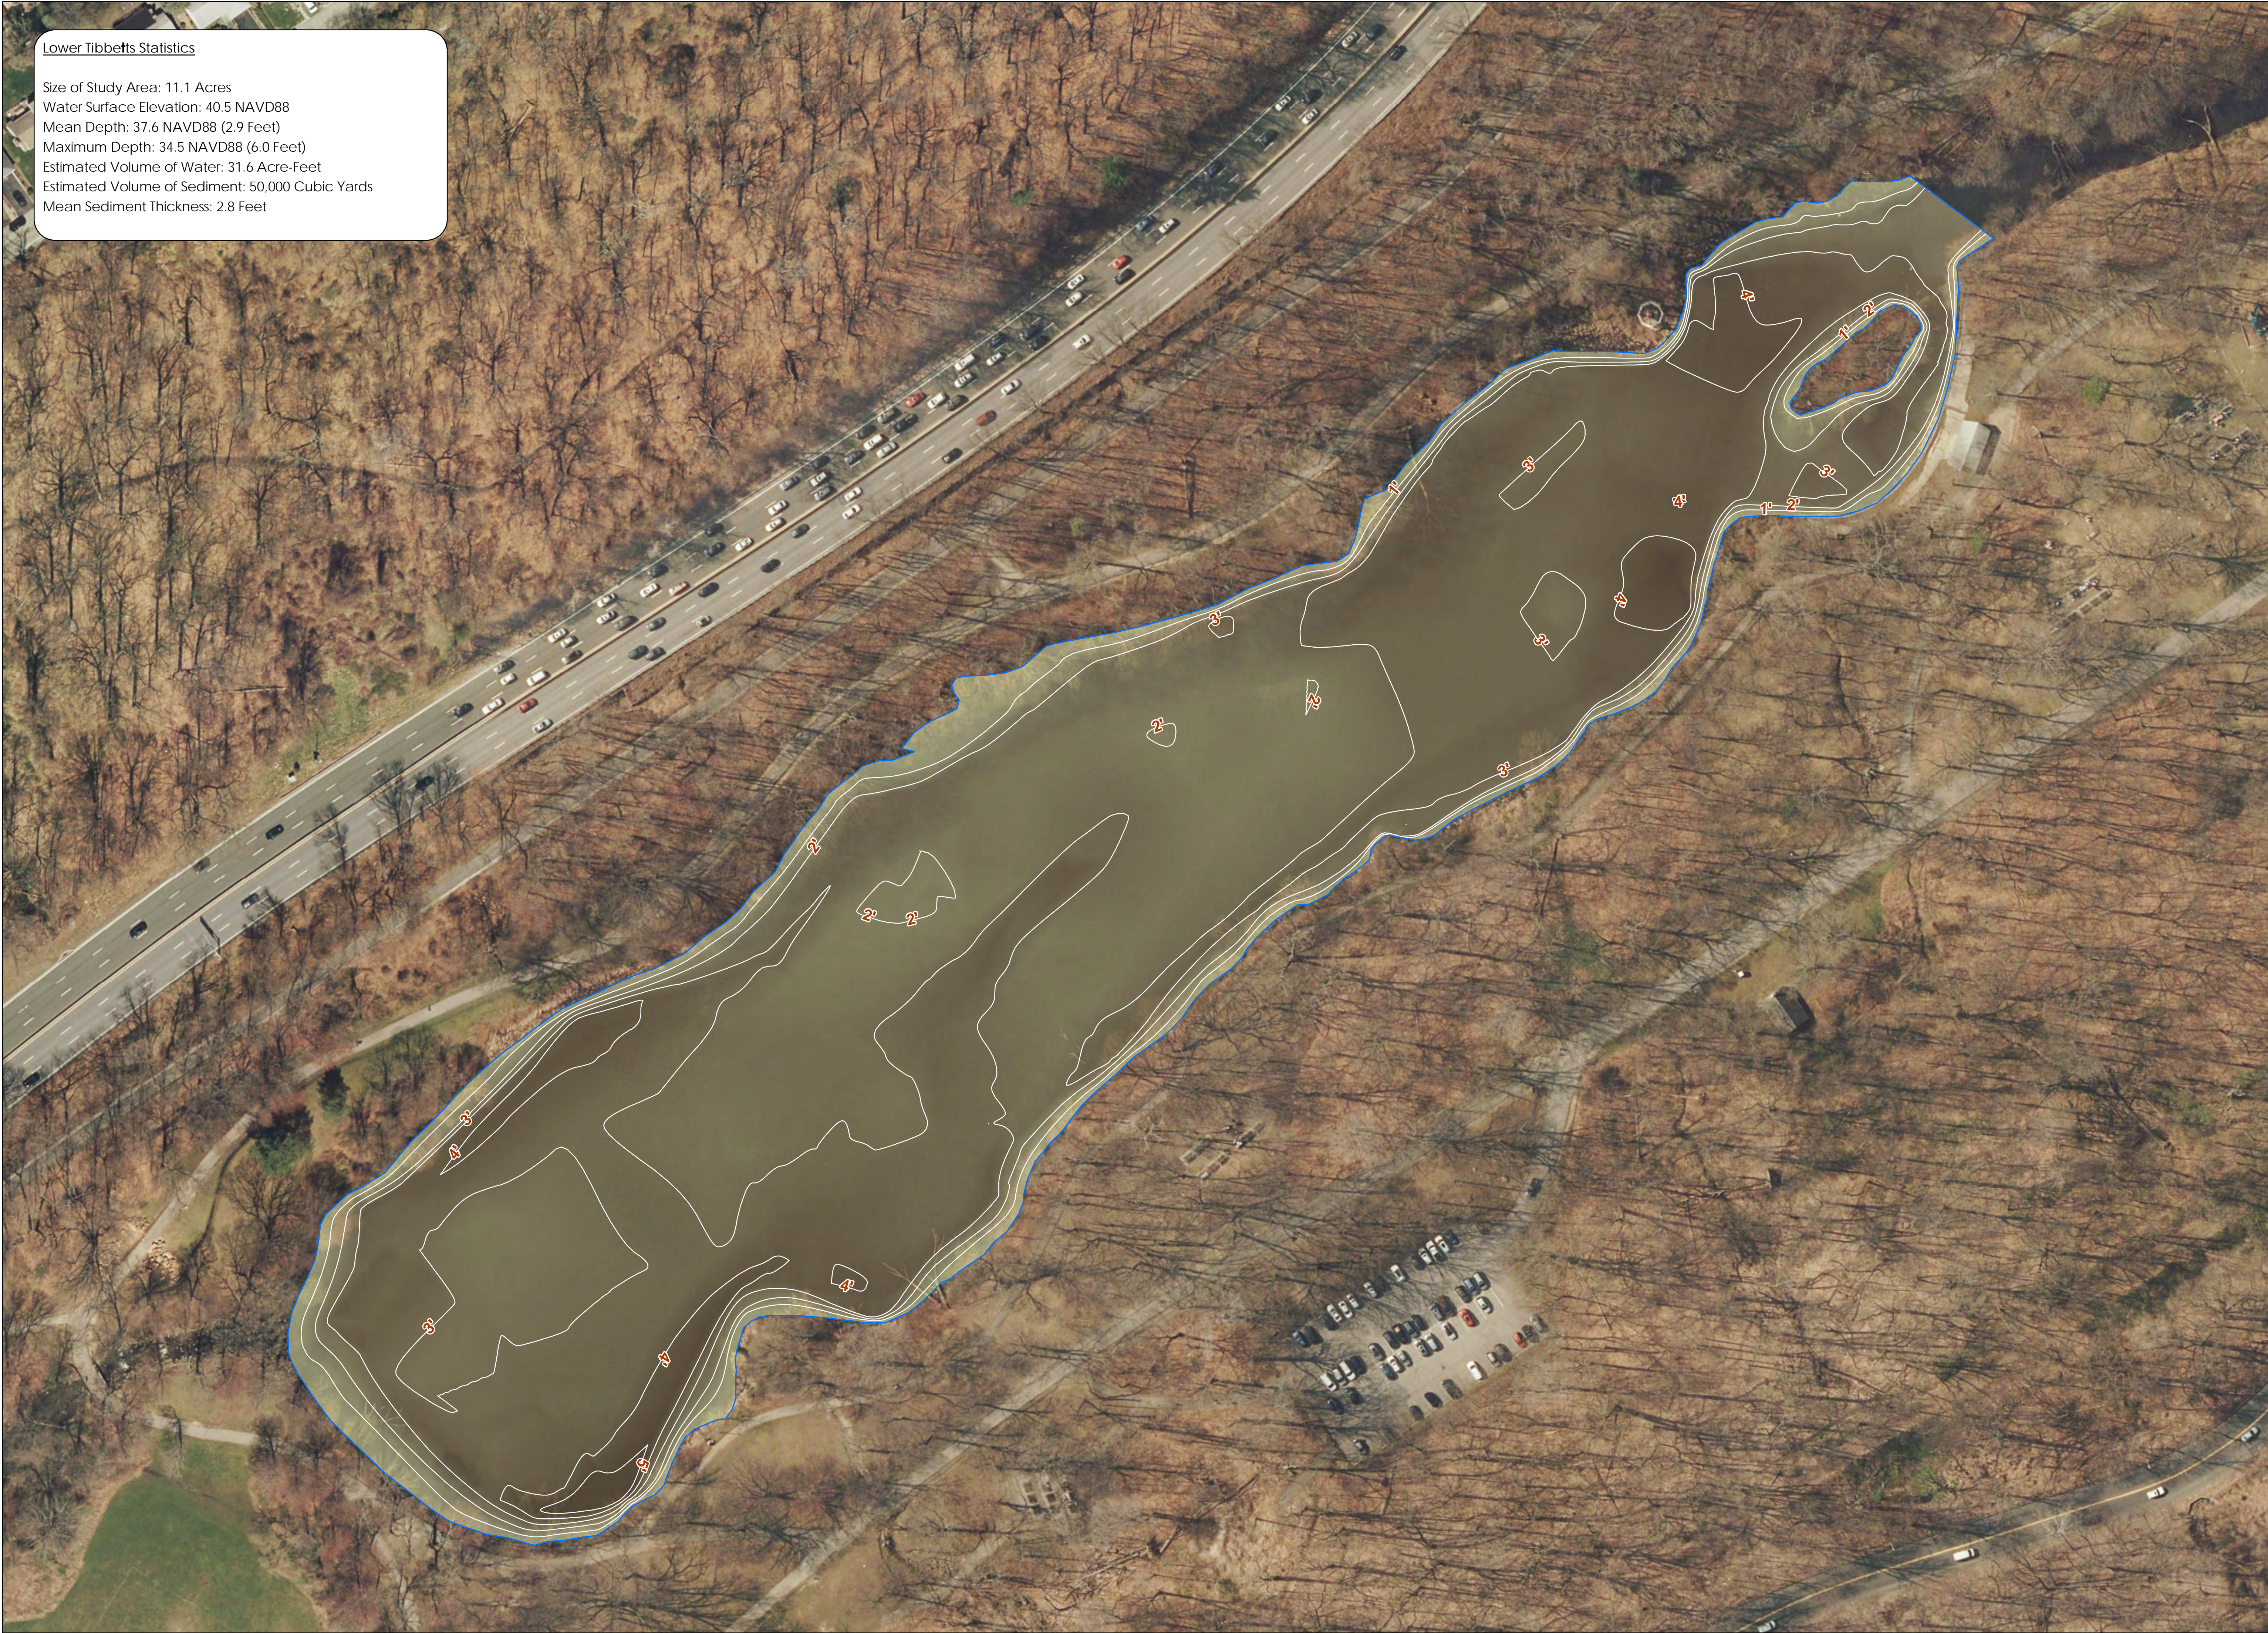
Size of Study Area: 11.1 Acres
Water Surface Elevation: 40.5 NAVD88
Mean Depth: 37.6 NAVD88 (2.9 Feet)
Maximum Depth: 34.5 NAVD88 (6.0 Feet)
Estimated Volume of Water: 31.6 Acre-Feet
Estimated Volume of Sediment: 50,000 Cubic Yards
Mean Sediment Thickness: 2.8 Feet
