TIBBETTS POND RESTORATION AND MANAGEMENT PLAN

CITY OF YONKERS, WESTCHESTER COUNTY, NEW YORK

MAY 2021

PRINCETON HYDRO, LLC
1108 OLD YORK ROAD
RINGOES, NJ 08551
WWW.PRINCETONHYDRO.COM

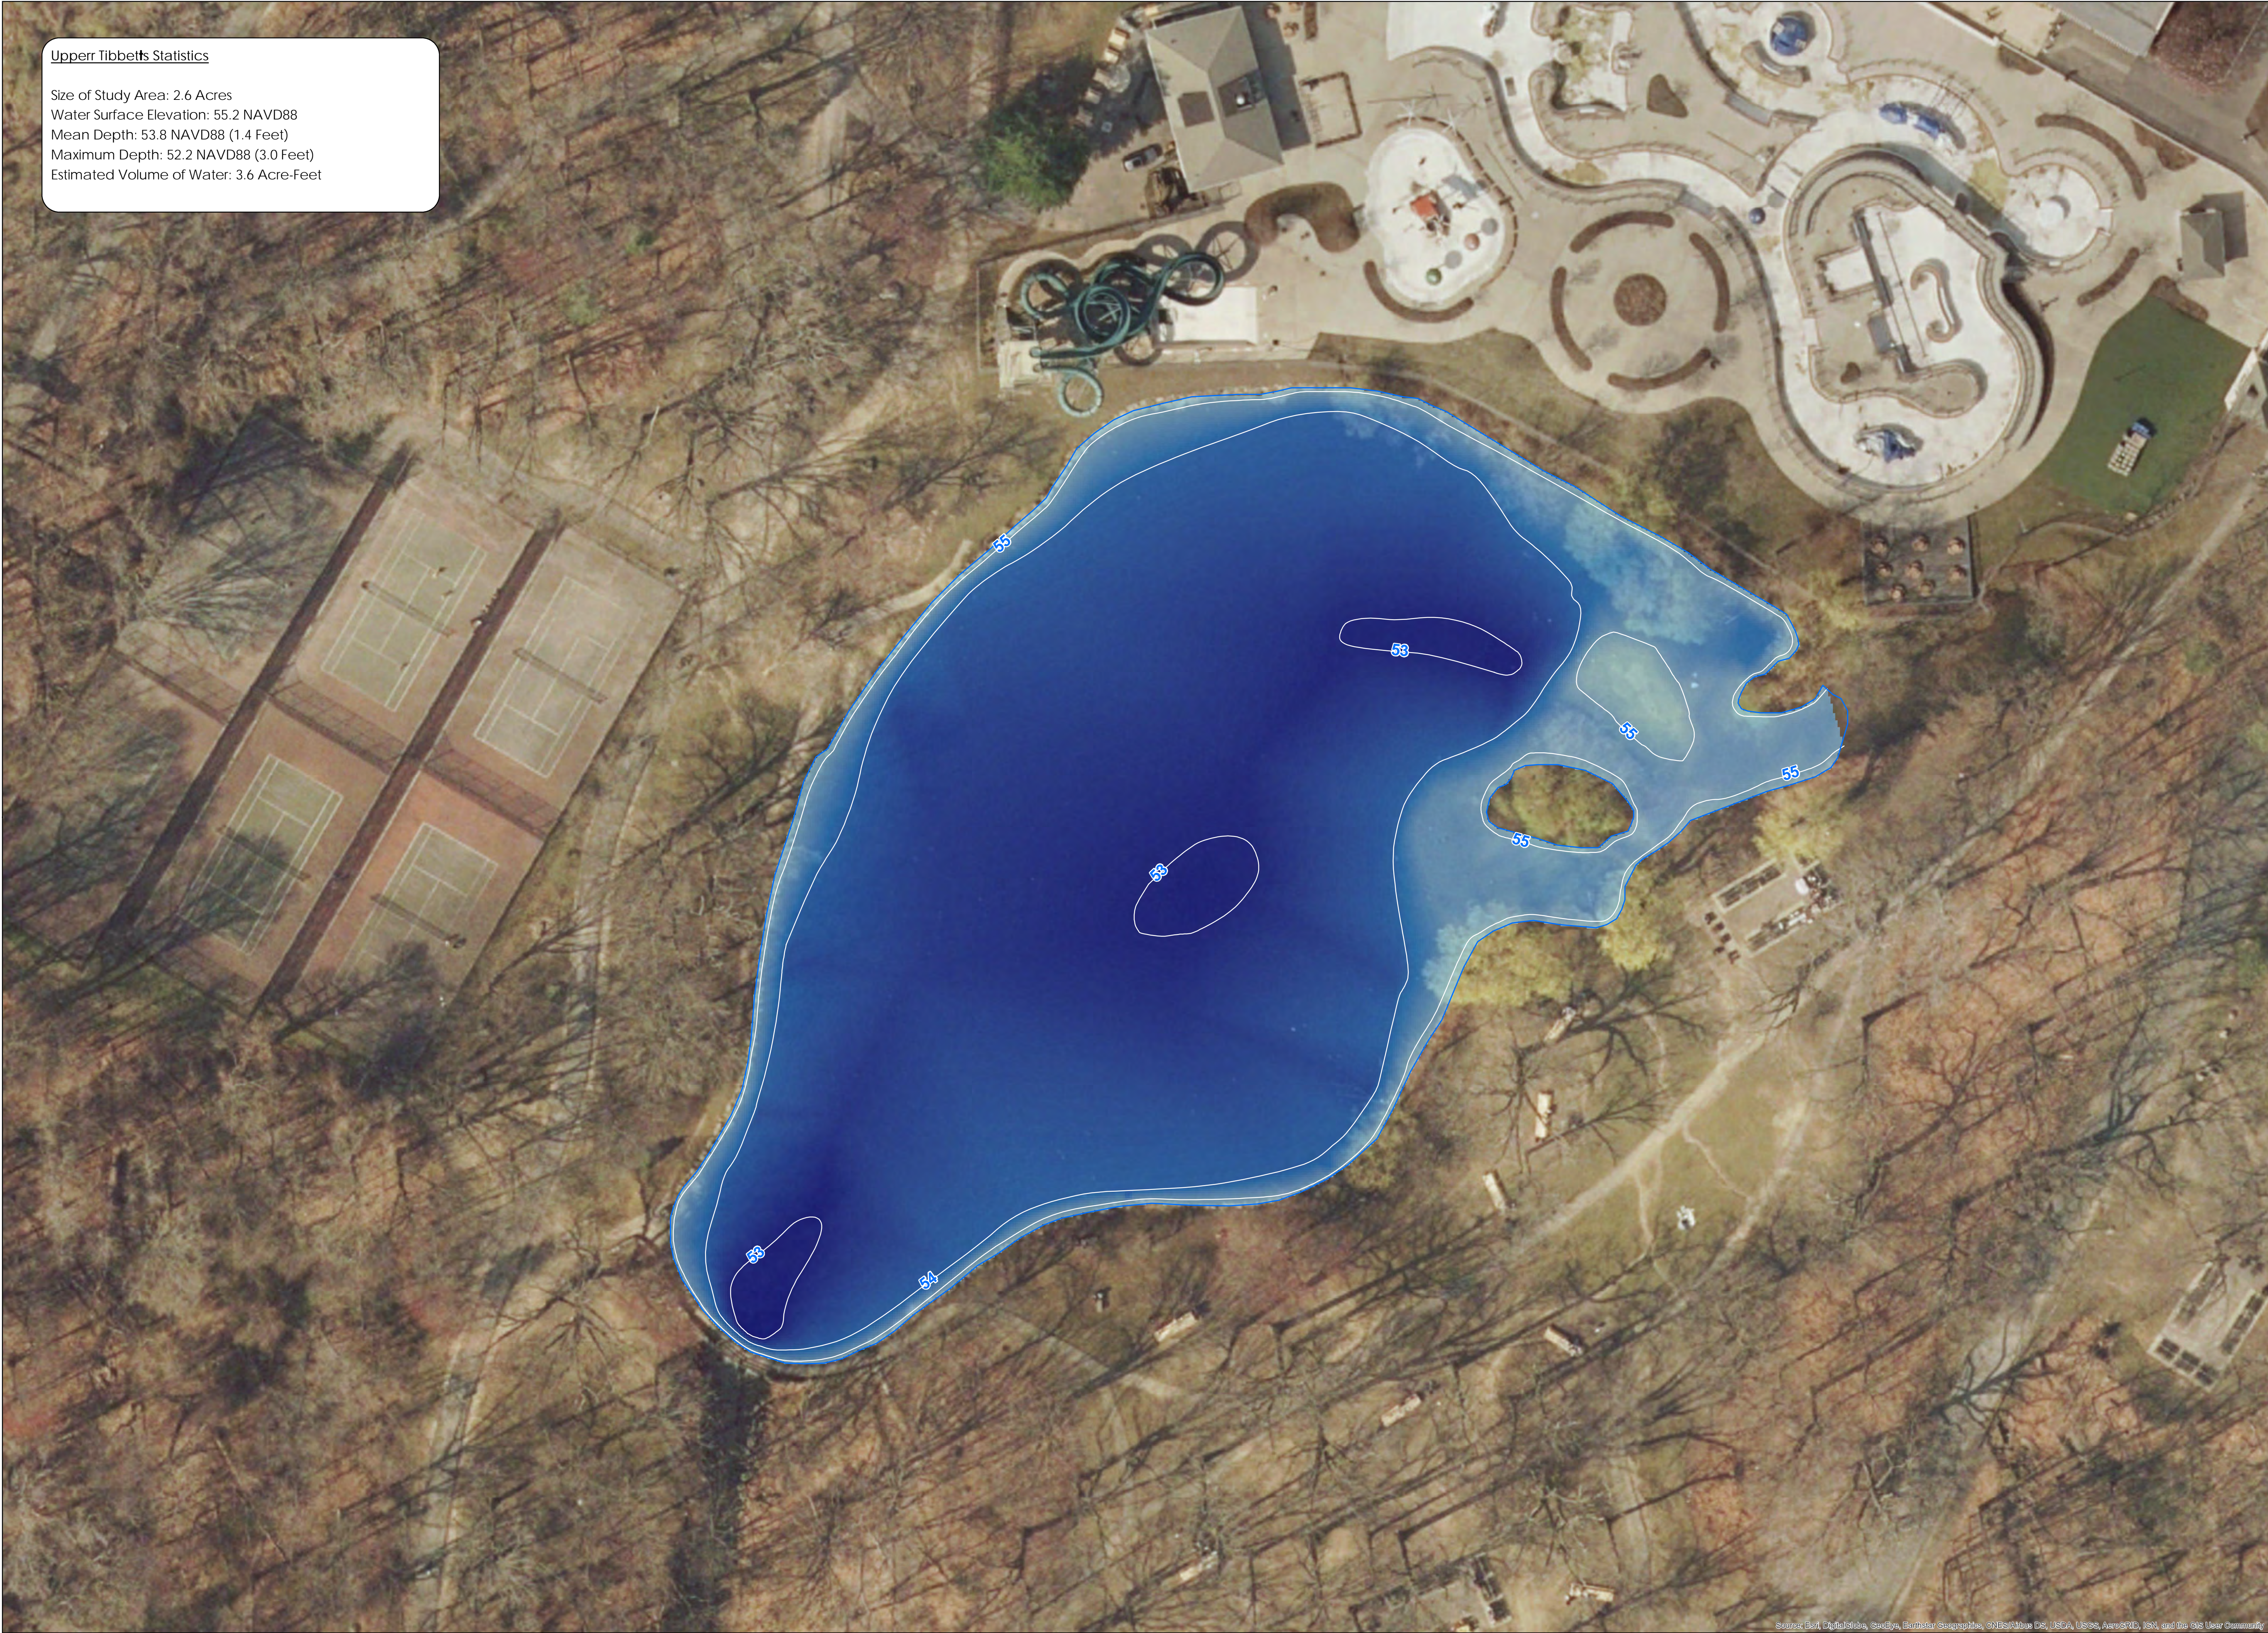
Size of Study Area: 2.6 Acres
Water Surface Elevation: 55.2 NAVD88
Mean Depth: 53.8 NAVD88 (1.4 Feet)
Maximum Depth: 52.2 NAVD88 (3.0 Feet)
Estimated Volume of Water: 3.6 Acre-Feet

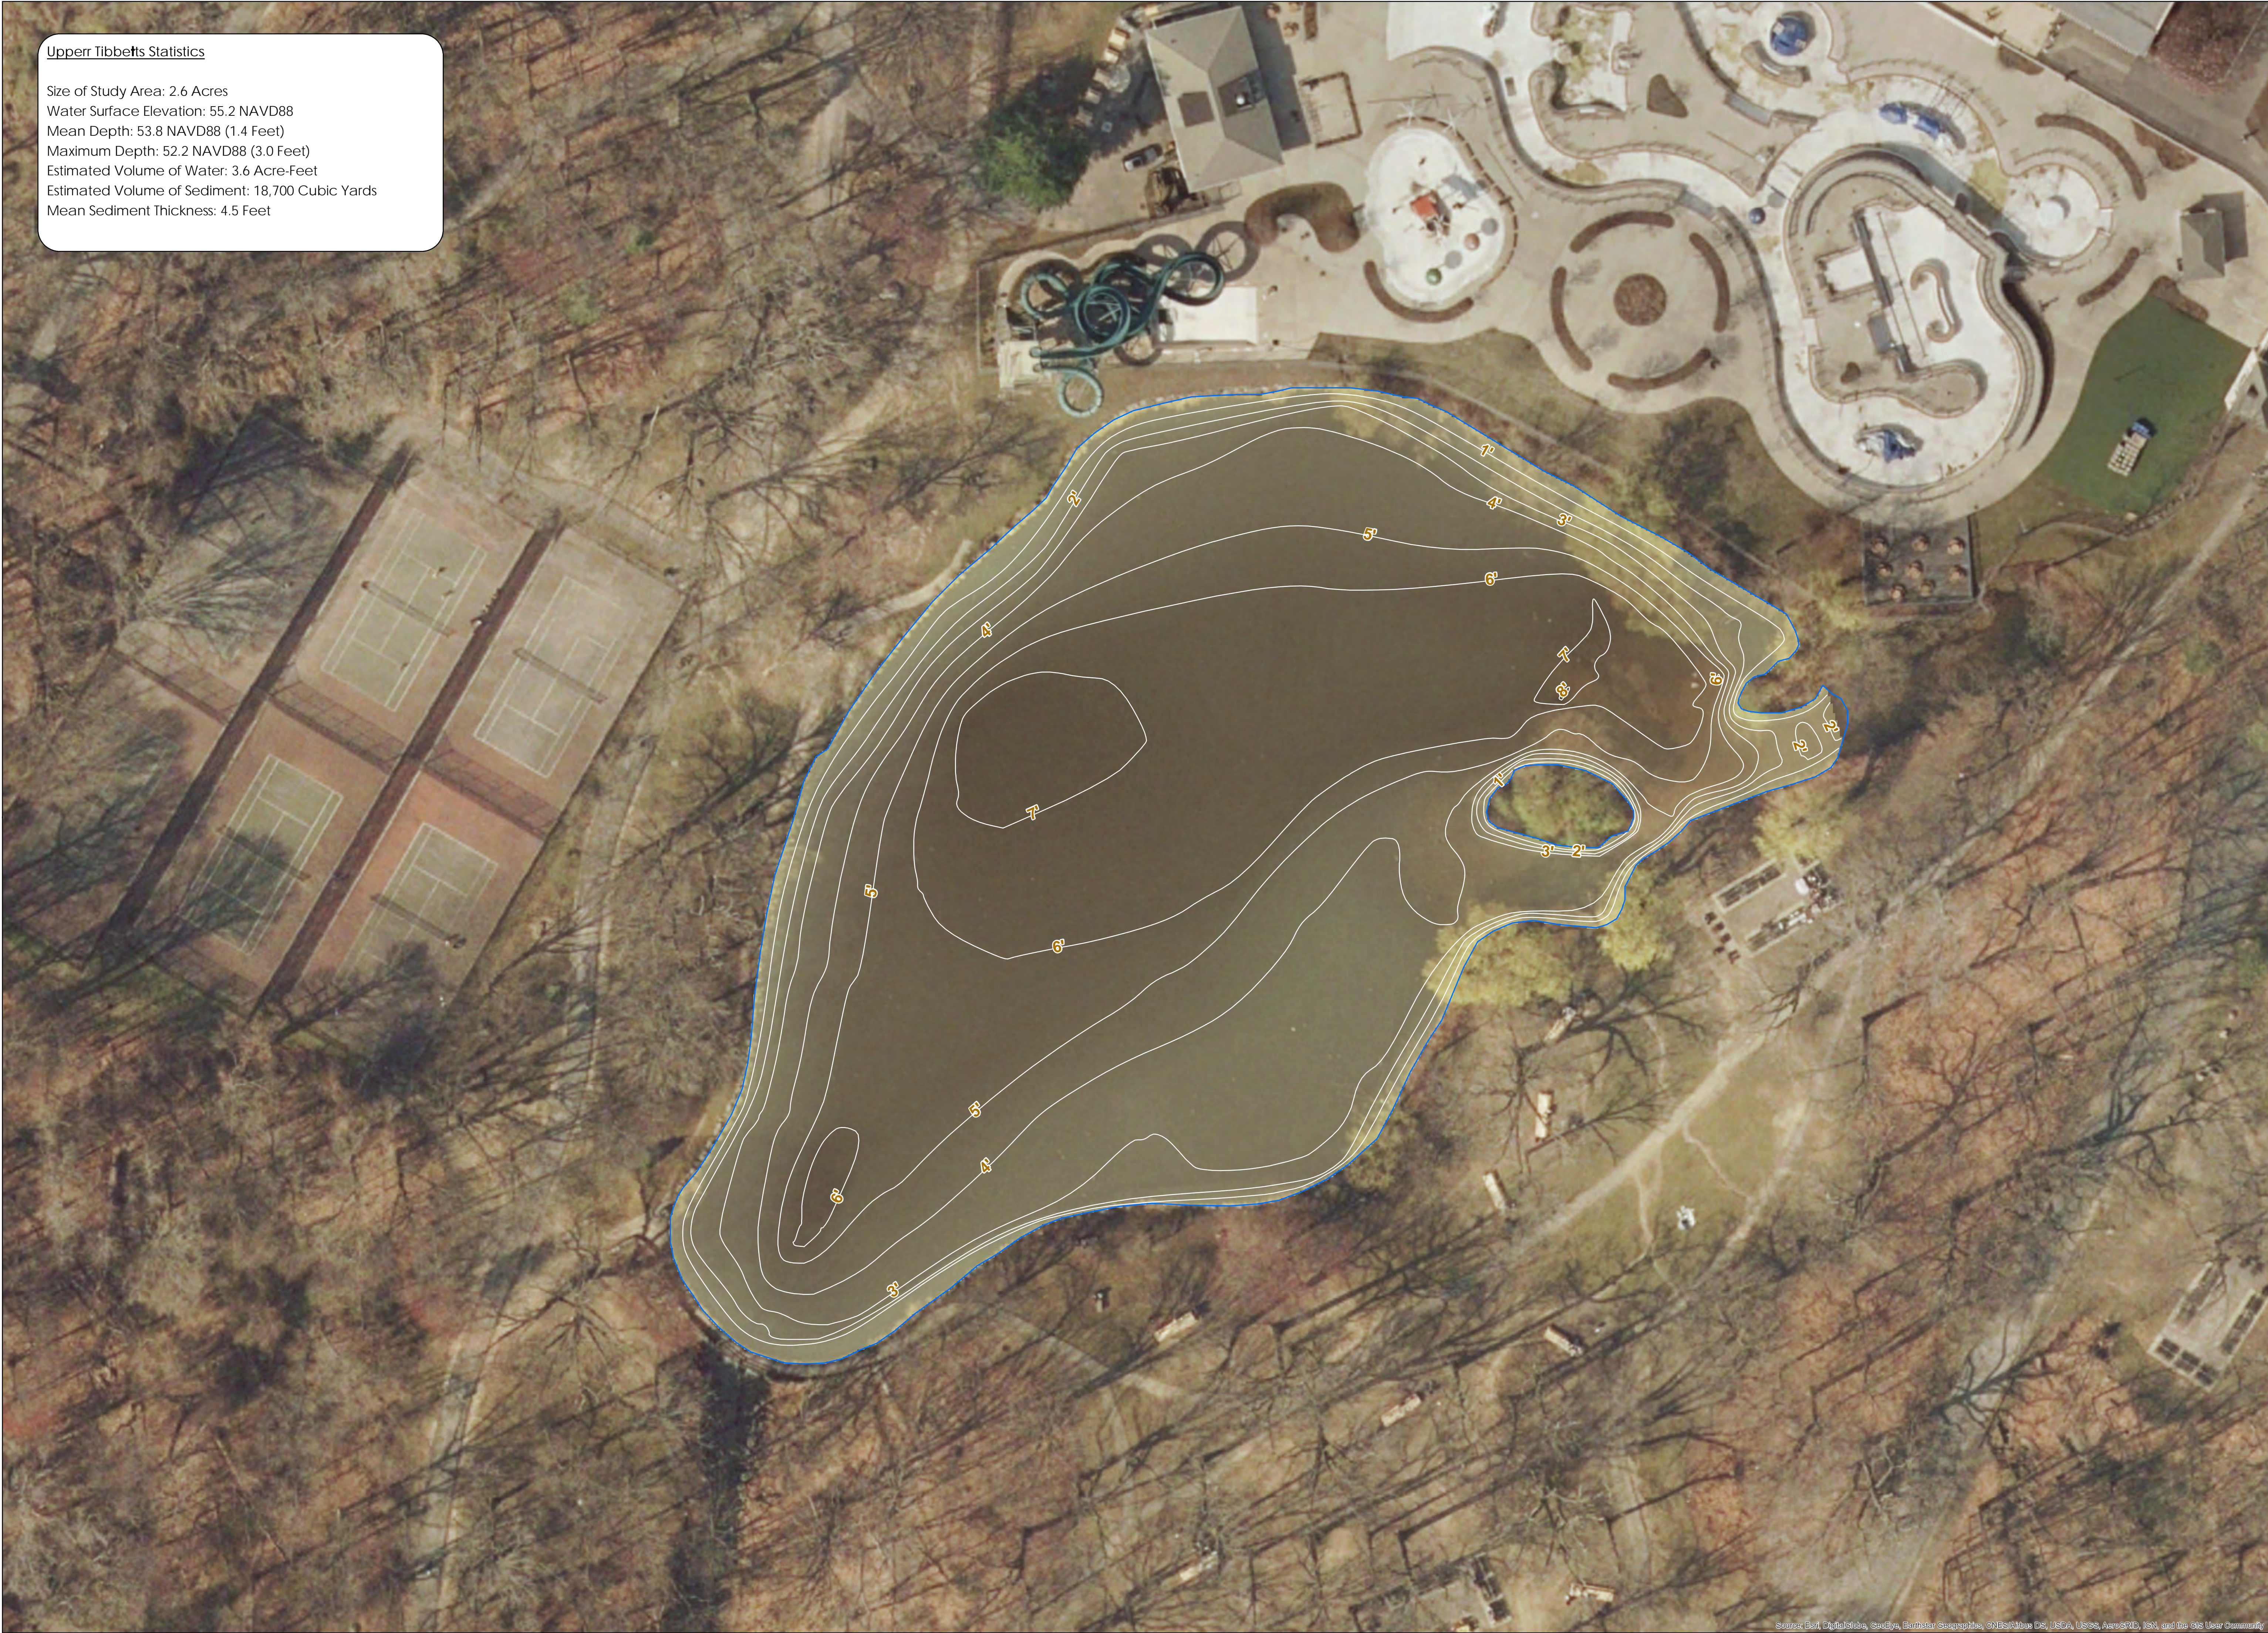
Size of Study Area: 2.6 Acres
Water Surface Elevation: 55.2 NAVD88
Mean Depth: 53.8 NAVD88 (1.4 Feet)
Maximum Depth: 52.2 NAVD88 (3.0 Feet)
Estimated Volume of Water: 3.6 Acre-Feet
Estimated Volume of Sediment: 18,700 Cubic Yards
Mean Sediment Thickness: 4.5 Feet

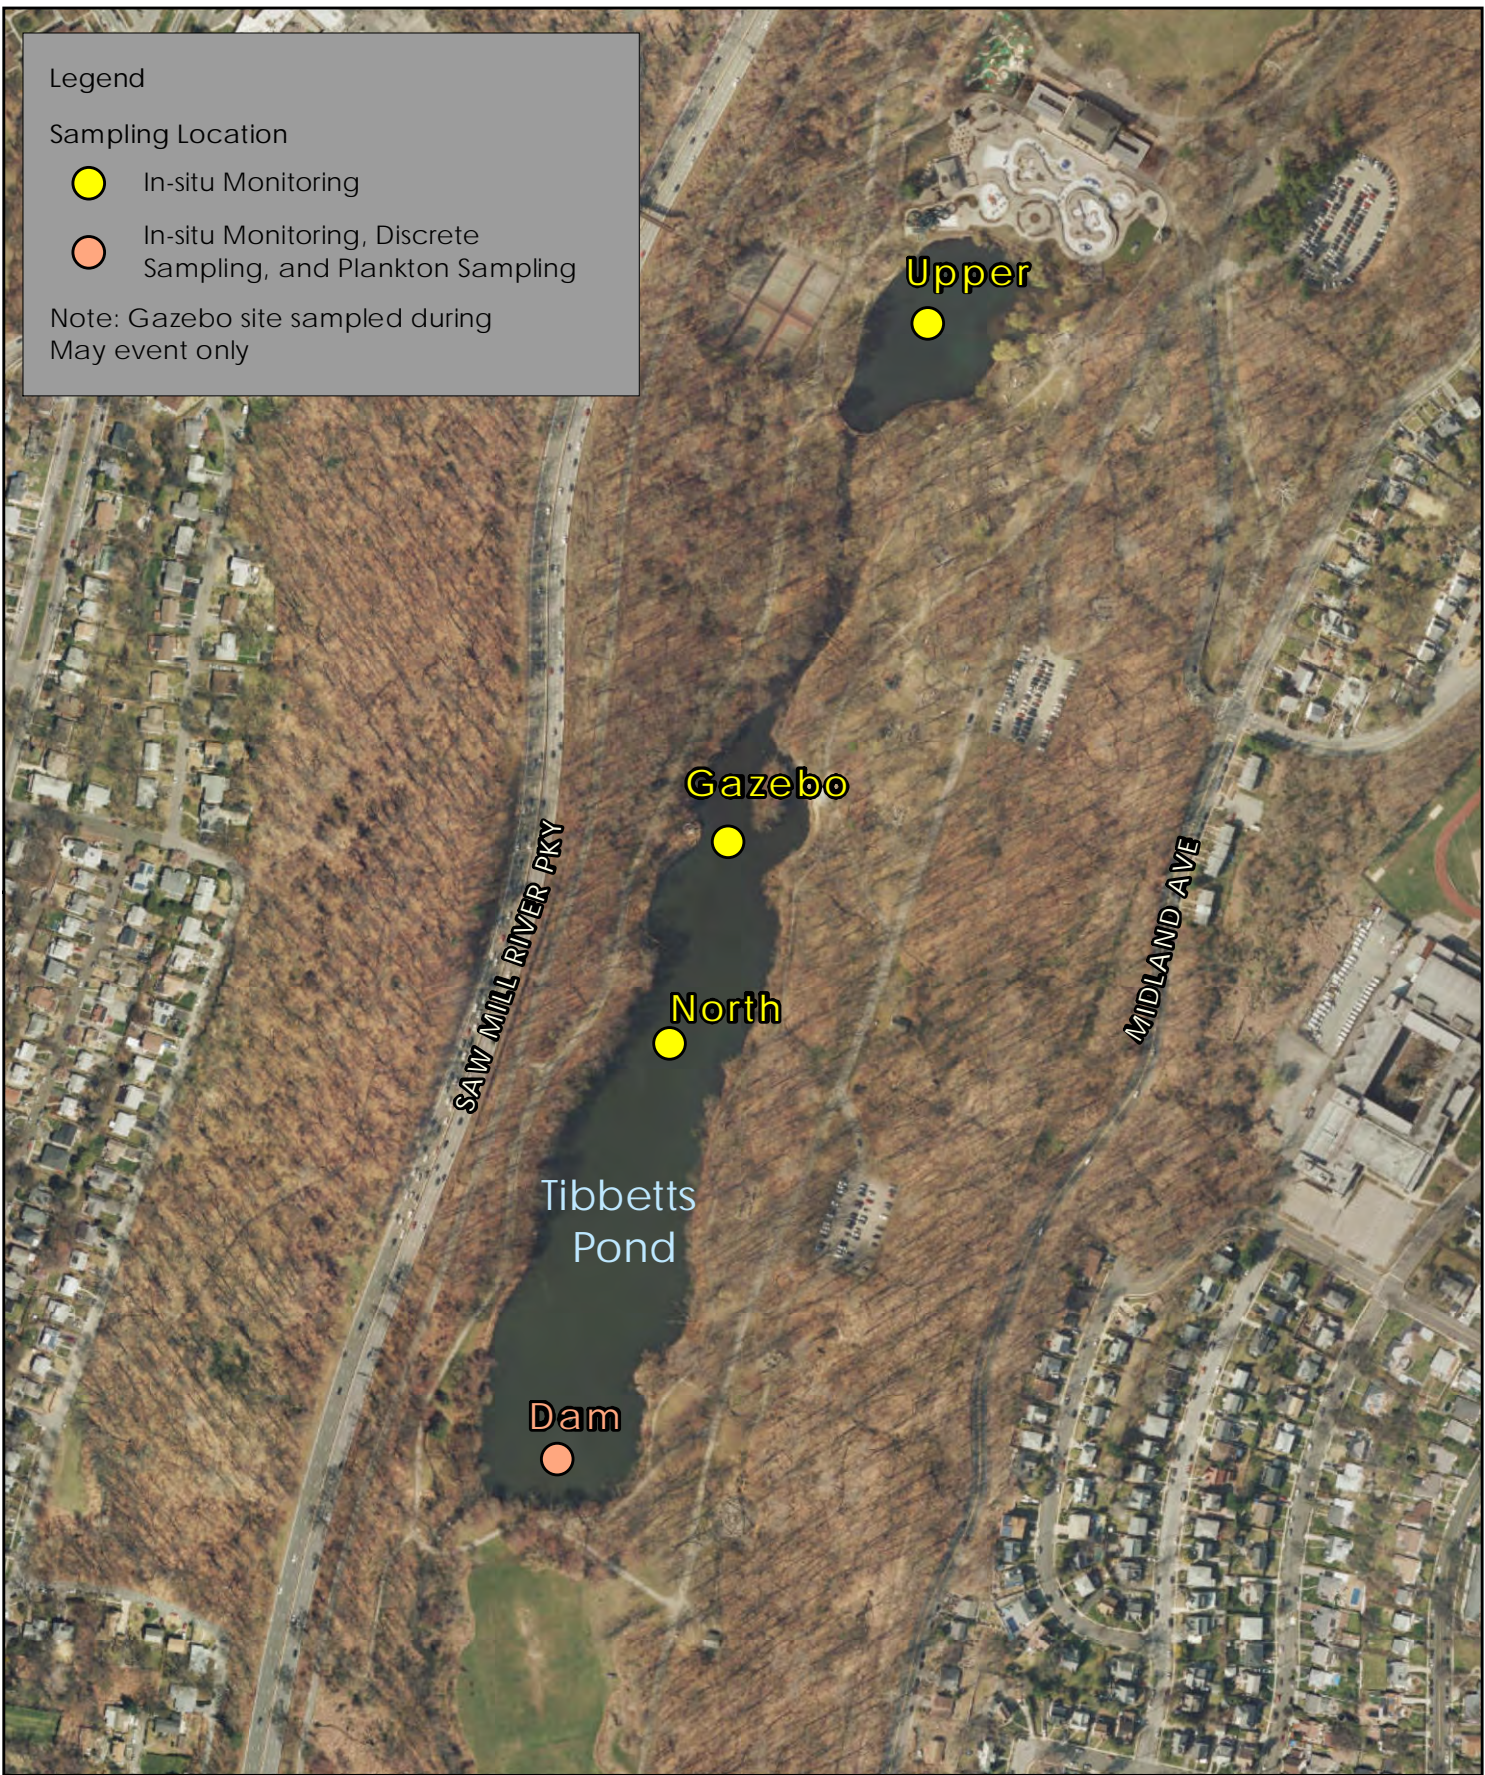
SAMPLING MAP

Appendix II: Water Quality Sampling Locations

NOTES:
1. Sampling locations are approximate.
2. Aerial imagery obtained from ESRI World Imagery.
