MERESTEAD

HISTORIC STRUCTURE REPORT

Prepared by
Harboe **A**rchitects, PC

AUGUST 2017

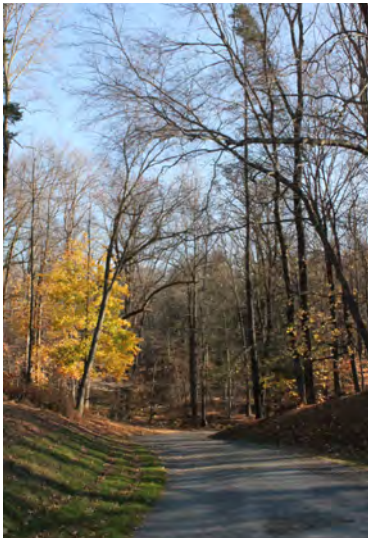
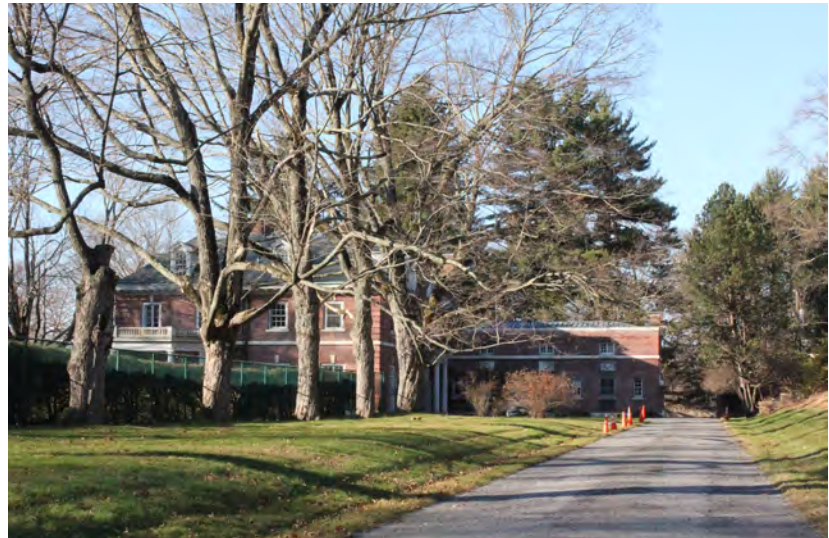
The road is in fair-to-good condition. It retains its original configuration but the bluestone gravel in the courtyard is sparse in many locations, revealing the dirt road below. The hedge at the south end of the forecourt was removed.

Figure II-99. Entry drive. (HA, 2015)

Figure II-100. Entry drive to forecourt, looking north. (HA, 2015)

The drive is an important feature of the site and its configuration and historic surface should be restored.

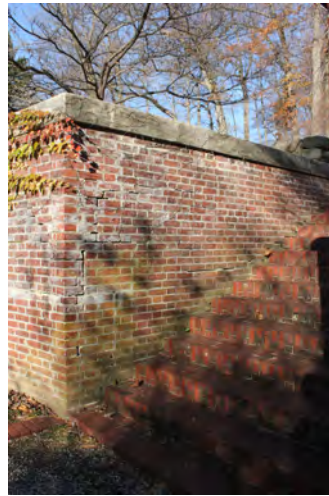
The curved brick masonry wall and stair are in fair condition. The most noticeable issue is the extreme efflorescence and mortar joint deterioration in the brick walls due to water infiltration. The water appears to be the result of non-existing or failed waterproofing and drainage at the backside of the wall, which allows the ground water to penetrate the masonry. In addition, the water is also causing some brick displacement and vertical cracking. The marble coping units have biological soiling and a few open joints but otherwise appear to be sound. The brick stairs are different from those used in the retaining wall and have redder appearance. The brick stairs are generally in fair-to-good condition with some spalled and missing units.

Figure II-102. Displaced brick, eroded mortar joints, and efflorescence at retaining wall. (HA, 2015)

- The brick displacement and cracking is likely due to water and ground pressure at the backside of the wall. Non-destructive testing and test excavations should be conducted to verify the presence and condition of any retaining wall tiebacks.
- Disassemble section of wall where brick is displaced and rebuild plumb.
- To fully repair the walls, the entire backside should be excavated to install new drain pipes along the base and waterproofing at the backside of the wall.
- New tiebacks should be reinstalled, if required, and the walls rebuilt.

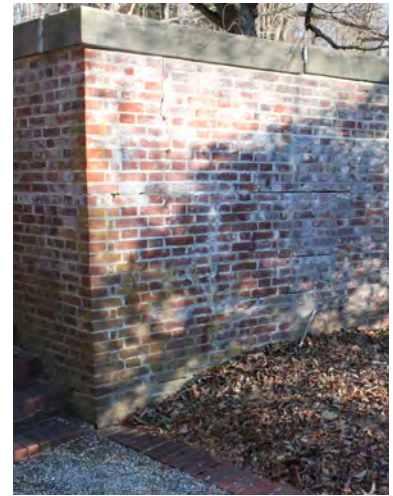
Figure II-103. Eroded mortar joints, cracked bricks, and efflorescence at retaining wall. (HA, 2015)

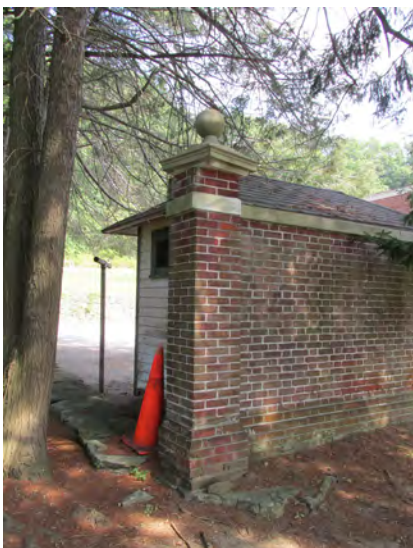
The brick masonry privacy wall is in fair-to-good condition. There are vines growing up both sides of the wall and on the coping units. The vines are likely the cause of the efflorescence and mortar erosion since their tentacles grow into the mortar joints and allow water to infiltrate the wall. The vines also retain moisture on the surface, exasperating the situation. This condition is most noticeable at the top half of the wall. Above the brick wall the marble coping units have biological staining and the marble finial at the north end is displaced and not securely set. This appears to have been caused by an impact that moved the stone.

Figure II-106. Displaced marble finial cap at brick masonry end post (Image from Harboe Architects).

- Remove all vines.
- Clean marble base and/or coping units. The cleaning methods and product should be mocked-up to determine the gentlest means possible to of successfully remove the soiling.
- Repoint all mortar joints in brick and stone masonry. New mortar is to match the original mortar as determined through material testing.
- Areas of damaged/cracked brick should be removed and replaced with either salvaged brick from a concealed or less visible areas, or new brick that matches the size, color, and texture of the original.

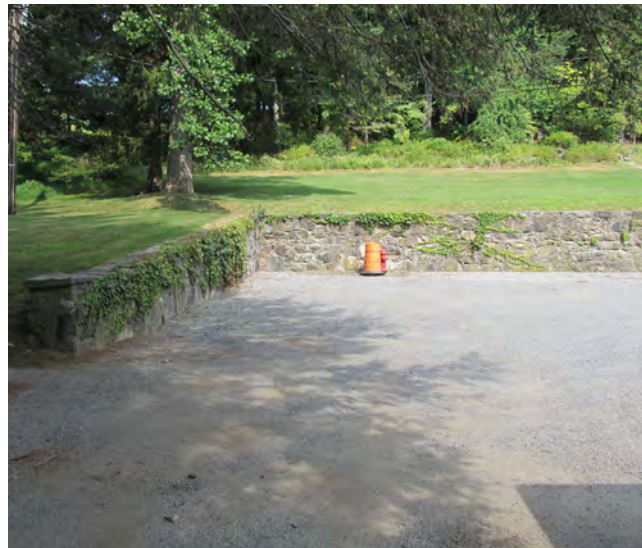
The field stone retaining wall appears to be in good condition. The walls have minor mortar joint erosion and about a third are covered with vines. These vines can cause damage to the stones by growing tentacles into the mortar joints. The tentacles allow for water to penetrate the wall which can lead to freeze-thaw damage.

Figure II-107. Stone retaining wall at north and east ends of the servant's court (Image from Harboe Architects).

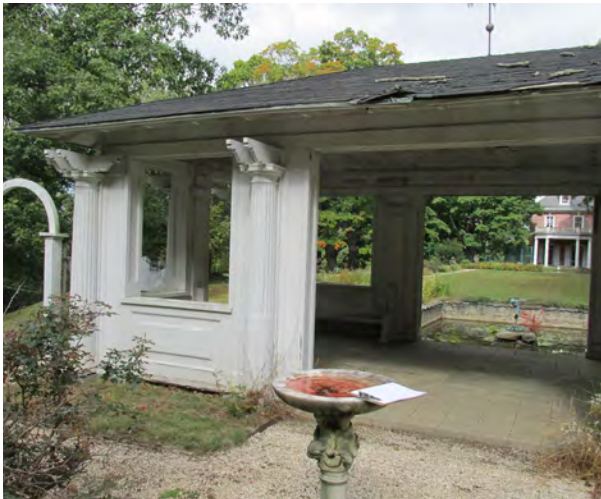
Overall the garden house is in fair-to-good condition. Typical conditions include minor damage to the wood elements near grade, biological soiling, minor wood rot, and paint failure throughout. A few of the screens in the summer house soffit vents are torn. The asphalt shingle roof is starting to fail, with areas of damaged and missing shingles, and have biological growth. This damage is most pronounced on the south elevation above the south opening where the wood edging is badly damaged and tiles are displaced.

Figure II-110. Damaged garden house roof edge and missing gate. Looking north from rose garden. (HA, 2015)

- Rotted and damaged wood elements on the gates and summer house should be restored.
- Gates with loose joints should be restored.
- All woodwork should be prepped and painted.
- Damaged soffit vent screens should be replaced.
- The summer house roof should be re-roofed.
- Although the original hedge remains at the east side of the garden, new hedges should be planted along the west and south sides to enclose the garden and recreate the original configuration.
- Reconstruct the wood pergola using remaining original posts as templates.
- The rust staining should be removed from the bronze sculpture and the fasteners replaced with bronze.
- The edging along the paths should be re-set in the ground and gravel added to create a consistent thickness to adequately cover the paths.

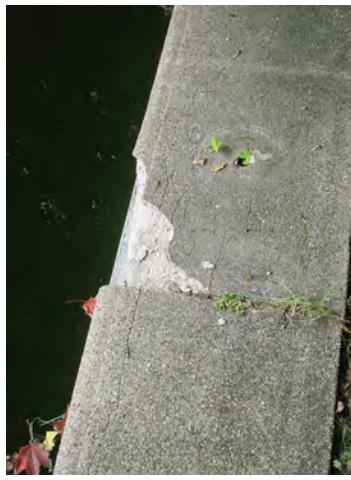
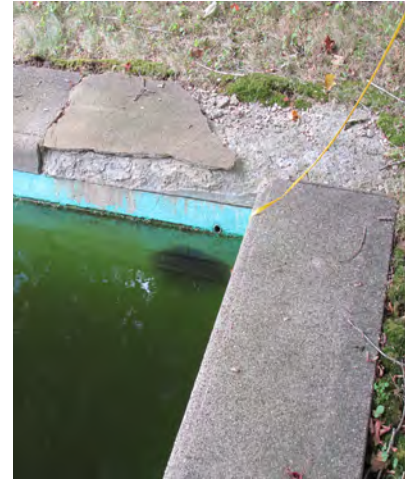
The pool was filled with water during each of the site visits so it was not possible to observe the wall and slab conditions. The perimeter concrete coping units are in fair condition. Approximately 5-10 appear to have significant delamination and/or spalling which will require the units to be replaced. A number of other units have cracks on their skyward surface that will allow water infiltration and lead to further delamination and spalling. There originally was a diving board at the south end of the pool that has since been removed.

Figure II-114. Damaged concrete swimming pool coping unit. (HA, 2015)

Figure II-115. Damaged concrete swimming pool coping unit. (HA, 2015)

- Drain the pool and inspect the concrete walls and floor slab for any damage.
- Re-seal seam between floor and walls if needed.
- Remove and replace damaged concrete coping units with new concrete units that match size, color, and texture of the originals.
- Replace rotted jamb members and flooring at changing house.
- Prep and paint all the wood elements.
- Remove vinyl floor tiles and replace with new sheet linoleum flooring. The color and pattern should complement the rustic nature of the building.
- Restore all door locksets.
- Refinish doors.

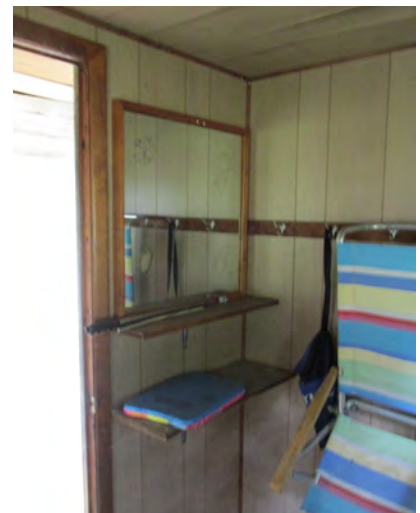
Figure II-120. Changing room mirror and shelf. Note paneling on ceiling is loose/displaced. (HA, 2015)

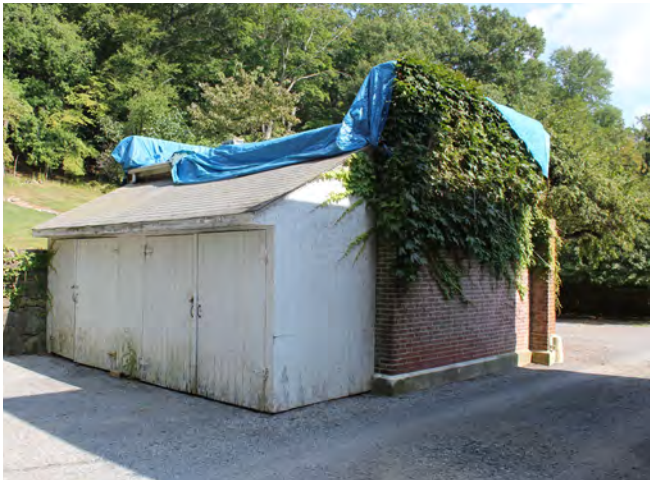
The brick masonry shed is in fair condition with the most significant damage caused by water infiltration through the walls and roof. Although the roof condition was not observed, it is evidently in poor condition since it is now covered with a tarp to keep the water out. Evidence of the water infiltration is most noticeable on the interior where there is extensive efflorescence on the brick walls and water staining on the roof decking. The exterior masonry walls appear to be in better condition with only select areas of mortar joint washout but significant areas are covered by vines which are likely the source for some of the water infiltration. The marble base is heavily soiled and there are vines running up the south elevation. The paint on the lean-to wood shed is failing and the bottom of the doors appear to have some wood rot.

Figure II-121. Garage/shed with wood addition. Tarp was recently added over the roof. (HA, 2015)

- Replace roofing
- Replacing damaged wood decking and roof joists

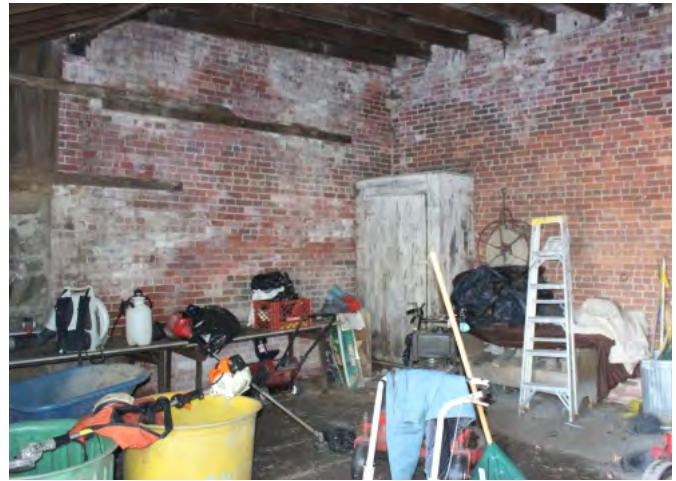
Figure II-122. Interior of garage/shed showing extensive efflorescence on brick walls. (HA, 2015)

Restoration of the brick masonry shed should focus on making it water tight to prevent further degradation. This would include the following treatments:

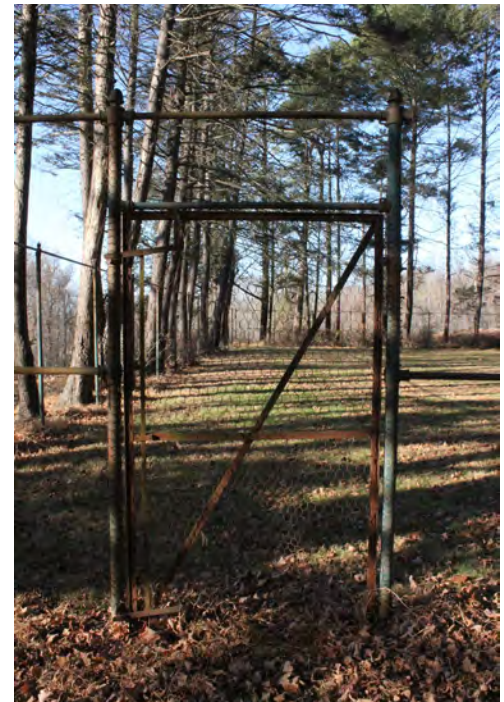
- The perimeter chain link fence is in poor condition and little remains besides the vertical posts.
- The grass court is still cut but the overgrown hemlocks may cast too much shade which may result in the grass thinning.
- All of the tennis court equipment has been removed from the courts and put into storage.

Figure II-127. Chain link fence entry gate. (HA, 2015)

- Removing the chain link fencing.
- Removing the existing hemlocks and planting a new hemlock hedge along the courts western and southern boundaries.
- Provide new net posts and netting.

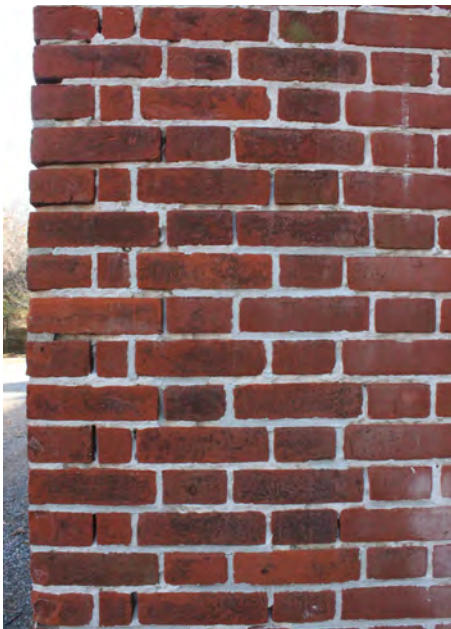
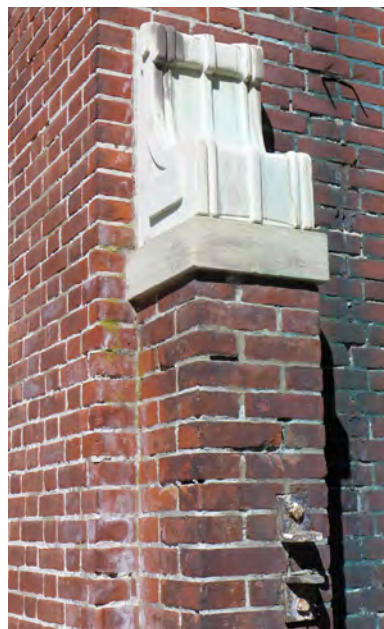
Most of the mortar joints at the brick and marble masonry are severely deteriorated and are no longer preventing water from infiltrating the wall. The mortar has eroded at most locations and has severely eroded at areas adjacent to downspouts, likely due to previous downspout leaks. The mortar is typically cracked where it meets the masonry units, allowing water to infiltrate the wall.

Figure II-130. Eroded brick mortar joints. (HA, 2015)

Figure II-131. Eroded brick mortar joints. (HA, 2015)

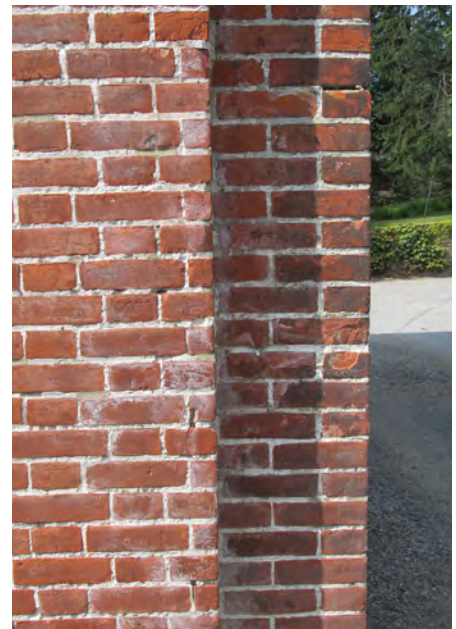
Figure II-132. Eroded brick mortar joints and soft brick. (HA, 2015)

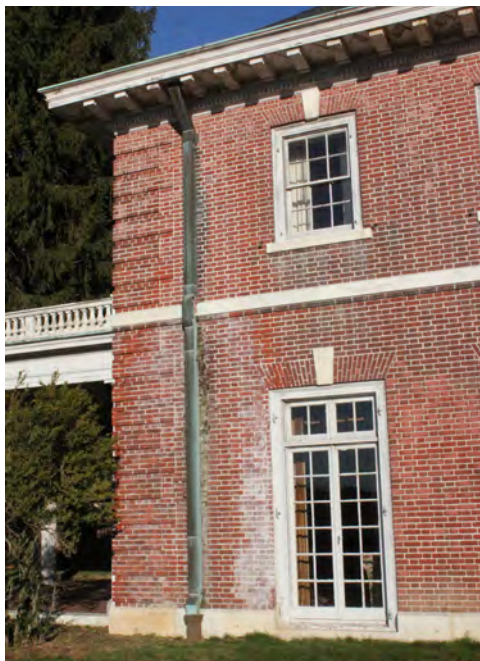
The brick masonry is typically heavily stained below the windows and adjacent to the downspouts. This staining has likely been caused by corrosion run-off from the original copper or bronze screens and copper downspouts. The staining and soiling of the masonry is a visual detractor from the house, but does not appear to be causing any further damage to the masonry. In addition, there are selectively painted bricks around the house. The care taker of the house, Tom Comito, indicated during an interview that many of the bricks were painted by a member of the servant staff during the 1980s with red paint to touch-up white paint drips from when the wood soffit was painted.

Figure II-133. Efflorescence on west elevation adjacent to downspout. (HA, 2015)

- After correcting the sources of water infiltration, removing the efflorescence will likely require multiple cleaning treatments.
- Displaced stones and brick should be carefully removed and reset. In many locations, this will require the removal and re-setting of stone and brick courses above.

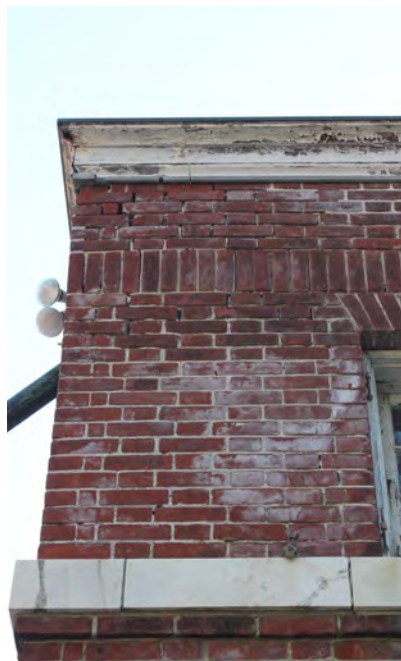
Figure II-134. Efflorescence on north elevation of servant's wing (HA, 2015)

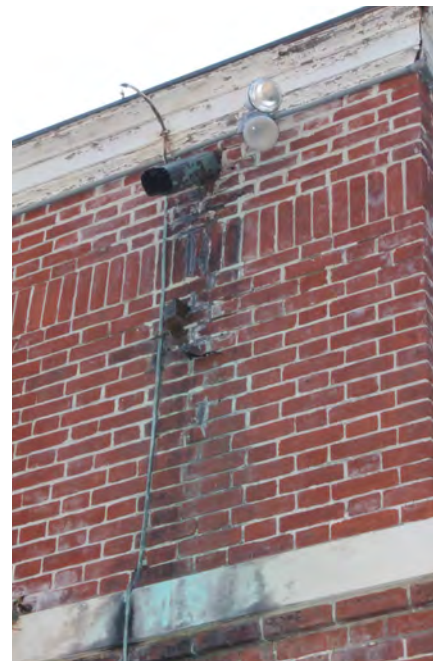
Figure II-135. Staining in the location of the missing downspout. (HA, 2015)

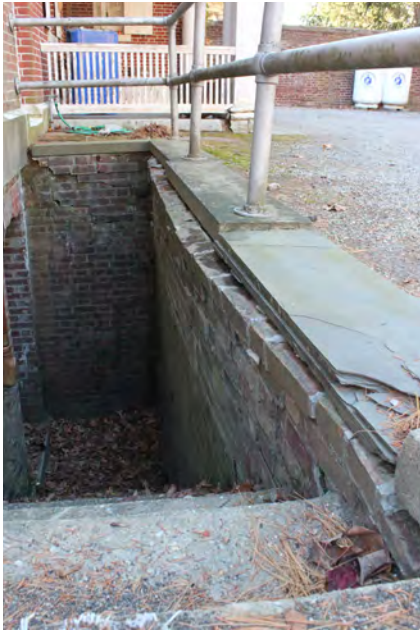
There are locations with displaced stone and brick units; This is specifically evident at many of the area wells and the brick side wall for the stairs to the basement. Some brick masonry is displaced and no longer securely set with in walls. This condition is at the areas of severely deteriorated mortar joints and efflorescence at the service court garden wall and the entry court retaining wall. At these locations the displacement has been caused by severe water infiltration.

Figure II-136. Displace brick at the basement stair sidewalls. (HA, 2015)

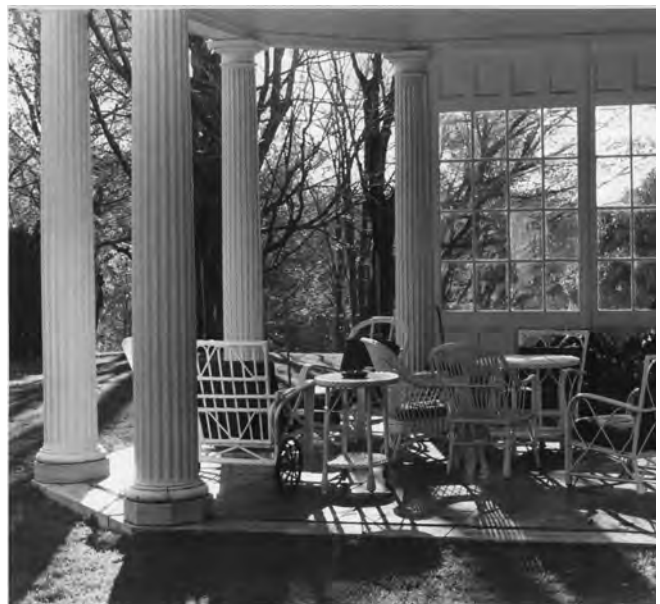
Figure II-141. Undated photograph of south porch showing the original round column bases. (HA, 2015)

All of the freestanding round columns at the entry porticos and porches are missing their original bases. The original round bases have been previously removed and replaced with octagonal bases. In addition, the replacement bases are in poor condition with rotted, displaced and missing pieces. The shafts of the columns are in good condition. When probed, some columns shafts have minor areas of rot at the bottom of shafts. The square column at the servant's porch has its original base. The base of this column is in poor condition with rotted, loose and displaced elements. The columns at the north porch and the servant's porch have had temporary wood shoring installed to support the roofs due to the poor conditions of the column bases.

- Recreate original round wooden bases.
- Reattach all loose elements.
- Assess structural integrity of north porch and re-stabilize within existing columns. Remove wood shoring.
- Consolidate rotted wood at base of columns with epoxy resin as needed, or provide wood Dutchman, and treat with Borate plugs.
- Prep and paint entry portico/porches off-white (Munsell 5Y 9/1 or Benjamin Moore OC-94 "Windswept"). Refer to BCA's *Material Analysis* report. (provided to Westchester County separately).

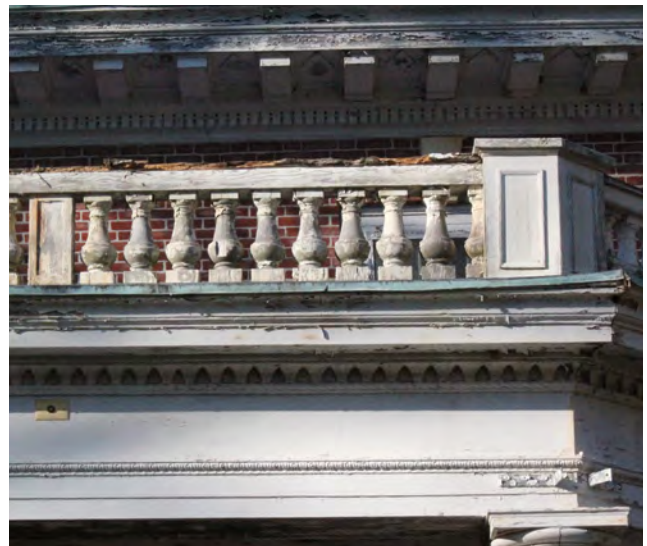
The baluster railings at the roofs of the north and south porches are in poor condition. It is believed that the corner columns as well as the top and bottom rails were replaced in 19xx (per tom.....). The top rail is severely rotted and the bottom rail is slightly to moderately rotted. The turned balusters are believed to be original and are in good to fair condition. They have some weathering and UV damage, but appear to be sound.

Figure II-143. Baluster railing at south porch. (HA, 2015)

- Remove and reconstruct top and bottom rails with Cypress to match originals in size and profile and to shed water.
- Carefully remove all rotted/damaged balusters sections. Consolidate rotted wood sections with epoxy resin or replace entire baluster with attic stock available in the basement or custom baluster that matches size and profile of the original.
- Prep and paint entry baluster railings off-white (Munsell 5Y 9/1 or Benjamin Moore OC-94 "Windswept"). Refer to BCA's *Material Analysis* report. (provided to Westchester County separately).

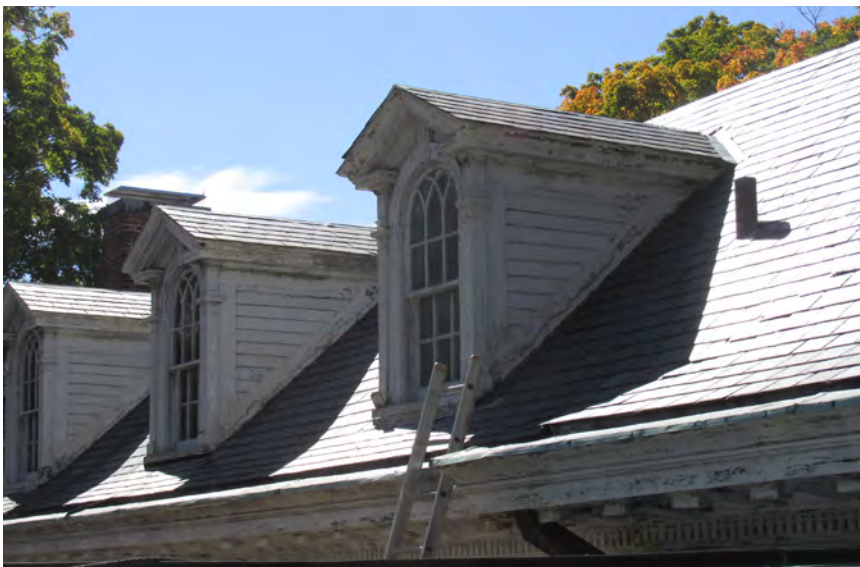
Figure II-144. Dormers along at east elevation. (HA, 2015)

The wood siding and trim of the dormers is typically in fair condition. No areas of rot were observed when surveyed through the windows and the exposed framing and roof decks adjacent to them in the attic are in good condition with no signs of leaks. Much of the trim at the base of the pilasters at the dormer fronts is missing or loose.

- Reattach all loose trim.
- Recreate missing and rotted trim pieces and siding to match the exact size and profile of the originals.
- Prep and paint entry dormers off-white (Munsell 5Y 9/1 or Benjamin Moore OC-94 "Windswept"). Refer to BCA's *Material Analysis* report. (provided to Westchester County separately).

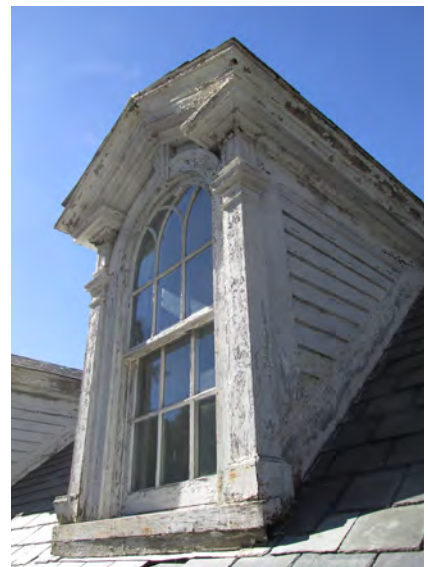
Figure II-145. Detail photo of dormer. (HA, 2015)

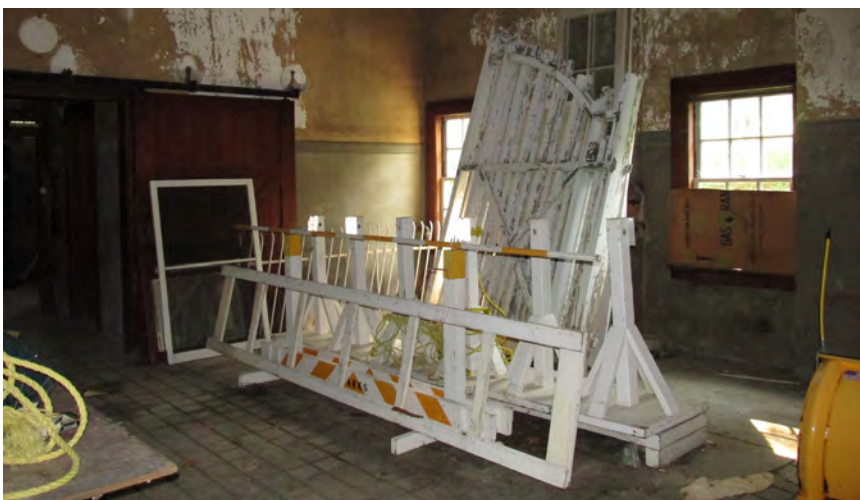
Figure II-146. Original wood gates to servant's court are stored in the Carriage House. (HA, 2015)

The gates are in fair condition. Some of the members have been previously replaced. The hinge side member of one gate that has been previously replaced is split, suggesting an inherent weakness at this location. Some of the members are loose. The paint is peeling and in poor condition.

- Carefully disassemble and rebuild all loose gate elements.
- Provide new historically appropriate hardware and reinstall wood gate.
- Prep and paint entry gates off-white (Munsell 5Y 9/1 or Benjamin Moore OC-94 "Windswept"). Refer to BCA's *Material Analysis* report. (provided to Westchester County separately).

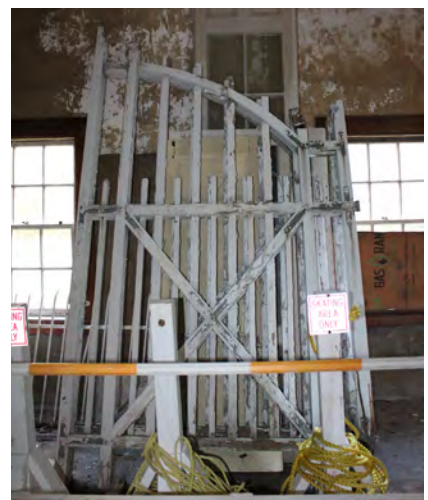
Figure II-147. Original wood gates. (HA, 2015)

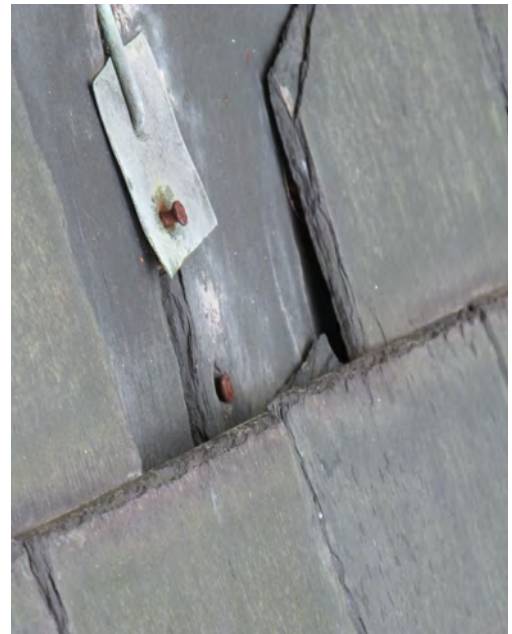
Figure II-149. Corroded ferrous anchors at slate roof. (HA, 2015)

The slate roofs are nearing the end of their serviceable life. The original slate fasteners are ferrous and, where they can be observed at areas of missing slates, they are moderately corroded. In addition there is pitting and cracks at the copper flashings creating conditions that can allow water to infiltrate. Approximately 5 % of the slates appear to be loose or missing and another 5% appear to have been previously replaced. The slates appear to still be in fair to good condition and it may be possible to salvage the slates for reuse when the slate roof is replaced. The roof deck is exposed in the unfinished portion of the attic at the south half of the house. It consists of ¾ x 6 ½ inch tongue and groove wood plank sheathing. It appears to be in good condition where it is visible.

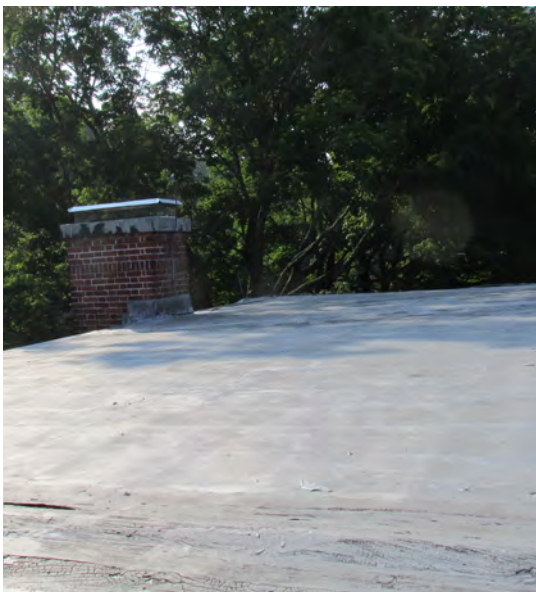
Figure II-150. Asphaltic roofing at flat roof over house, looking southeast. (HA, 2015)

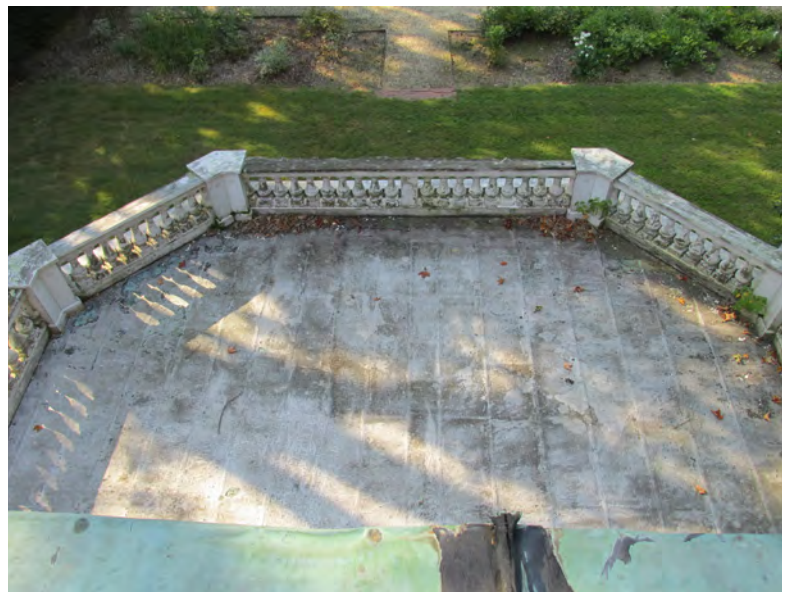
Figure II-151. Flat seam copper roof with asphaltic coating on south porch. (HA, 2015)

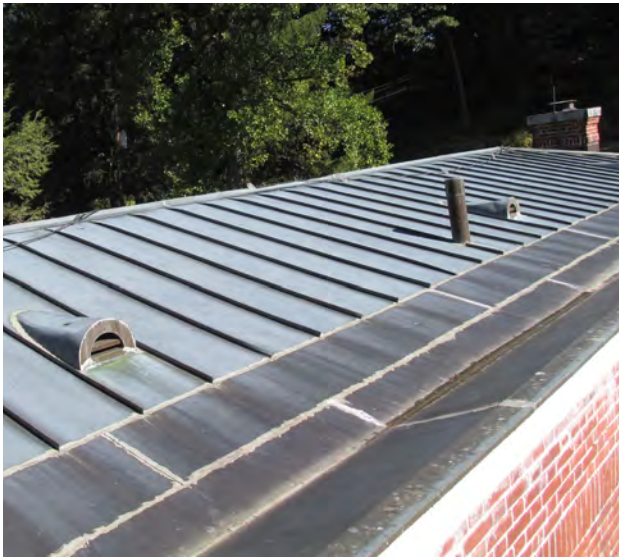
Figure II-152. Standing seam copper roof with flat seam gutter liner over the servant's wing. (HA, 2015)

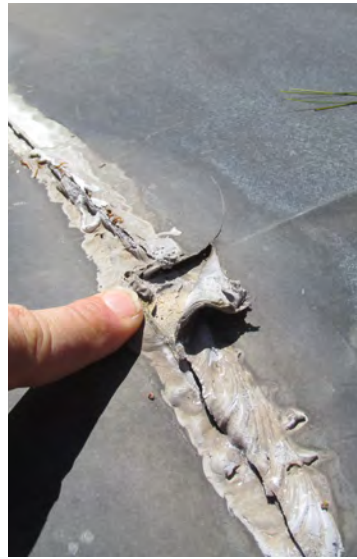
Figure II-153. Failed solder joint at flat seam gutter on servant's wing. (HA, 2015)

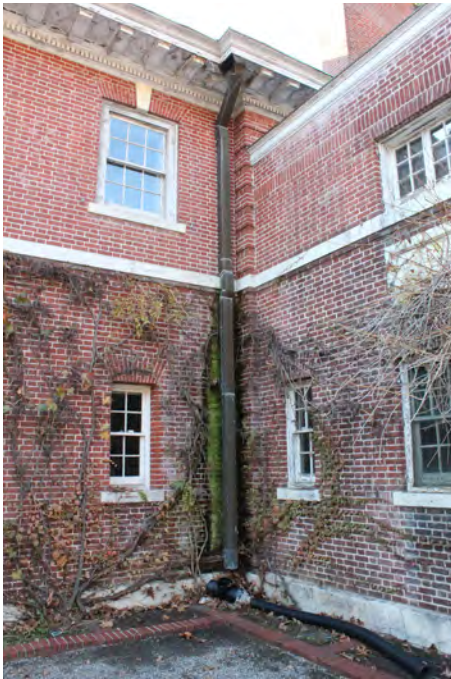
Figure II-155. Copper downspout at intersection of house and servant's wing. Note, downspout not connected to a drainage pipe. (HA, 2015)

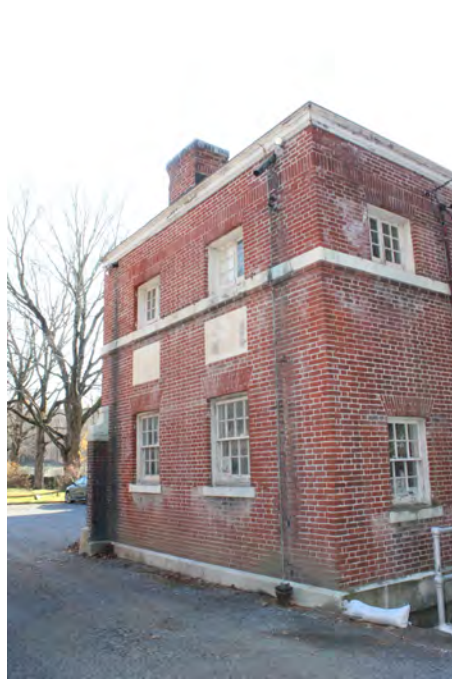
Figure II-156. Missing copper downspouts at east elevation servant's wing. (HA, 2015)

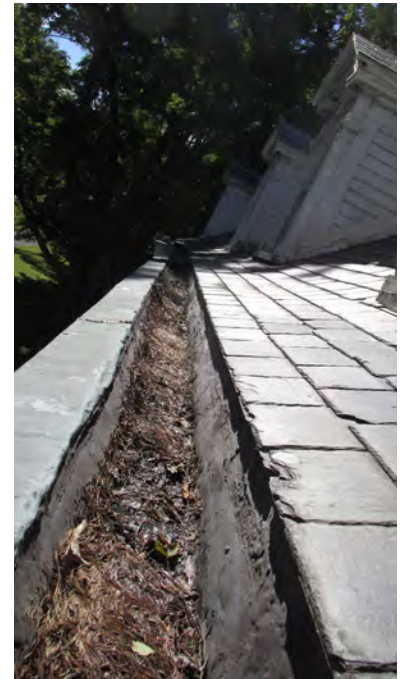
Figure II-157. Main house built-in gutter. Gutter has been coated with an asphaltic coating. (HA, 2015)

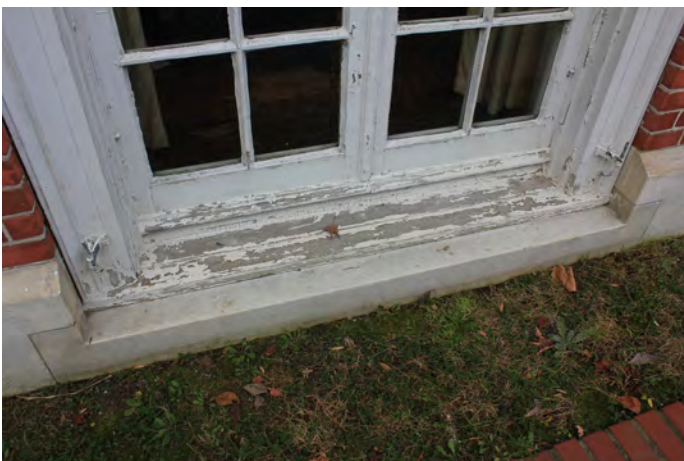
Figure II-164. Severely worn wood sill at French doors. (HA, 2015)

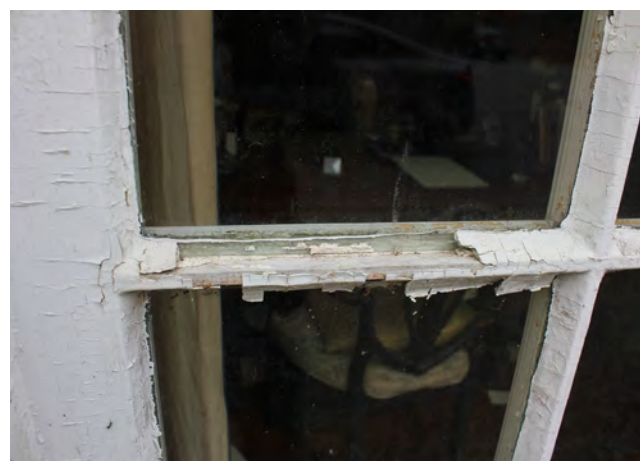
Figure II-165. Missing glazing putty at French doors. (HA, 2015)

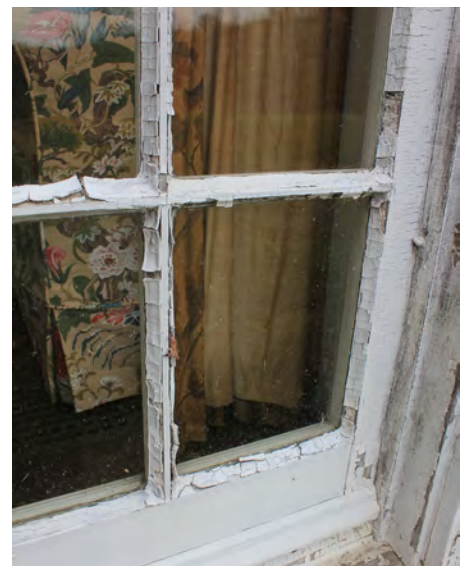
Figure II-174. Failing glazing putty. (HA, 2015)

wood sills are weathered and have minor uv damage. The window sash, typically operate well. About half of the double hung windows and broken or missing sash chords. The sash weather stripping is in good condition and appears to provide some control of air infiltration. The glass has a noticeable distortion indicating that it is cylinder glass and likely original. One exception to this is the glass at the west entry portico, which appears to be float glass, and is therefore may be replacement glass. All of the glass is set with exterior glazing putty. The putty is typically in poor condition with erosion and missing putty.

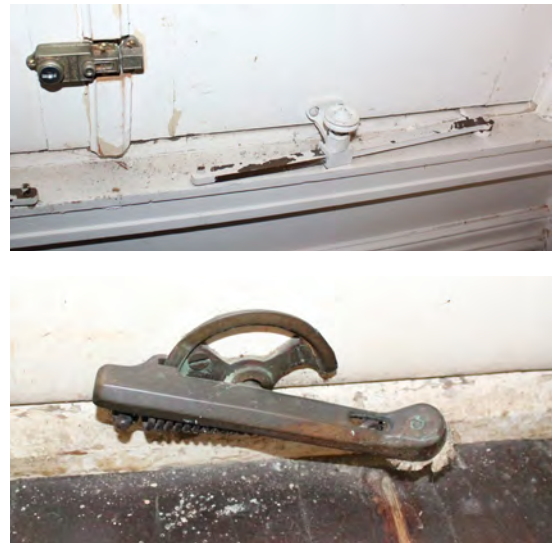
Figure II-185. Bronze floor mounted hold-opens on French doors in first floor primary spaces (below) and second floor bedrooms (top). (HA, 2015)

The French door hardware appears to be in good condition. The bronze has minor surface wear and there is minor paint drops on the hinges. The floor mounted hold opens are generally in fair condition and many of the rods are bent. These bent elements scratch the interior floor finishes when the doors are opened.

Since all of the hardware was only visually observed, each hardware element should be re-assessed and operated to determine how well it functions and restored accordingly. Typical treatments include:

- Remove all paint on hardware.
- Hardware finishes should be cleaned and/or re-finished.
- Adjust hardware locks so they operate smoothly.

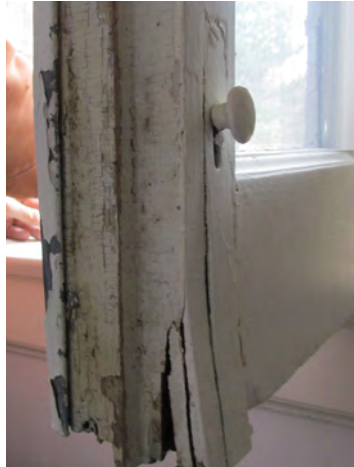
Figure II-190. Bottom casement sliding closer bolt. (HA, 2015)

The casement window hardware is generally in good condition. Some of the sliding bolts in the servant's wing casement windows have been removed and others have been painted over so they no longer work. The bottom sliding bolt on the middle casement window the servant's corridor is bent.

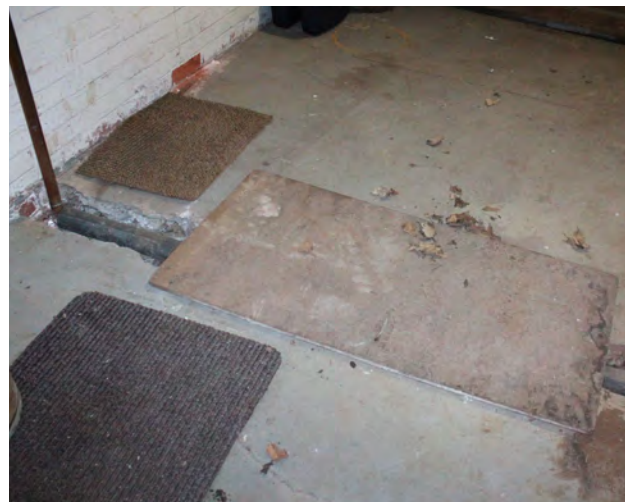
Figure II-199. Part of basement concrete floor was cut-out to install piping. (HA, 2015)

The concrete appears to be in good condition. The paint has been worn away in many locations and there is minor cracking throughout. A trench has been cut into the concrete floor in the room with the furnace and hot water tank.

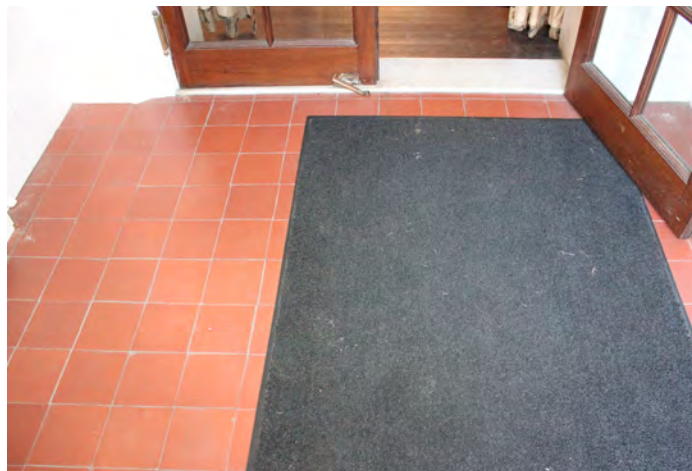
Figure II-200. Quarry tiles in Vestibule (101). (HA, 2015)

- Vestibule quarry tiles appear to be in good condition. Some of the tiles have broken off in the corners but have since been in-filled with grout. The grout joints are slightly eroded and soiled.
- The small square ceramic tiles appear to be in good condition besides general soiling and a few cracked tiles.
- The white hexagonal ceramic tiles in the second floor bathrooms appear to be in good condition. Typical conditions include: minor rust staining, minor scratches, some cracked tiles (tiles appear to be stable), select areas of mortar or sealant patches, and an area where 2-3 tiles are loose without grout.

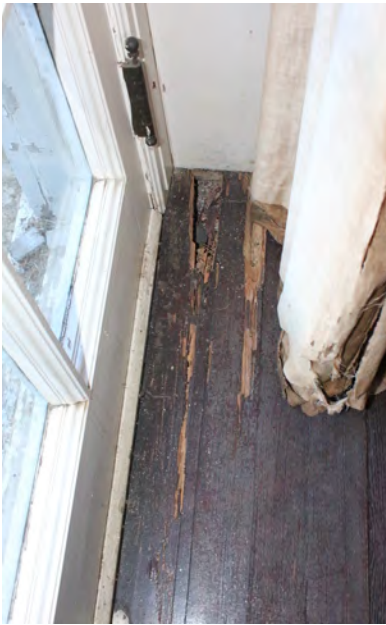
Figure II-206. Termite damage in Dining Room (108). (HA, 2015)

- Termite damage in front of the west doors of the Dining Room
- General scratches and gouges. These scratches are most evident at the French doors along the north and south walls where the floor hold open devices are sagging and scraping the floor.
- UV damage to the existing finish by the French doors
- Finish is severely worn in Laundry Room and third floor unfinished spaces
- Variations in the floor finish. Much of the wood strip flooring on the first and second floor has a dark resinous finish in comparison to the finish in some of the smaller rooms and closets as well as under the Dining and Living room rugs. This darker finish is not believed to be original.

- Carefully remove termite damaged wood flooring in the Dining Room and patch in new strip flooring that matches the size, species, and color of the original wood flooring.
- Remove paint splatter
- Strip and refinish wood flooring in areas of Primary Significance to match original resinous finish observable under rugs in Living Room (106) and Dining Room (108). An area under the rugs in the Living and Dining room should not be stripped but rather preserved as an example of an early or original finish.

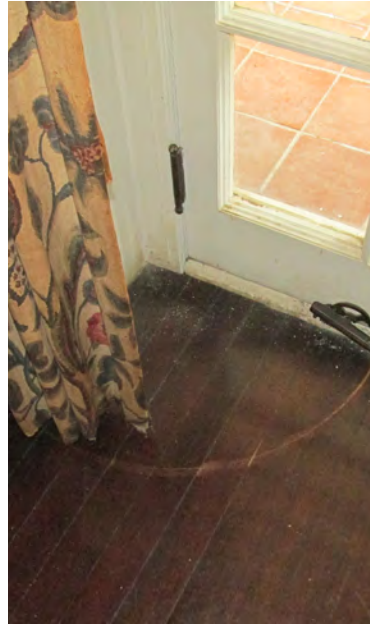
Figure II-207. Floor scratches from bent hold-open in Dining Room (108). (HA, 2015)

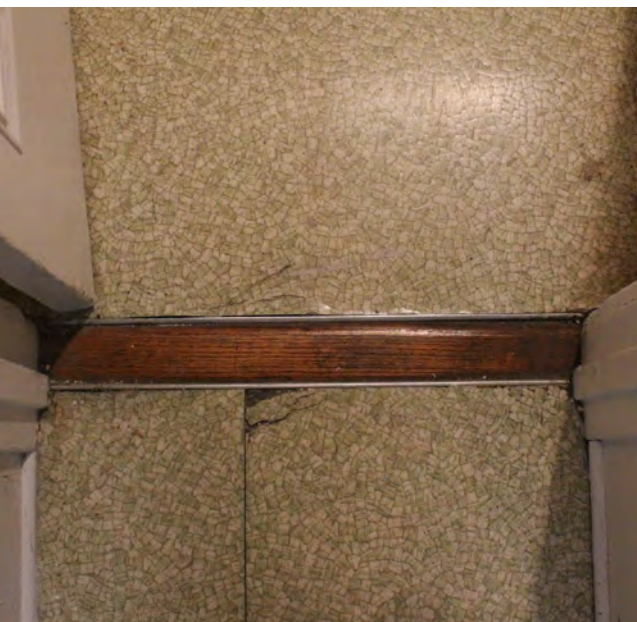
Figure II-209. Linoleum in first floor Servant's Corridor (115). (HA, 2015)

- Linoleum in first floor servant's wing and second floor Servant's Bathroom appears to be in fair condition. Typical conditions include areas of loose linoleum, small chips along the seams, and general soiling.
- The linoleum in the Coat Room Closet appears to be in good condition with only general soiling.

- Although the linoleum in the servant's wing and upstairs servant's bathroom was added during the Period of Significance, it is nearing the end of its serviceable life. Small sections should be lifted or removed to determine if there is a finished floor below. Depending on the condition of the flooring below, it may be able to be restored. Small sections of the removed linoleum should be saved for archive.
- Clean linoleum in Coat Room Closet.

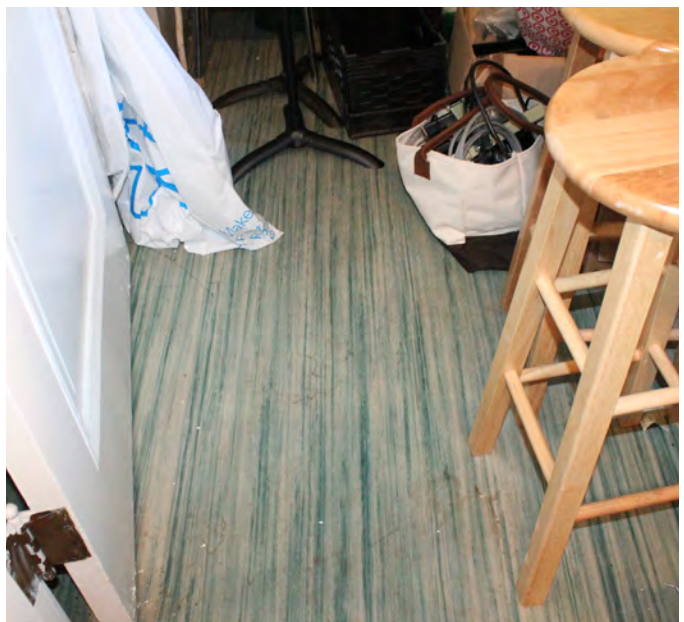
Figure II-210. Linoleum in Coat Room Closet (110). (HA, 2015)

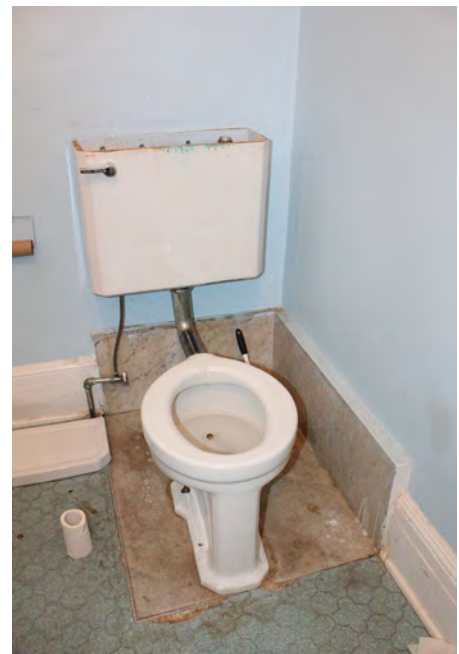
Figure II-212. Linoleum in Servant's Bathroom (218). (HA, 2015)

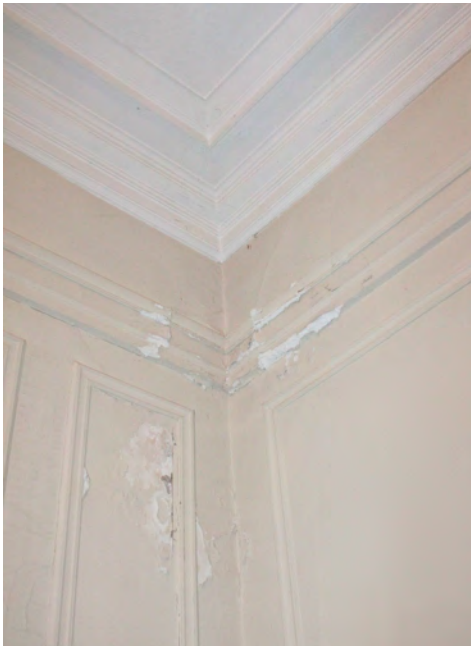
- *Peeling paint* was observed throughout the house but was most evident in areas of water infiltration such as in the Dining Room, Hall, and throughout the first and second floors of the servant's wing.

- *Water staining* was observed in areas that have been known to have water leaks. These areas include the wall of the Dining Room and Hall, the majority of the servant's wing, and in some of the third floor bedrooms.

Figure II-221. Peeling paint and plaster damage in Hall (107). (HA, 2015)

Chipped and Delaminated Plaster: Remove all loose and delaminated plaster. Prep and provide new plaster patch. New patch is to match the color and texture of the original.

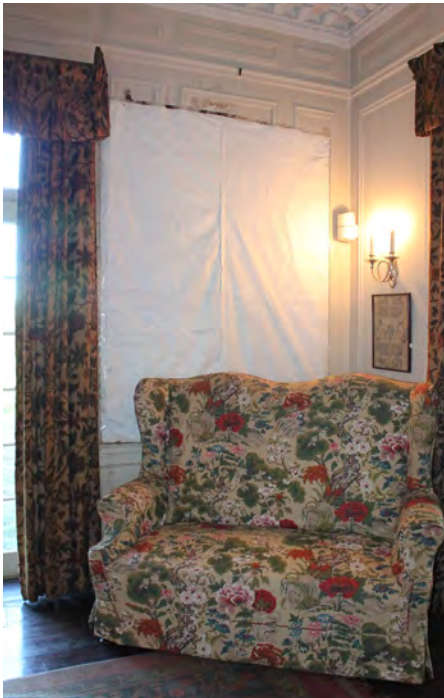
Figure II-223. Water damaged plaster covered by tarp in Dining Room (108). (HA, 2015)

- There appears to be canvas, or gypsum board, on the ceiling that is splitting at the seams
- Water staining and peeling paint in northwest corner. The area of damage was covered by a tarp and only a small section was observable.

- Areas of stained plaster and/or wallpaper as well as evidence of possible mold growth could be an environmental hazard. Such staining and mold are due to previous water infiltration. An environmental consultant should be hired to create inspection openings and discover if there is any mold growth in the wall

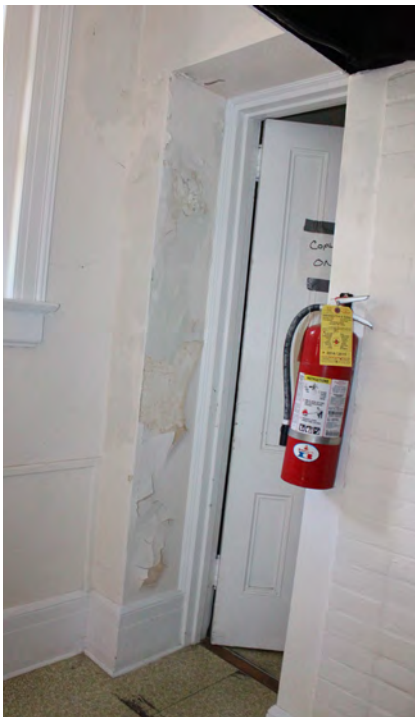
Figure II-225. Peeling paint and delaminated plaster in Kitchen (116) at door to closet. (HA, 2015)

- Areas of delaminated, cracked and peeling paint. Severe delamination of wall plaster near door to Closet (117)
- Large area of peeling paint and water staining on south wall by window

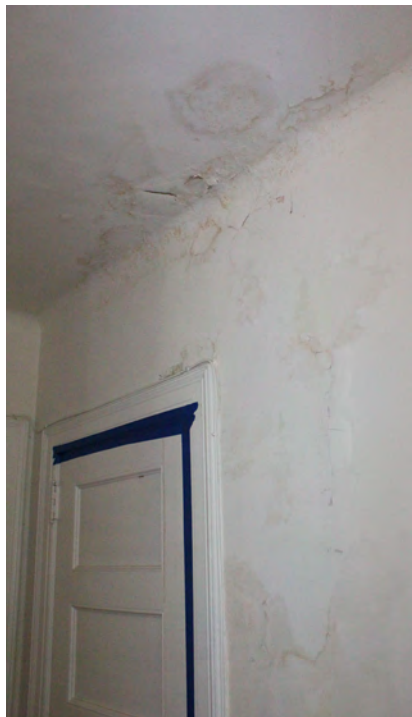
Figure II-227. Delaminated plaster and water staining in Laundry Room (119). (HA, 2015)

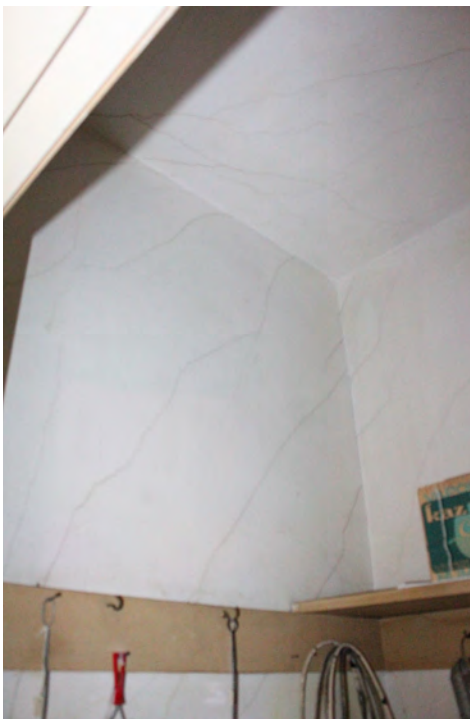
Figure II-229. Second floor Hall Closet (202A). (HA, 2015)

- Extensive cracks in closet walls and ceiling
- Incipient cracking in ceiling
- Minor paint peeling at ceiling

- If cracks are incipient, check to see if surrounding plaster is delaminated and, if so, treat as noted above.
- Small hairline cracks can be left alone
- Cracks larger than 1/16" wide should be cut-out and patched with a finish mix of plaster that matches the original. Prep and paint.

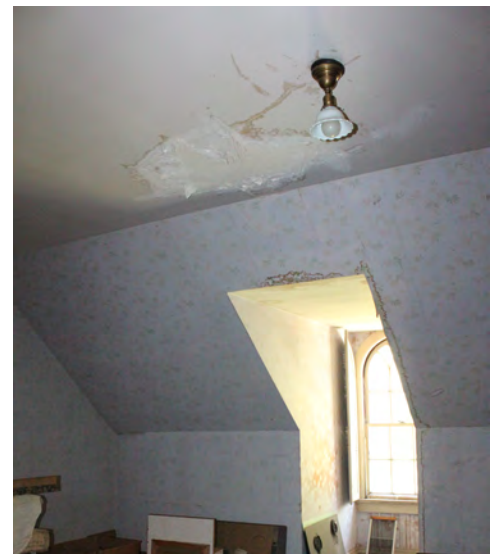
- Large plaster patch at ceiling. Paint is peeling around and on patch and there is water staining.
- Most of the wallpaper has been removed.
- Water staining on wall paper

Figure II-235. Water staining and peeling paint in Bedroom 9 (307). (HA, 2015)

- In areas other than those of Primary Significance and which will not be extensively used by guests, minor water staining can remain if the plaster below is sound and there is no mold growth.
- In areas other than those of Primary Significance and which will not be extensively used by guests, extensively stained wallpaper should be removed and either replaced with attic stock of the same kind if available or the plaster, prepped, and painted.
- Remove wall paper that has been stained or has mold growth. If attic stock is available, re-paper the wall after plaster has been repaired. If no attic stock is available, remove all the wallpaper and either prep-and-paint walls or re-paper walls with a historically appropriate wallpaper.
