MERESTEAD

HISTORIC STRUCTURE REPORT

Prepared by
Harboe **A**rchitects, PC

AUGUST 2017

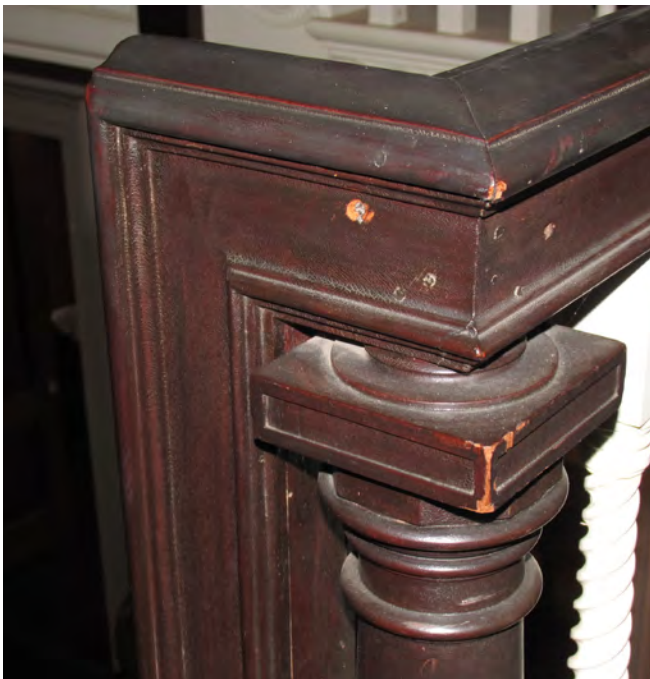
Figure II-239. Holes and scratches at main stair handrail. (HA, 2015)

- Worn, scratched, or nicked paint surfaces
- Scratches and nicks in the resinous finishes
- Paint splatter. This is most evident on the treads of the stair to the third floor.
- Small holes and gouges in the main stair handrail from the insertion of nails
- Craze finish on stair handrails

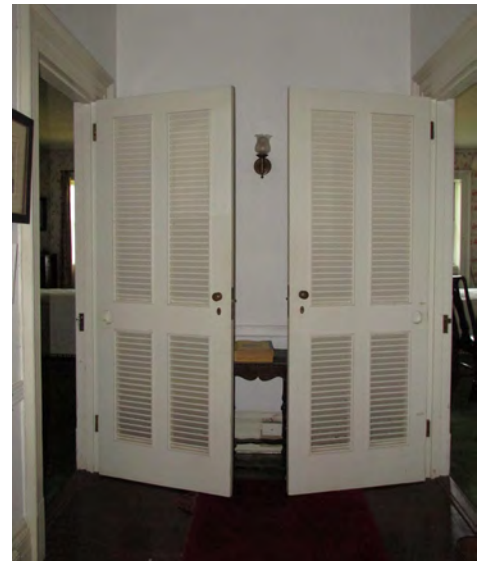
Figure II-277. Louvered doors were installed at the family and servant's bedrooms. (HA, 2015)

Based on a general visual survey, all of the doors appear to be in good condition; Each door was not tested to see how well it functioned. Typical conditions include general wear, minor scrapes and gouges, and select areas of peeling paint.

All painted doors and frames should be prepped and painted the colors recommended in BCA's *Material Analysis* report (provided separately to Westchester County).

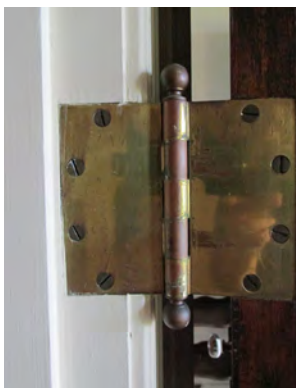
- Painted hardware (typically the hinges)
- Missing knobs
- Non-historic brass knobs

Figure II-288. Bronze butt-hinges with ball finials are the predominant hinge type. (HA, 2015)

- Inspect each hardware element to determine how well it functions
- Strip paint from hardware
- Replace newer knobs with historic replicas that are appropriate for that door.
- Provide new glass knobs that match the original knob type appropriate for that door.

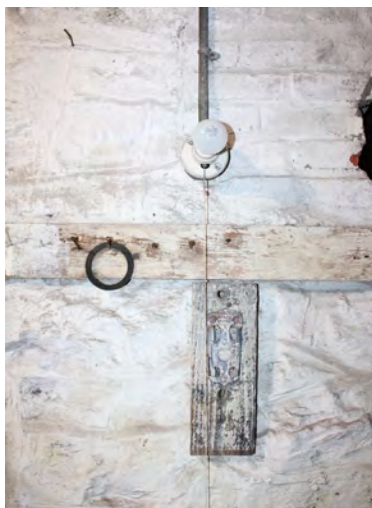
Figure II-292. Light fixture type L1; bare bulb and porcelain socket with pull-chain. (HA, 2015)

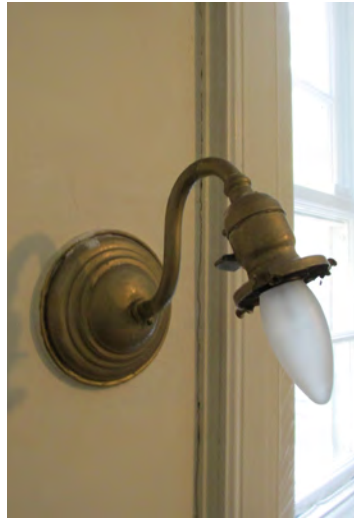
Figure II-302. Light fixture type L11; Bronze or brass single lamp decorative sconce. Sconce missing its glass shade. (HA, 2015)

- *Badly Worn Finishes/Overpaint:* Strip lacquer and re-patinize to match original finish. Re-lacquer.
- *Missing Shades:* Provide shades from attic stock or purchase replication shade that matches size and design of originals.
- *Non-original Socket Shells:* Replace with historic salvage socket shells that match size and finish of originals.
- *Can Lights:* The can lights clash with the architectural style of the house and should be replaced with more historically appropriate wall sconces. Sconces similar to fixture types L4 and L5 are still available through companies that market historic replica fixtures such as Rejuvenation.

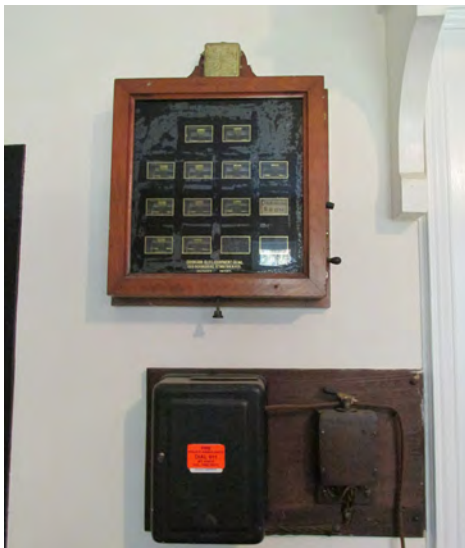
The servant's call bell system appears to be visually in good condition. Some of the buttons when pressed still ring in the pantry.

Figure II-315. Original servant's call annunciator box in Pantry (109). (HA, 2015)

The servant's call bell system should be retained and maintained.

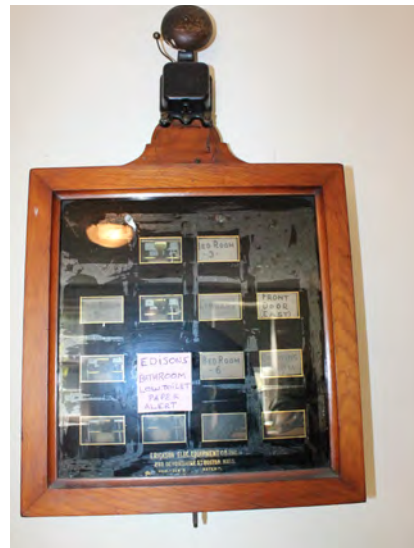
Figure II-316. Original servant's call annunciator box in Servant's Hall (118). (HA, 2015)

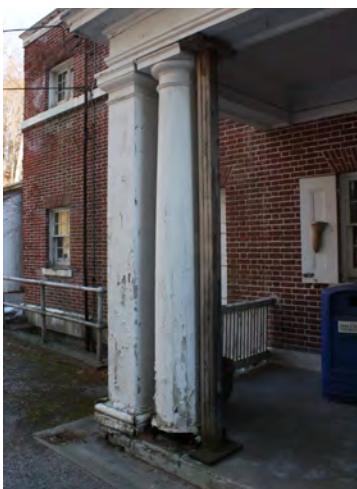
The structural system should be assessed by a licensed structural engineer to determine its integrity. A couple of locations are of potential concern. The dining room floor joists for instance, were infested by termites during a localized event in which many of the joists were damaged. The joists were since reinforced by sistering on new joists, part of the subflooring was replaced, and additional wood posts were added in the basement. Wood posts were also added at the north porch to support the balcony above. The porches structural integrity should be assessed and the original wood supports in the wood stave columns either replaced or reinforced so that the shoring can be removed.

Figure II-318. Additional wood posts used to support north servant's porch. (HA, 2015)

A licensed structural engineer should be hired to assess the structural integrity of the house.

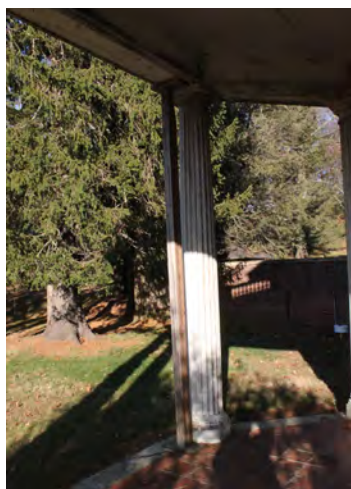
Figure II-319. Additional wood posts used to support north porch. (HA, 2015)

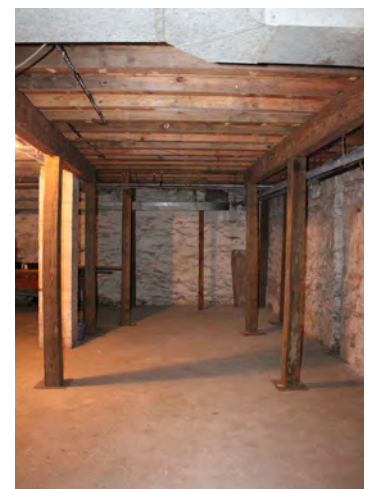
Figure II-320. Additional wood posts installed in the basement to reinforce dining room floor. (HA, 2015)

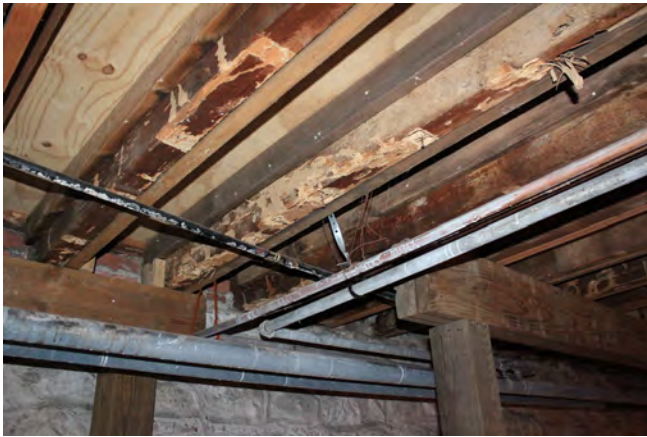
Figure II-321. Termite damaged floor joists under the dining room. (HA, 2015)

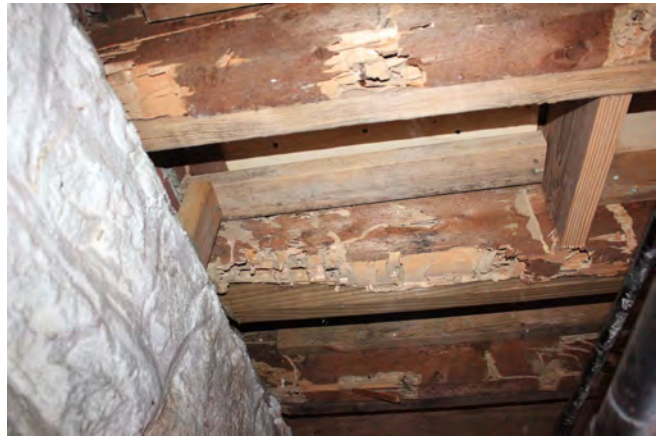
Figure II-322. Termite damaged floor joists under the dining room. (HA, 2015)

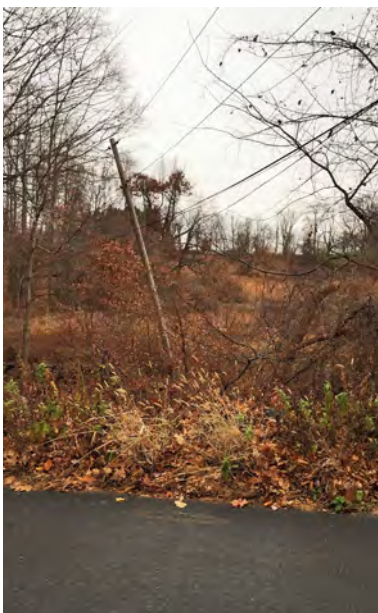
The Manor House is fed with a single phase overhead electrical service that originates from Byram Lake Road and is routed through the trees along the east side of the property. It was reported that the overhead lines are prone to damage during storms. The primary service terminates at a utility owned pole mounted transformer located behind the Manor House where it is transformed to single phase 200A, 120/240V. The service is routed underground from the pole to the basement where it terminates at a utility meter and 200A main disconnect switch. The existing overhead service is in poor condition. Many of the customer utility poles are leaning over. The trees near the overhead lines are overgrown making the lines prone to damage during storms.

Figure II-323. Overhead electric service. (OLACE, 2015)

- Upgrade the existing single phase overhead electric service by replacing it with a new three phase underground service for better reliability.
- Replace the existing live front knife switch panelboards with new circuit breaker panels with spare circuits to accommodate future branch circuits.

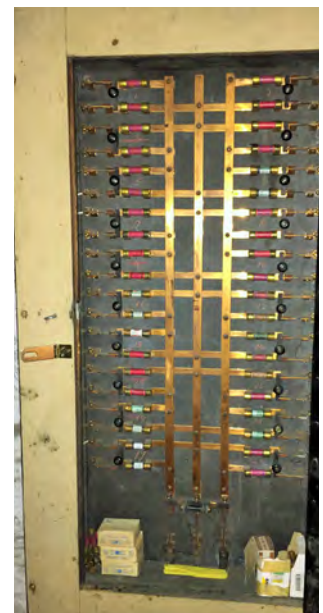
Figure II-325. Merestead house panelboard. (OLACE, 2015)

- Provide new circuit breaker panelboards
- Replace all branch wiring for existing equipment and lighting to remain
- Replace all ungrounded receptacles and branch wiring. Install additional receptacles to support the proposed building use.

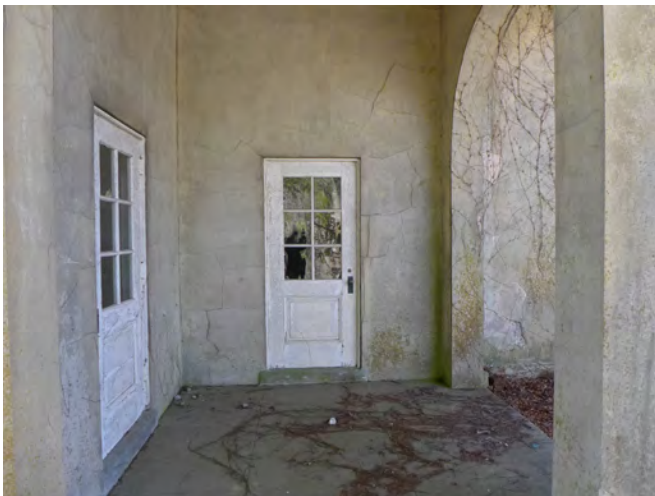
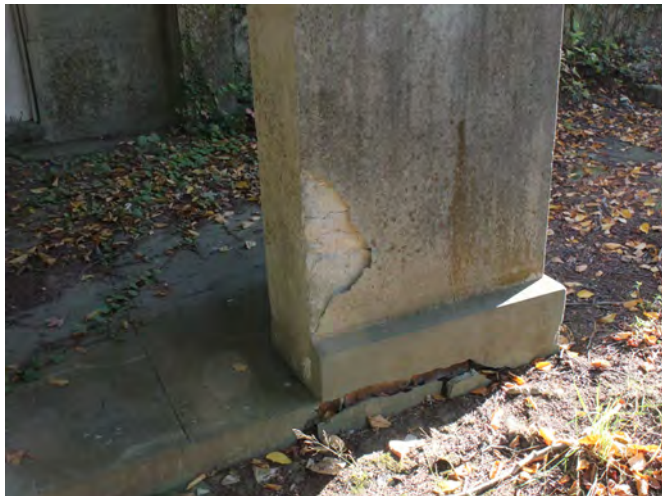
The concrete appears to be in good condition with only minor chips and cracks and some biological staining.

Figure III-27. Concrete slab at east porch to stable wing. (HA, 2015)

Figure III-28. De-laminated concrete at porch column base. (HA, 2015)

Mock-up different cleaning products to determine the gentlest means possible to effectively clean the surface.

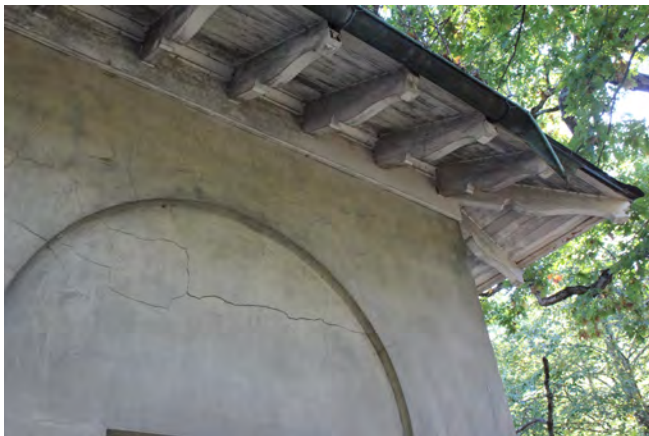
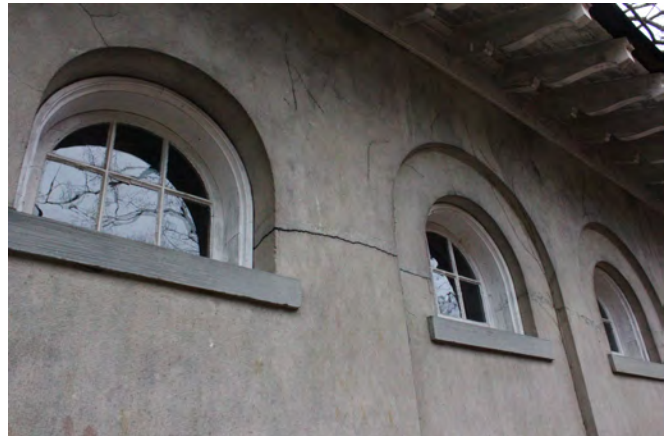
- *Cracks/Spalls:* There is extensive cracking throughout and select areas of spalling along the base and on either side of the south central doorway. Stucco areas with significant cracks may also be delaminated which will lead to further spalling. The cracks appear to be partly due to the age of the stucco, but also because of lack of maintenance and water infiltration. The roof is currently missing most its perimeter copper gutters and downspouts which allows rain runoff to saturate the ground adjacent to the base. The excess ground water eventually penetrates the stucco and wicks up the walls causing further damage during freeze/thaw cycles.

Figure III-31. Cracks in stucco. (HA, 2015)

Figure III-32. Cracks in stucco. (HA, 2015)

- *Cracks/Delamination/Spalls:* All of the exterior stucco should be sounded to determine its stability. Isolated cracks larger than 1/16" wide should be routed-out and patched with stucco that matches the color and texture of the original. If the stucco is delaminated, it should be removed and the area re-patched. If not, then only the cracks should be patched unless the proximity and quantity make this unrealistic. In that case, the badly cracked stucco should also be removed and re-stuccoed. Areas where the stucco has spalled off and missing should be re-stuccoed.
- *Biological Growth:* There are various cleaning products that can remove biological growth from stucco. Mock-ups should be undertaken to determine the gentlest means possible to effectively clean the surface.
- *Vines:* All vines should be removed from the exterior.

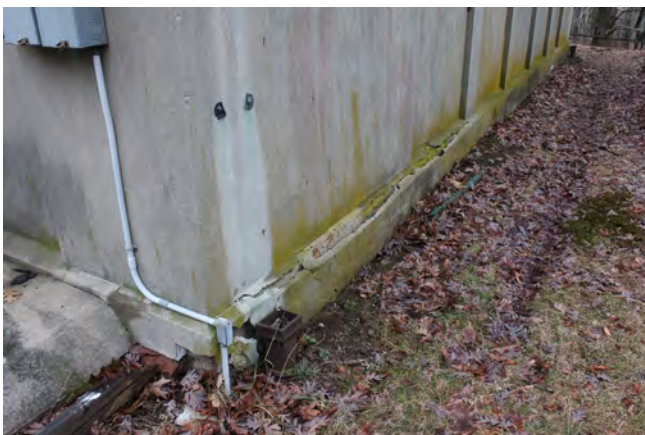
Figure III-33. De-laminated stucco at base. (HA, 2015)

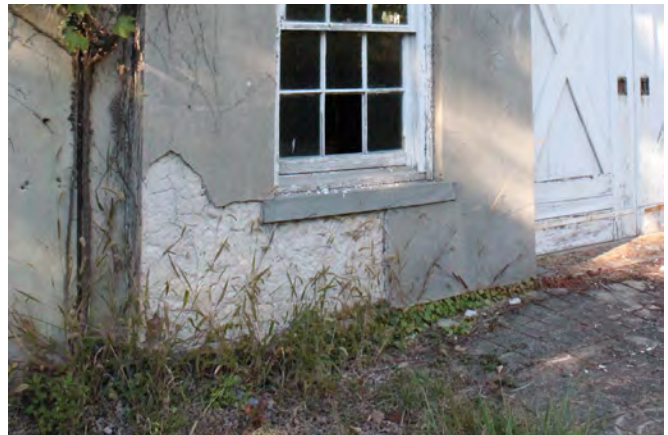
Figure III-34. Missing stucco near carriage room doors. (HA, 2015)

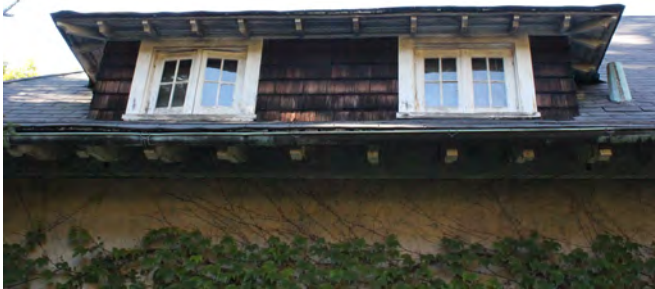
Figure III-35. Wood shingles on dormer walls. (HA, 2015)

The wood shingles appear to be in fair condition. They are all believed to be original and due to their age, they are quite weathered and nearing the end of their useful life. Many of the shingles near the bottom of the dormers are split, displaced, or missing.

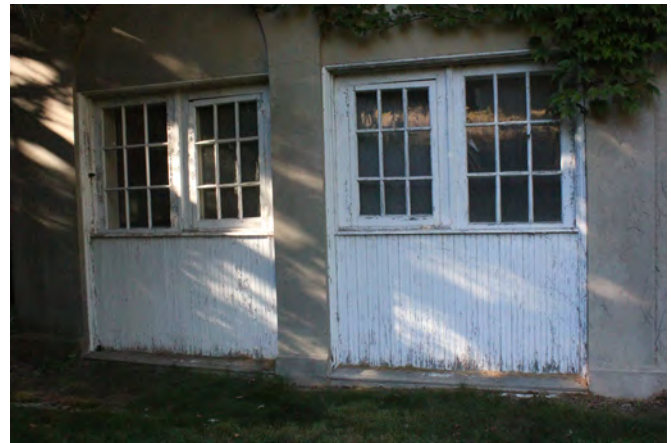
Figure III-36. Wood partition in-fill walls at enclosed porch. (HA, 2015)

The wood partition walls are in fair condition and have moderate paint failure as well as select areas of wood rot near the bottom of the boards.

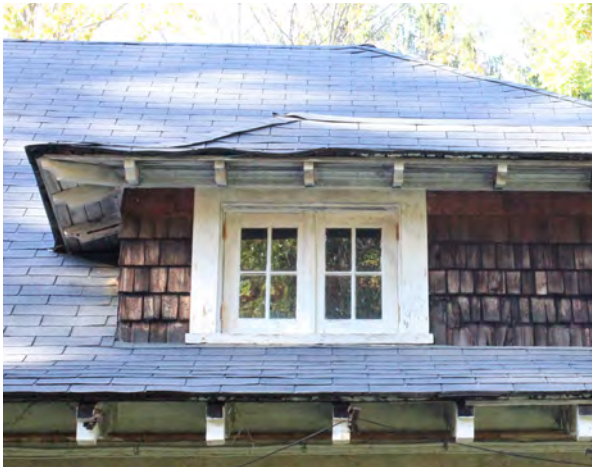
The asphalt shingled roof is over 20 years old and nearing the end of its serviceable life. As Tom Comito also acknowledged, it was installed over the existing wood shingles rather than removing everything down to the rafters to save money. These wood shingles are still partly visible in some locations and likely account for the wavy appearance along the roof edge. In addition, there is an area of localized roof damage at the south east corner, above the manure pit. The roof may have been hit by a tree limb which ripped off a section of both the asphalt and wood shingles as well as some of the decking.

Figure III-48. Asphalt shingle roof. The underlying wood shingles are partly visible at the roof edge and account for some of the waviness. (HA, 2015)

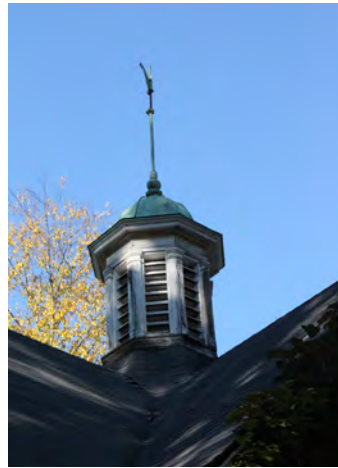
Figure III-49. Cupola. (HA, 2015)

The cupola was only observed from grade but it also appears to be in poor condition; The paint has essentially failed, the wood is weathered, and some of the wood fascia trim has fallen off. Tom Comito had concerns about the cupola as far back as 2000 and indicated that it is, “weak and becoming unstable.”²³ An up-close examination should be conducted by a structural engineer to assess its structural integrity.

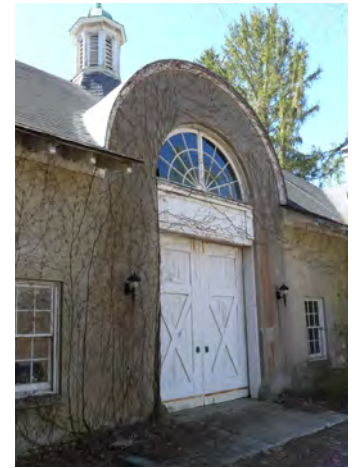
Figure III-50. Flat seam, curved copper roof. (HA, 2015)

The flat seam copper roof over the north doors to the carriage room was reported to be in poor condition by Tom Comito in 2000 and has not been repaired since.²⁴ In fact, even in 2000, Mr. Comito noted that it was regarded by former site superintendent, Harris Cullam, as the location of an “old leak.”²⁵ Continual water infiltration has since caused extensive damage to the plaster walls and ceiling in the former groom’s room.

- Remove existing roof and decking. Inspect underlying structural members and replace as necessary. Provide new curved decking and flat seam copper roof.

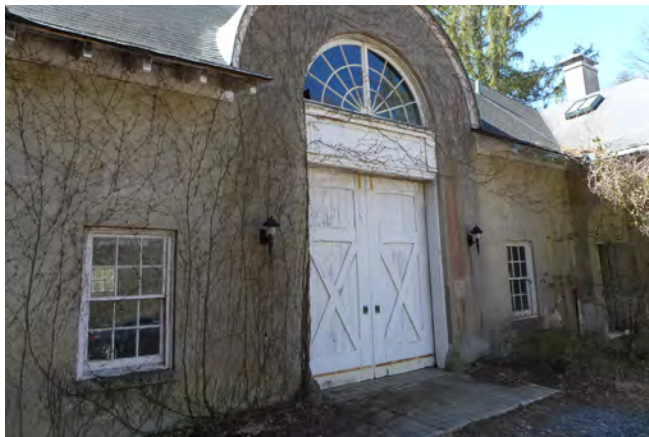
Figure III-53. Painted wood spandrel panel on north elevation. (HA, 2015)

- A paint finish assessment should be undertaken by a trained conservator with experience working on National Register buildings to determine the original paint colors.
- An up-close physical assessment of the spandrel panels should be undertaken to determine the wood's condition.
- Rotted sections or woodwork should be cut-out and replaced by a Dutchman or, if the rot is extensive, the element should be replaced in-kind. Small areas of rot can be removed and area patched with wood epoxy.
- Prep and paint all woodwork their original paint colors.

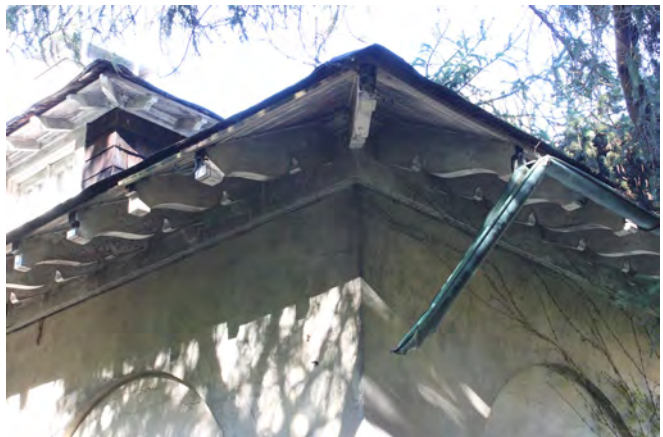
Figure III-54. Missing and damaged copper gutters. (HA, 2015)

The copper gutters and downspouts are in poor condition. Only about half of the gutters and none of the downspouts remain. Most of the gutters that do remain are typically coming loose from the building and many are bent. This has been the condition for at least the past sixteen years for Tom Comito in his “Merestead As I Know It,” and was a concern as far back as 2000. The missing gutters and downspouts are likely a significant reason for the stucco damage. Instead of rainwater being carefully collected and drained away from the building, the water is oversaturating the ground adjacent to the carriage house and penetrating the stucco. Once in and behind the stucco, the water expands when frozen, causing the stucco to crack and eventually spall. Cracked and spalled areas provide additional means of water infiltration making a bad situation worse.

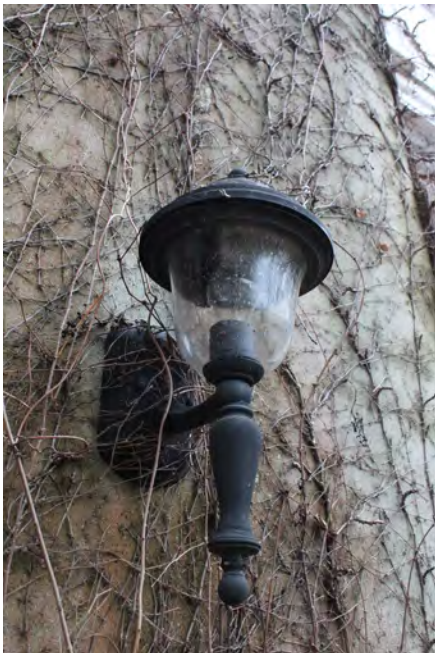
Figure III-55. Carriage lantern. (HA, 2015)

The exterior of the carriage lamps appear to be in good condition. The finish is slightly faded and there are small areas of chipped paint but otherwise the fixtures appear to be sound.

- Conduct an up-close assessment of all the fixtures to determine the type and extent of any damage as well as their approximate age.
- Refinish the metal fixtures.
- Provide a new custom pendant fixture for the east porch to match that at the west porch.

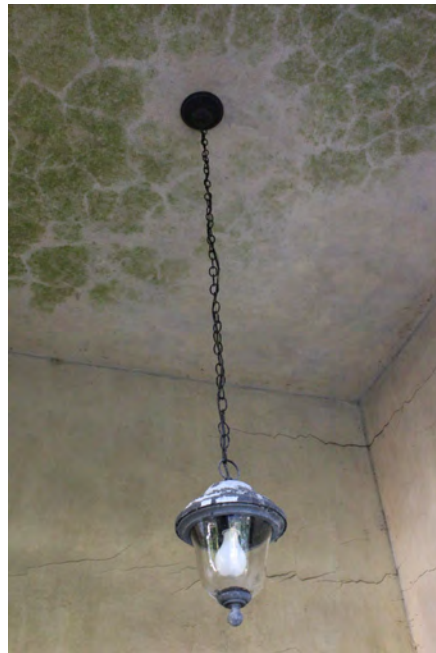
Figure III-56. Pendant light fixture at west porch. (HA, 2015)

The remaining pendant light at the west porch appears to be in fair-to-good condition. The paint is missing on about half of the fixture body.

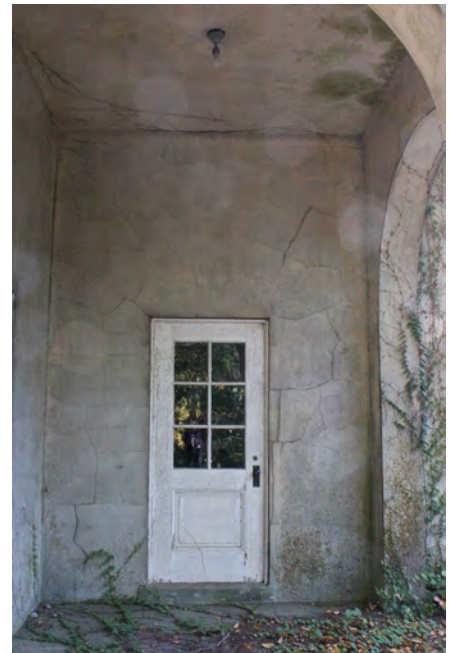
Figure III-57. Missing pendant light fixture at east porch. (HA, 2015)

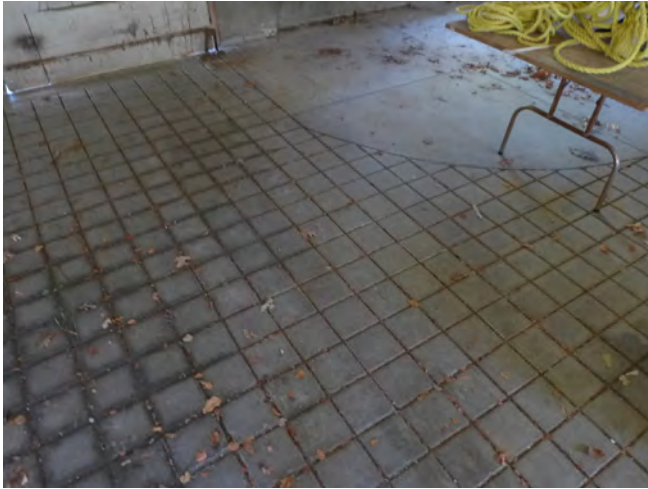
Figure III-58. Concrete paving in carriage room. (HA, 2015)

The concrete flooring, although soiled, appears to be in good condition.

- Clean; Mock-ups of different cleaning products should be performed on heavily soiled and stained areas to determine the most effective yet least aggressive product.

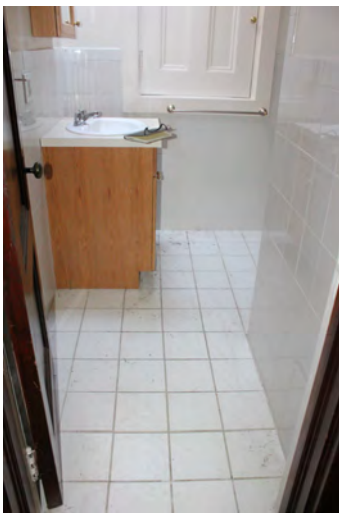
Figure III-60. Tile floor in bathroom. (HA, 2015)

The ceramic floor appears to be in good condition. It is moderately soiled due to a lack of maintenance.

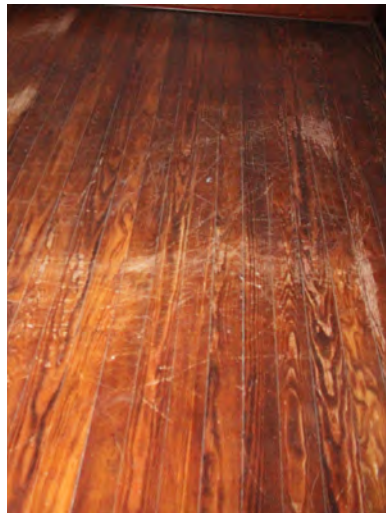
Figure III-61. Scratches in wood strip flooring. (HA, 2015)

The wood flooring appears to be in good condition. There are minor scratches and worn finish throughout the apartment rooms, although sections of the floor appear to be worse in some of the upstairs bedrooms.

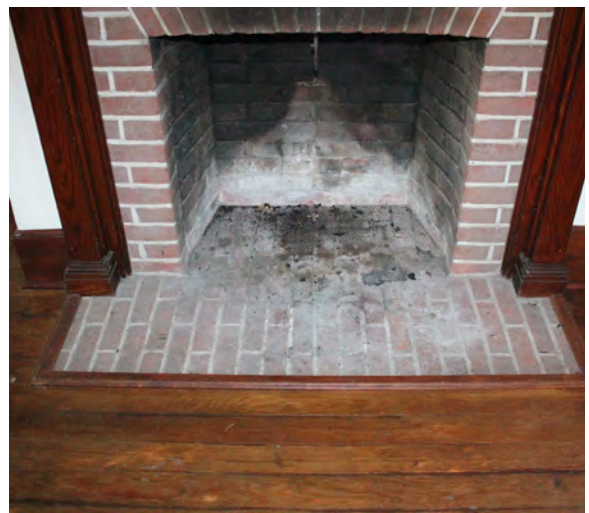
Figure III-62. Brick hearth. (HA, 2015)

The hearth appears to be in good condition. The most noticeable issues is soot residue from previous fires.

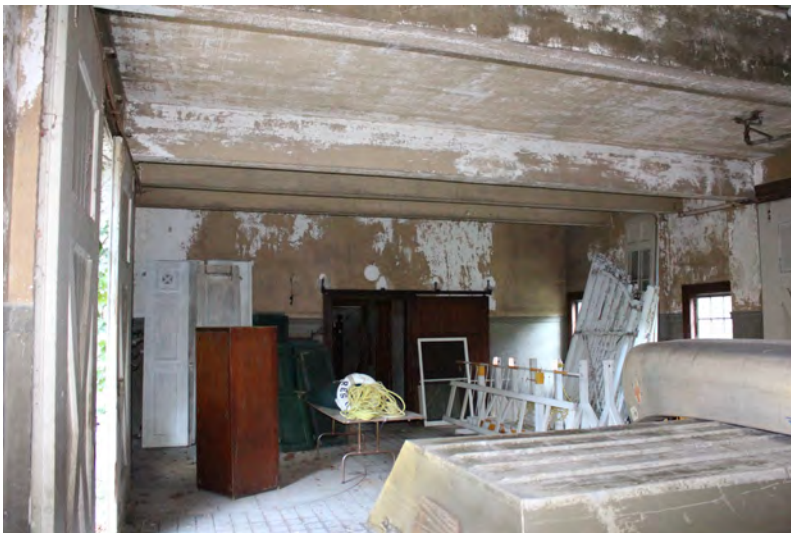
The cement wainscot appears to be in fair condition. Typical conditions include:

- Cracks.
- Cement patches that don't match the color of the original cement.
- Missing cap molding.
- Spalls. There are small spalled areas in the carriage room near the floor by the sliding entry doors.

Figure III-63. Cement wainscot and plaster walls and ceilings in carriage room. (HA, 2015)

- Investigate the original material properties of the cement and plaster as well as original paint finishes. The assessment should be conducted by a trained material and finish conservator whose portfolio demonstrates their expertise working on similar National Register historic properties.
- Cracks larger than 1/16" wide and areas of missing plaster should be patched in-kind. The replacement plaster should match the material properties of the original.
- Prep and paint the plaster the historic paint colors as determined by the finish analysis.
- Although the groom's bedroom is located in the loft space and does not directly contribute to the architectural character of the building, it is historically important in representing how and where lower servant's had to live. It should be restored back to its original configuration if economically feasible.

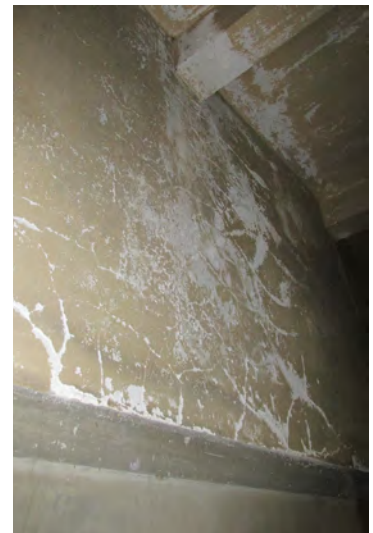
Figure III-64. Cracks in plaster. (HA, 2015)

The plaster in the apartment wing appears to be in good condition. This is likely because the spaces were occupied the longest, heated in winter, and partly remodeled in the early 2000s. The plaster in the carriage room and stable wing however, is typically in fair condition. These spaces have been out of use since the 1940s and therefore not maintained as well as the apartment. In addition, the carriage room and stable spaces are utilitarian in nature and were only minimally heated which likewise contributed to their poorer condition. The plaster in the groom's bedroom above the carriage room has completely failed due to ongoing water leaks. Here the plaster is mostly missing or damaged. Besides the groom's bedroom, typical plaster conditions include:

- Cracks
- Failed paint coating (e.g. weathered, peeling paint, alligatoring, etc.).
- Select areas of spalled/missing plaster.

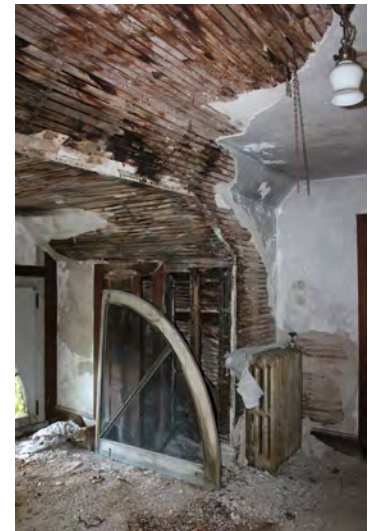
Figure III-66. Plaster damage in groom's bedroom. (HA, 2015)

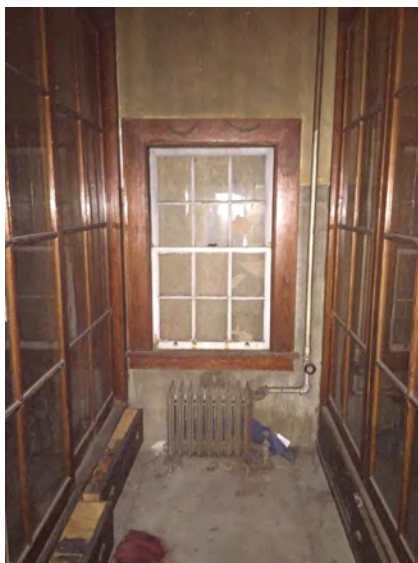
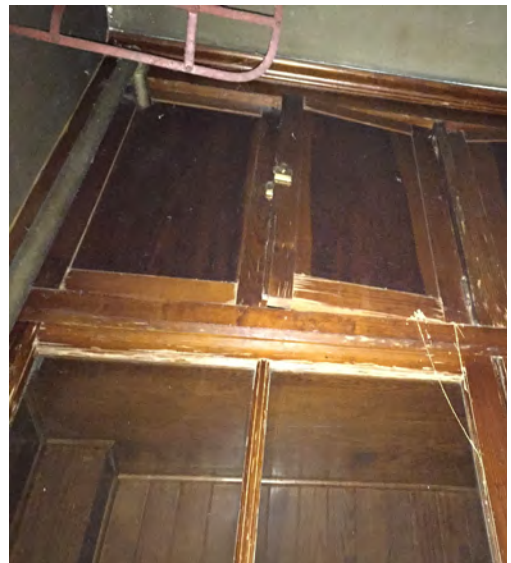
Figure III-89. Harness room storage cabinets. (HA, 2015)

The chimney piece and cabinets in the apartment kitchen and bathroom all appear to be in good condition. The harness storage cabinets have not been maintained and have numerous scratches and worn surfaces although they appear to be structurally sound.

- A conservator should be hired to investigate the wood finishes on the historic cabinets to determine the original appearance and finish properties.
- If it is desired that a space should have a restored appearance based on programming needs, the wood should be restored based on the conservator's findings. The chimney piece finish however, appears to be in good condition and can be maintained.

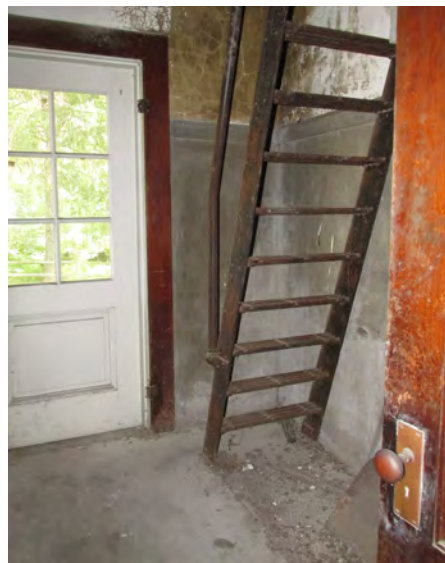
The ship ladder stair appears to be in structurally good condition although there appears to be surface corrosion throughout and the paint finish is extensively worn.

Figure III-92. Ship's ladder in stable wing. (HA, 2015)

The wood stairs can be maintained as they are unless programmatic needs create a desire to restore the entire house. In that case, a finish conservator should be hired to investigate the original wood finishes and the stairs refinished accordingly. Likewise, the metal ship ladder stair paint finish should be investigated and re-painted if the area is to be restored. Otherwise it could be left and interpreted as is.

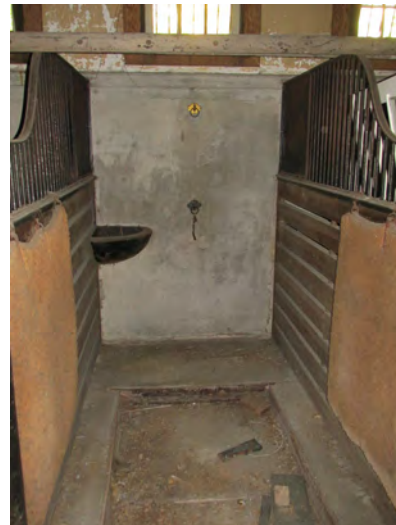
Figure III-94. Horse stall. (HA, 2015)

Despite not being in use, or possibly maintained, for over fifty years, the horse stalls appear to be fair-to- generally in good condition. Typical conditions consist of:

- Worn paint finishes and surface corrosion on the iron elements.
- Missing sanitary floor doors.
- Worn finishes on wood partition walls and door.

The horse stalls should be maintained in their current condition if the stable wing is going to be treated as historic interpretive space.

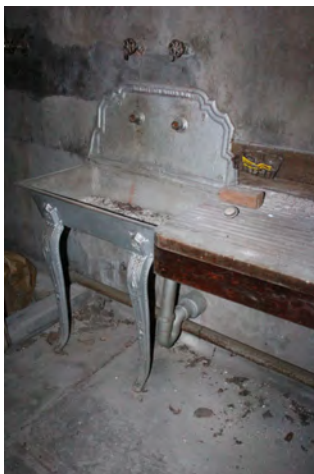
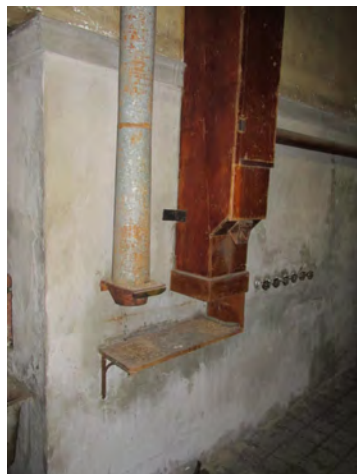
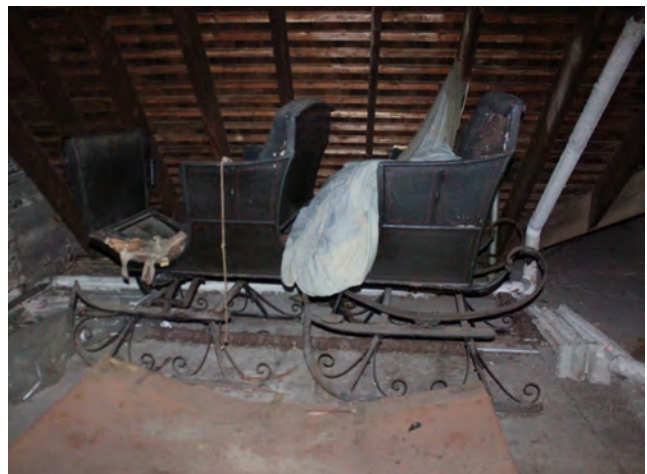
Figure III-107. Original sink in cleaning room. (HA, 2015)

Figure III-108. Oat and grain shoot in stable. (HA, 2015)

Figure III-109. Original sleigh. (HA, 2015)

All of these items should be catalogued and their condition assessed. Important artifacts (e.g. sleigh) could be displayed and would provide an important means of historic interpretation.

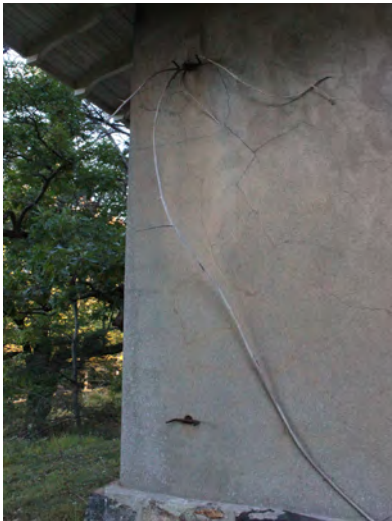
Figure III-117. Cracks in stucco. (HA, 2015)

The stone base does not show any signs of disrepair and the mortar seems to be intact. The stucco wall also looks sound at first glance but when it is observed more closely there are extensive cracks, particularly near the top of the wall. None of the stucco has spalled off but it should be fully sounded to determine if there are any areas of delamination.

- The walls should be completely sounded to determine if any of the stucco is delaminated. Areas of delamination should be removed and patched with stucco that matches the existing.
- Cracks larger than 1/16" should be cut-out and patched with stucco that matches the existing.
- Remove stucco in areas with extensive cracks and patch with stucco that matches the existing.

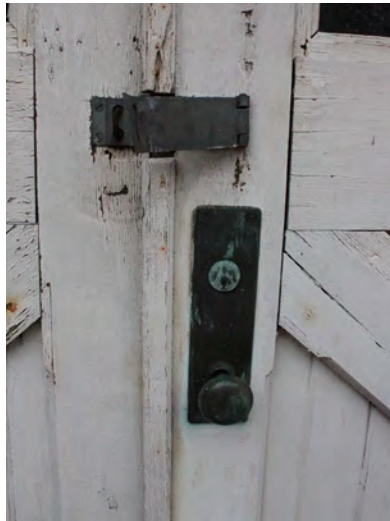
Figure III-118. Door hardware. (HA, 2015)

The hardware appears to be in fair-to-good condition. The bronze has patinized and is now a dark green color. Some of the door knobs appear to be loose and the far northern pair of doors are missing their lockset. The exterior door stops are missing their rubber bumpers.

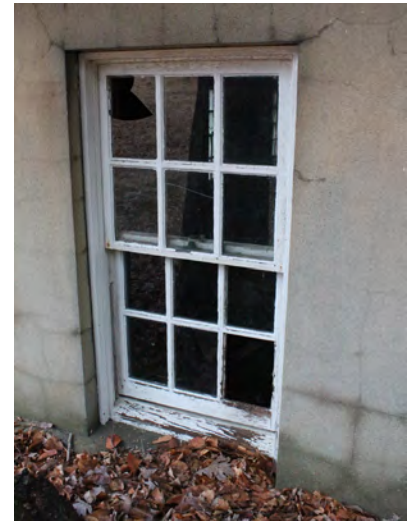
Figure III-119. 6/6 double-hung window. (HA, 2015)

The windows appear to be in fair condition. All of the windows have some paint failure, especially on the sills, and there are some open joints. The exterior glazing putty appears brittle and missing in some areas. Each window should be operated and inspected more closely to determine how well they still function.

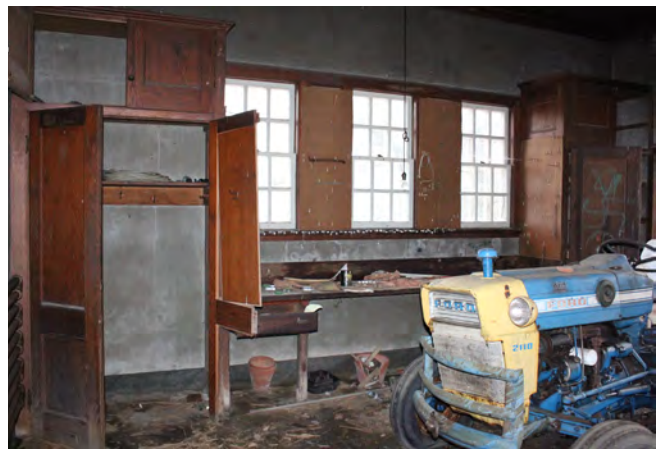
The interior of the garage appears to have been only minimally maintained since it was last actively used. There is considerable debris and staining on the floor and all of the interior paint and resinous finishes are very faded. In addition, there is damage to some of the cabinet doors along the south wall. The condition of the heating pipes and electric fixtures is not known. Despite these rather minor conditions, there doesn't appear to be any significant damage to the interior wall surfaces and the garage retains much of its historic and architectural integrity.

Figure III-123. Cabinets and work bench along south wall. (HA, 2015)

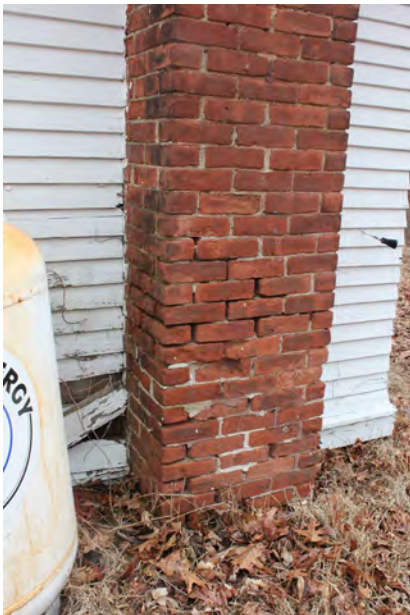
The exterior of the pump house and spring house is in fair condition. Typical conditions include damaged and missing wood siding, significant loss of brick mortar in the lower half of the chimney, and worn asphalt shingles. The roof over the spring house is in poor condition, and large areas of the shingles are missing, exposing the nailers and earlier wood shingles below. The main, and perhaps original, door to the pump house is missing its knob but the backplate and mortise box remain.

Figure III-134. Siding damage and loss of masonry mortar. (HA, 2015)

The pump house and spring house are original features to the site and the exterior should be restored, as feasible, to maintain its material integrity and prevent future degradation. Priority should be placed on painting the exterior woodwork, repointing the chimney, and replacing the roof. The woodwork should be painted the original paint color as determined by a trained finish conservator. A round knob should be reattached to the lockset and the entire door hardware stripped and its original finishes restored.

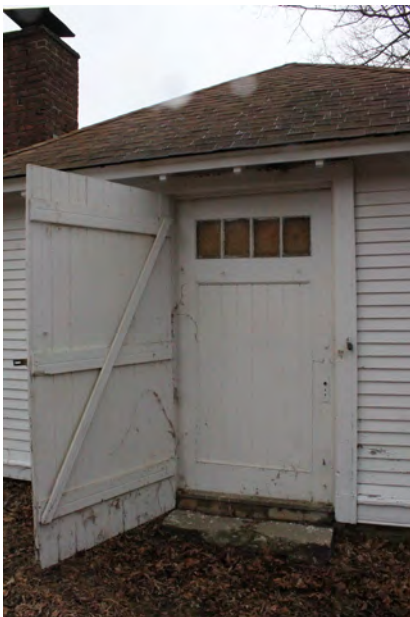
Figure III-136. Exterior doors to pump house. (HA, 2015)

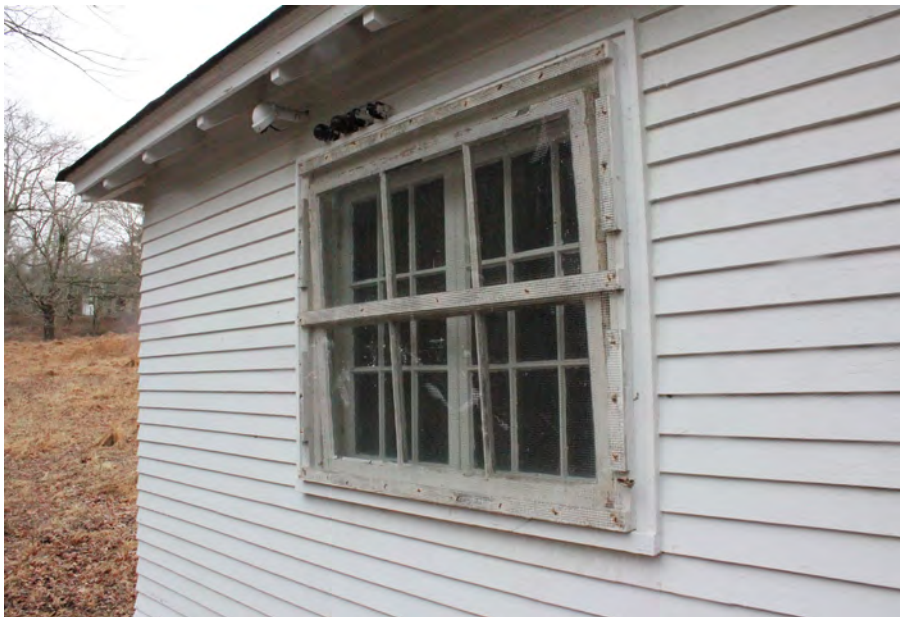
Figure III-137. Casement windows and screen at pump house. (HA, 2015)

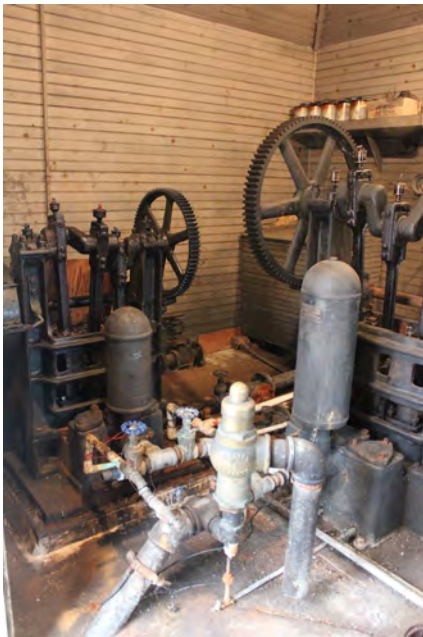
The interior of the pump and spring house appears to be in good condition. There aren't any signs of significant structural or water damage.

Figure III-138. Interior of the pump house. (HA, 2015)

Provide routine maintenance.

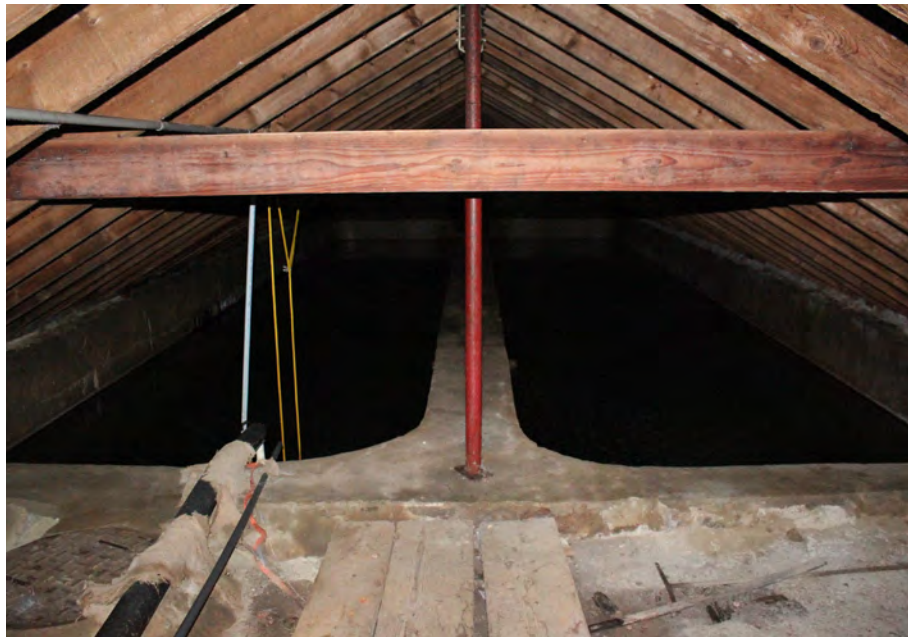
Figure III-139. Interior of reservoir building. (HA, 2015)

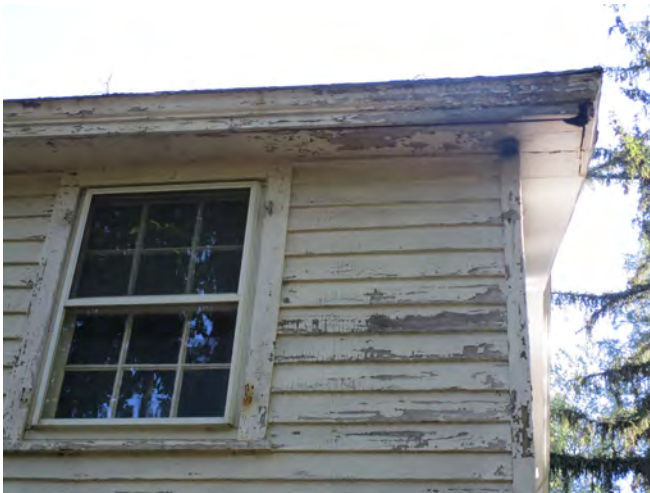
The clapboard siding is in fair condition. While there are some damaged and missing clapboards and wood trim elements, most of the siding is intact. The paint is significantly cracking and peeling throughout the entire exterior of the house. Ivy is growing on the east side of the house and could likely cause damage to the wood siding.

Figure IV-28. Paint failure on clapboard siding. (HA, 2015)

Damaged clapboard siding and wood trim should be repaired where possible. If damage is too severe, new replacement wood siding and/or trim may be necessary. All exposed exterior wood elements should be prepared and painted. The ivy should be removed from the house and surrounding area in order to prevent any further growth and damage to the exterior walls of the house.

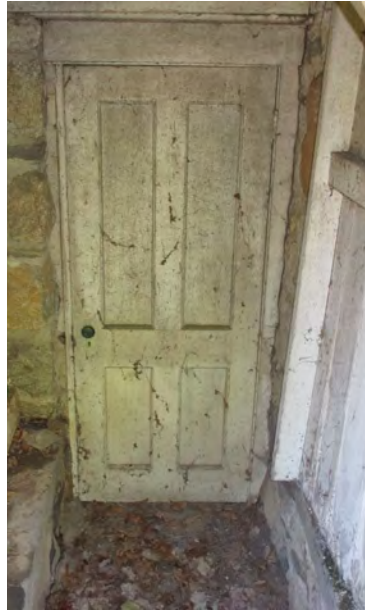
The wood paneled basement door located on the east side (addition) of the house and provides access to the basement. The door and frame appear to be in good condition. The lean-to structure covering the opening is in poor condition. There is damage to the vertical wood board siding on the south side of the structure and at the base. The paint finish is significantly worn and peeling. The wood plank door has been removed from the opening. It is in fair condition. The paint is almost entirely worn away on the door.

Figure IV-31. Four-paneled wood basement door to 20th century addition with narrower sticking profiles. (HA, 2015)

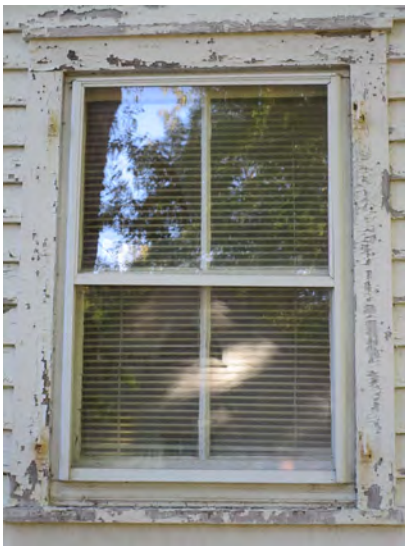
The windows are in fair condition. All of the windows have several layers of paint on them and some of the windows have been painted shut. The paint is chipping off. Damaged wood sashes and glass panes are minimal. The storm windows are in poor condition.

Figure IV-33. 2/2 double-hung window in 19th century section of the house with aluminum storm window. (HA, 2015)

The windows should be removed, the paint stripped, windows re-glazed, and sash re-painted.

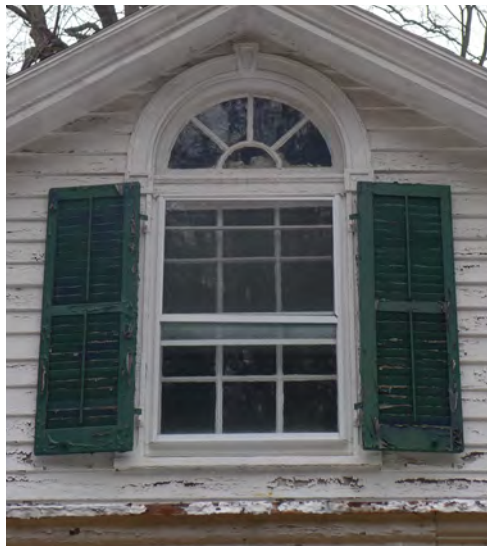
Figure IV-34. 6/6 double-hung window with fan lite above and aluminum storm window. (HA, 2015)

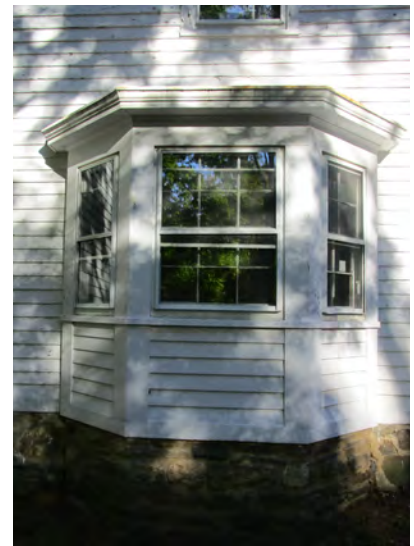
Figure IV-35. 6/6 and 4/4 double-hung windows in bay addition of 19th century section of the house. (HA, 2015)

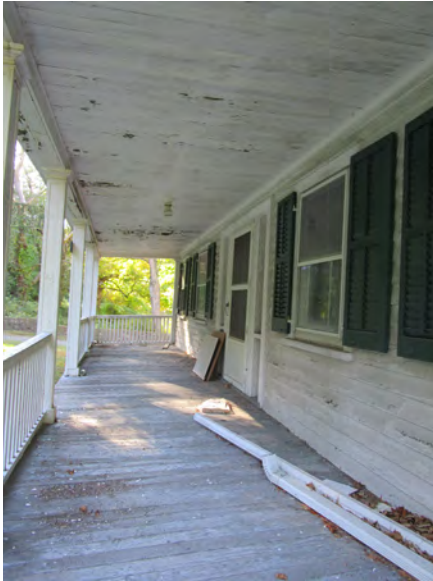
The front porch (south side of the original farmhouse) is in poor condition. There is significant damage at the southeast corner of the porch. The porches on the north side of the house are in fair/poor condition.

Figure IV-36. Porch on 19th century section of the house, looking west. (HA, 2015)

The front porch requires significant repair. Damaged wood elements should be repaired. Wood elements that are severely damaged should be replaced with new wood elements. New foundation supports are required under the porch.

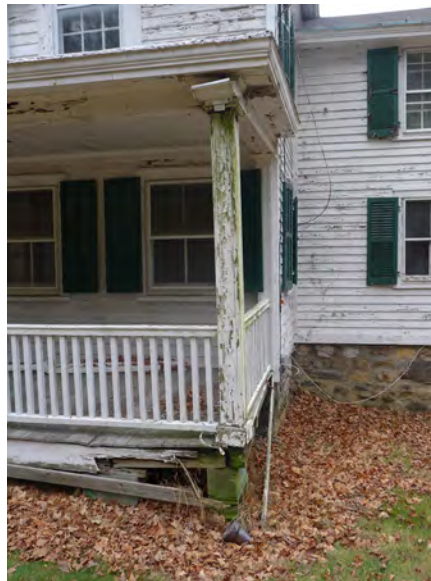
Figure IV-37. Rotted and missing wood at southeast corner of porch. (HA, 2015)

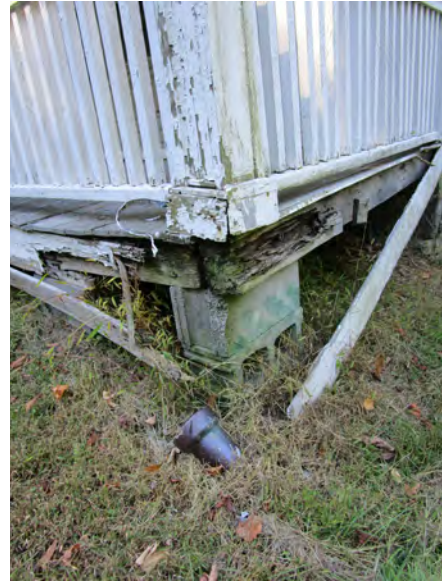
Figure IV-38. Close-up of rotted and missing wood at southeast corner of porch as well as added CMU corner support. (HA, 2015)
