MERESTEAD

HISTORIC STRUCTURE REPORT

Prepared by
Harboe **A**rchitects, PC

AUGUST 2017

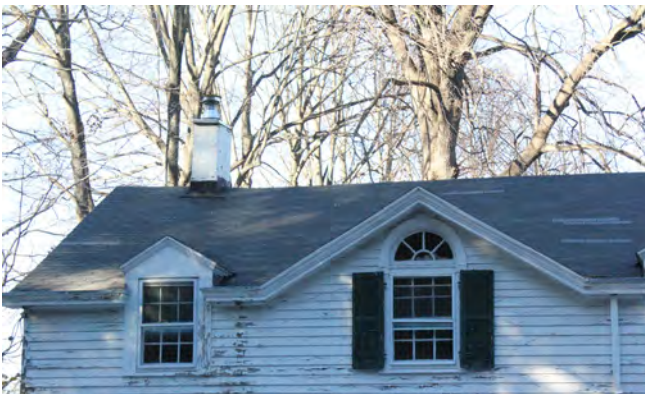
Figure IV-39. Roof on 19th century section of the house (HA, 2015)

The roof is in fair condition. There are some damaged asphalt shingles.

The roof is close to the end of its useful life and will likely need to be replaced in the near future. While the original roof was likely wood shingles, asphalt shingles would be a more economical option unless a period restoration is determined to be desirable. The built in soffit gutters need to be repaired and recoated or lined with metal. The downspouts need to be reinstalled at all locations where they are currently missing. Any damaged wood trim at the eaves should be repaired and painted.

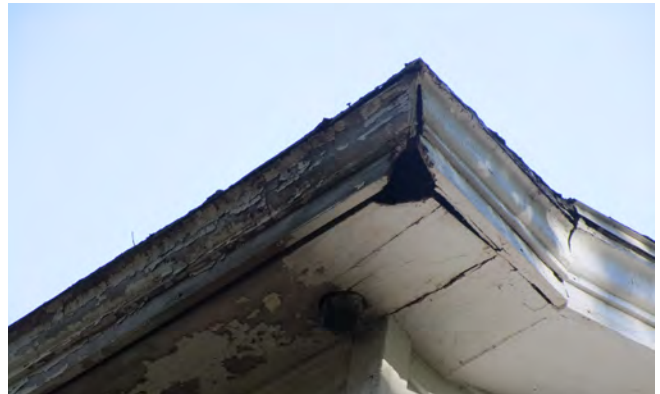
Figure IV-40. Loose and damaged soffit boards. (HA, 2015)

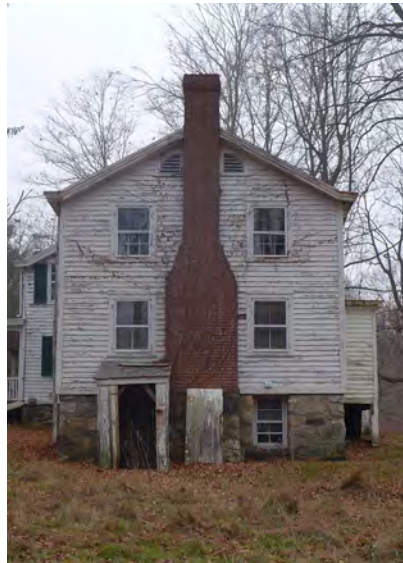
The chimneys are in fair condition. There is ivy growing on the chimney on the east side of the house.

Figure IV-42. Chimney at east elevation of 20th century addition. (HA, 2015)

All ivy should be removed from the east chimney. Any loose or open mortar joints should be repointed with a mortar that matches the mix of the existing mortar.

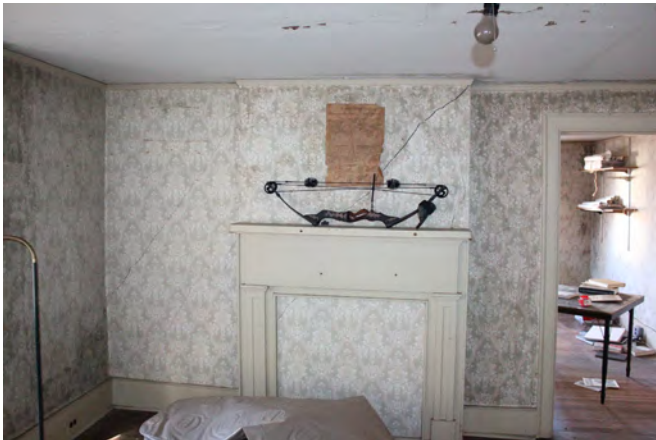
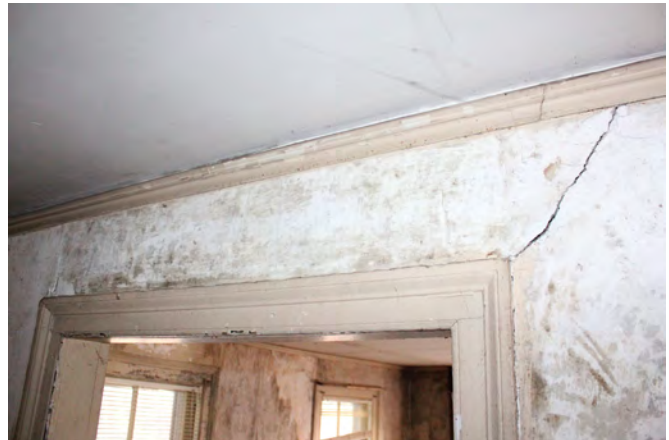
The painted plaster walls are in fair condition. The walls are moderately soiled and paint is peeling off the plaster. The walls that have wallpaper on them are in fair condition; however, the condition of the wallpaper is poor. The wallpaper is significantly faded and stained, and it is peeling off of the wall. There are large sections of wallpaper missing. There is a large opening in which plaster and lath have been removed in the east wall in the northeast bedroom of the original 19th century portion of the house. There are also large cracks in the wall above the mantel in the living room and west wall in the kitchen in the 19th century portion of the house. The painted wood beadboard walls in the porches on the north side of the house are in fair condition. The walls are soiled and the paint is peeling. The basement walls are in fair condition. The walls are significantly soiled. The paint on the parged walls is worn and peeling.

Figure IV-47. Plaster crack in plaster above salon/living room mantle piece in 19th century section of the house. (HA, 2015)

Figure IV-48. Plaster crack in plaster above salon/living room mantle piece in 19th century section of the house. (HA, 2015)

All damaged plaster and lath should be repaired and/or replaced as needed. The source of leaks in the wall should be resolved prior to repairing water damaged plaster. All plaster containing mold should be removed and replaced. All loose paint should be removed and walls repainted. All lead paint should follow the required procedures for removal and disposal. Damaged wallpaper should be removed. Historic wallpaper patterns should be matched for replacement paper. Additional research on the wallpaper is needed. Replicating the historic wallpaper will depend on the future programmatic needs for the house.

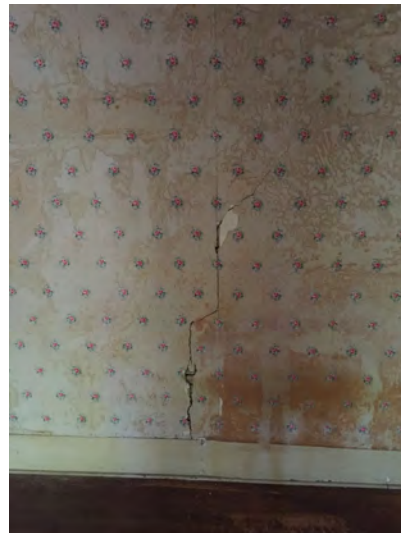
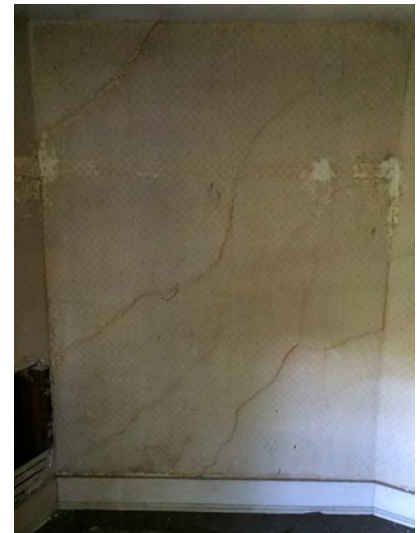
Figure IV-50. Cracks in plaster wall. (HA, 2015)

Figure IV-51. Cracks in plaster wall. (HA, 2015)

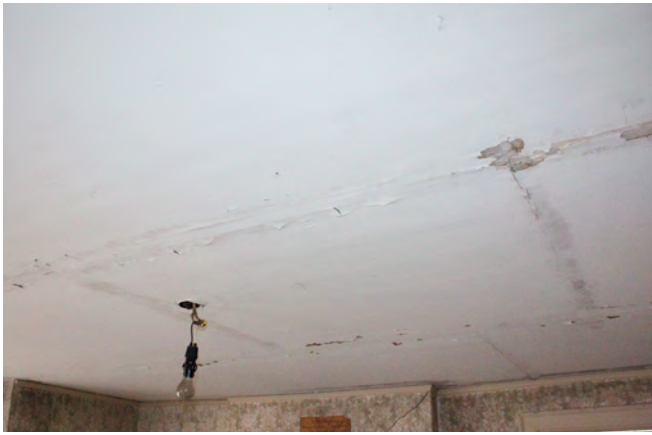
The painted plaster ceilings are in poor to fair condition. The paint layers are peeling and there are several locations where there is water damage, including what appears to be mold growth. There are also multiple locations where the plaster is cracked or missing.

Figure IV-52. Patches in ceiling plaster and peeling paint in 19th century section of the house. (HA, 2015)

All damaged plaster and lath should be repaired and/or replaced as needed. The source of leaks in the wall should be resolved prior to repairing water damaged plaster. All plaster containing mold should be removed and replaced. All loose paint should be removed and walls repainted. All lead paint should follow the required procedures for removal and disposal.

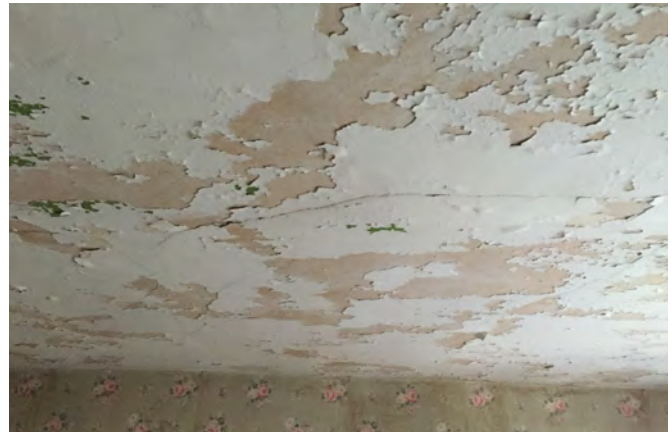
Figure IV-53. Peeling paint in 19th century section of the house. (HA, 2015)

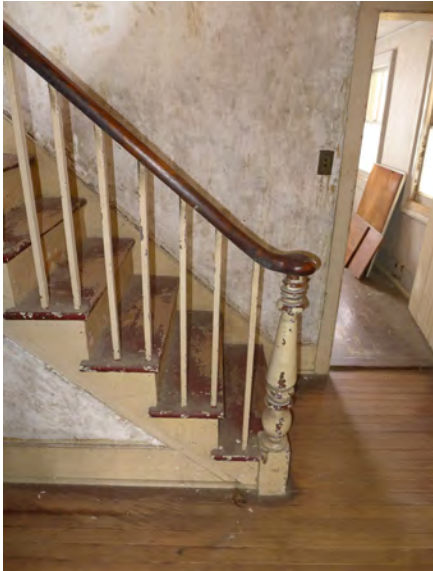
Figure IV-69. Staircase in 19th century section of the house. (HA, 2015)

The main stair is in fair to good condition. The paint on the risers and the finish on the treads are worn. The treads are sagging in the middle due to age and use. The wood handrail, spindles, and newel posts are in good condition. There are some small nicks, scratches and chipped paint. The stairs in the addition appear to be in good condition. The carpet on the stairs is worn. It should be noted that the carpet was not pulled up to investigate the condition of the wood treads and risers. The stairs to the basement and to the attic appear to be in good condition.

Damaged wood elements should be repaired or replaced. The stairs are to be stripped and refinished.

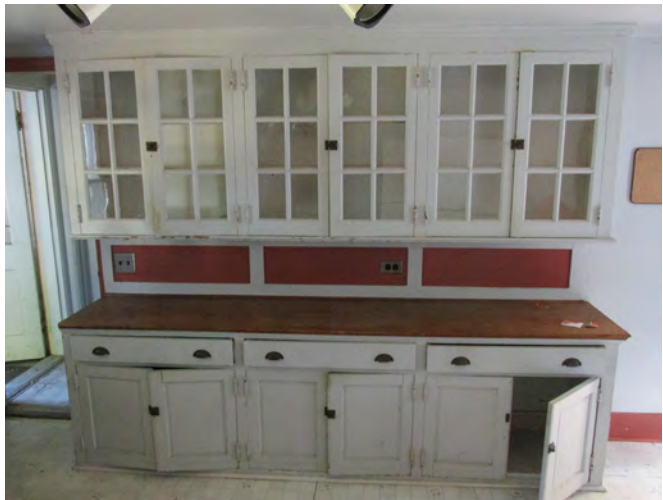
Figure IV-76. Original kitchen cabinets in circa 1909 addition. (HA, 2015)

The cabinets in both kitchens appear to be in fair to good condition. There is minimal damage including worn and chipped paint, scratches, and moderate soiling. Countertops appear to be in good condition with some minor scratches, gouges, and staining.

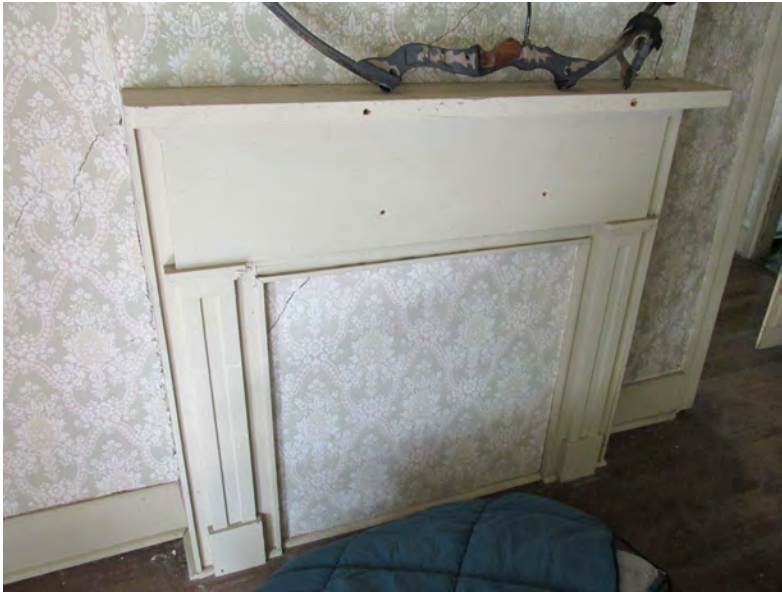
The fireplace and faux fireplace appear to be in good condition. The mantels on both have some minor nicks, scratches, and chipped paint.

Figure IV-77. Mantel piece in salon/living room in 19th century section of the house. It is not known if the mantel piece is original and no fireplace appears to ever have been constructed based on thickness of the wall and lack of foundation in the basement. (HA, 2015)

The fireplace mantels are historic and should be retained. The mantels should be stripped and refinished.

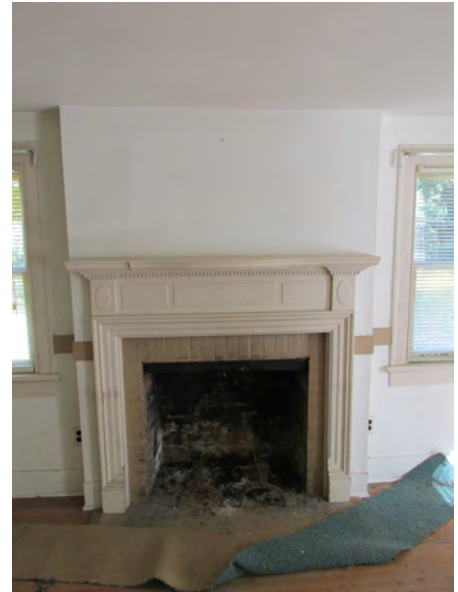
Figure IV-78. Mantel piece in Dining Room of circa 1909 addition. (HA, 2015)

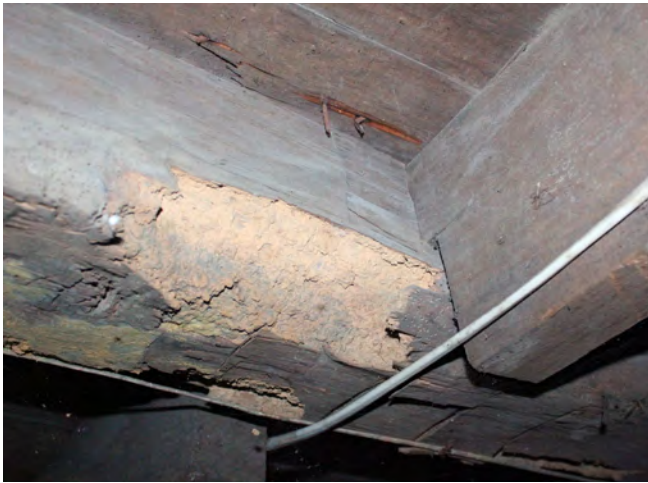
Figure IV-79. Heavy timber floor beams in 19th century section of the house. Termite damage has caused significant damage to some of the members. (HA, 2015)

The wood posts in the basement are rotted below the concrete flooring according to caretaker, Tom Comito. The supplemental steel posts appear to be in good condition. There is some termite damage on the wood floor joists in the basement. There is some loss of section on structural wood members in the attic as well. It is not clear if this is from termite damage or rotted wood.

Wood structural members damaged by termites and rot should be repaired and reinforced where necessary. If damage is too extensive to be repaired, the structural member may need to be replaced. A structural analysis of the house should be conducted in order to determine its structural integrity.

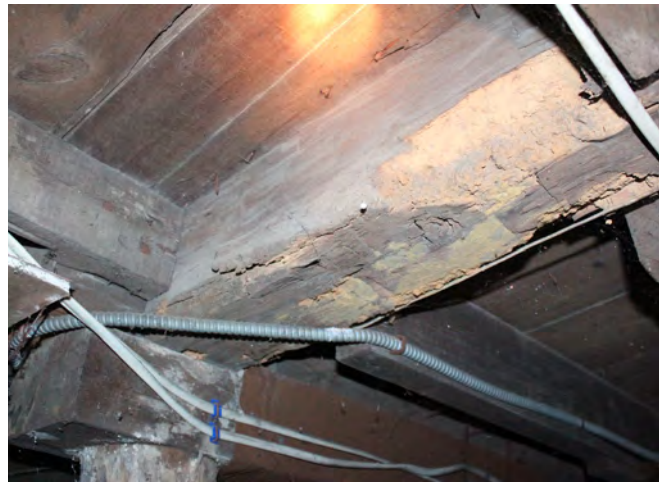
Figure IV-80. Another image showing the heavy timbers and termite damage. (HA, 2015)

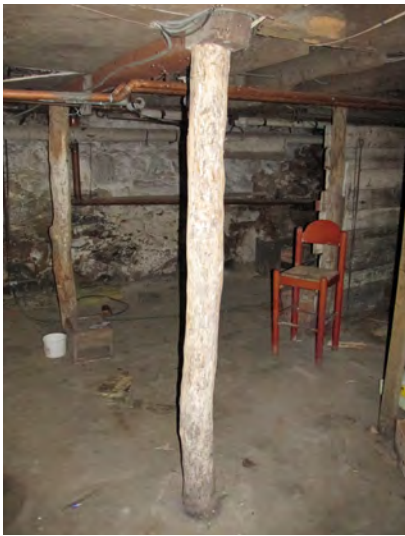
Figure IV-81. Wood post in basement of 19th century house. The wood post essentially consists of a tree branch that was minimally hewed. (HA, 2015)

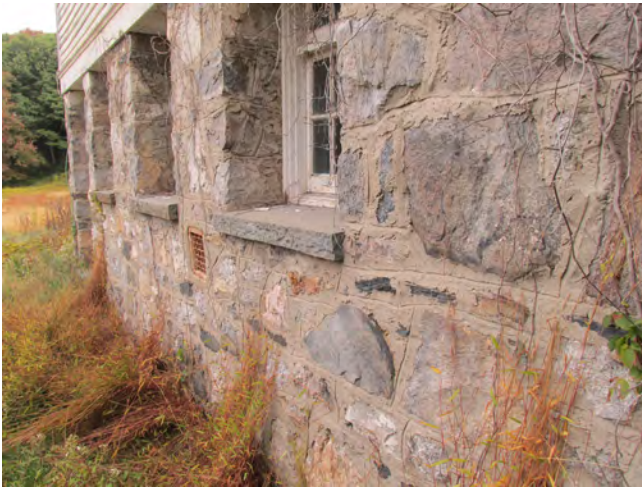
The stone foundation walls appear to be in good condition. There is some moderate soiling on the surface of the walls and some areas where ivy is growing, which could possibly damage the mortar joints. The clapboard siding is in fair condition. The paint is worn and peeling.

Figure IV-95. Fieldstone foundation wall. (HA, 2015)

The stone foundation walls should be cleaned with the gentlest means possible that still removes soiling on the surface. Any loose mortar should be removed and replaced to match the existing mortar.

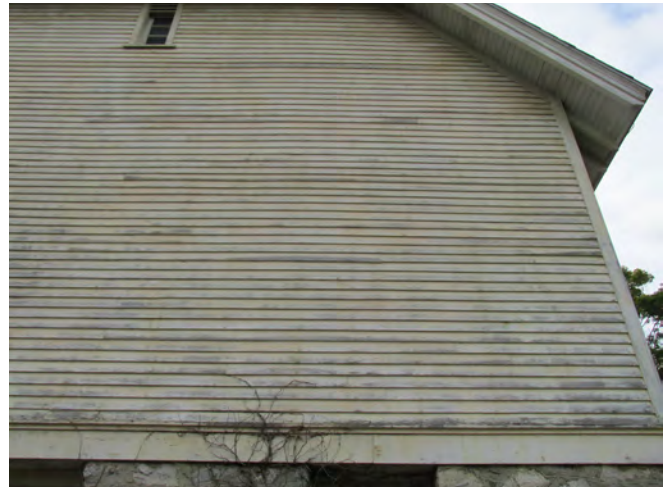
Figure IV-96. Painted clapboard siding (HA, 2015)

The clapboard siding should be prepared and painted. Any damaged siding and wood trim should be repaired where possible. If damage is too severe, wood siding and trim should be replaced and painted to match the existing adjacent elements. All ivy should be removed from the barn and the area immediately around it prior to painting.

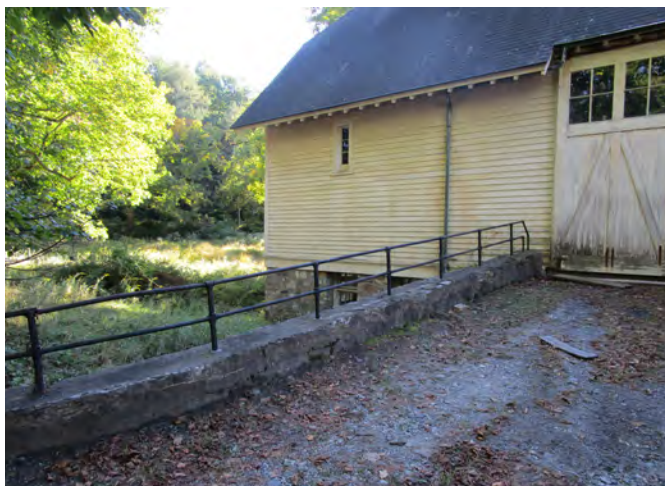
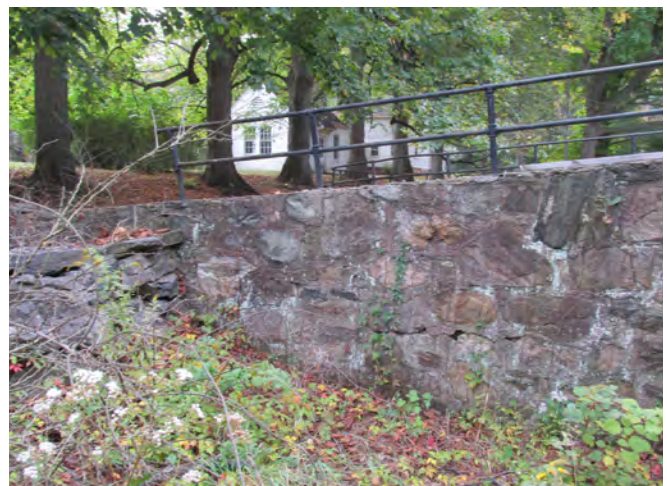
The ramp is in fair condition. There is missing and failing mortar in the stone retaining walls on either side of the ramp. The concrete skim coat on the top of the retaining walls is cracking and spalling. There is some surface corrosion on the metal pipe railings as well as multiple locations where the pipe is loose or has detached from the metal fittings.

Figure IV-97. Ramp to cow barn. (HA, 2015)

Figure IV-98. Fieldstone ramp walls and metal railings with connection fittings. (HA, 2015)

Loose and missing mortar on the stone retaining walls should be replaced. The walls should be cleaned with the gentlest means possible that still removes soiling on the surface. Damaged concrete on the top of the wall should be removed and replaced to match the existing adjacent. The metal pipe railing should be cleaned, surface corrosion removed, and reset in the existing fittings.

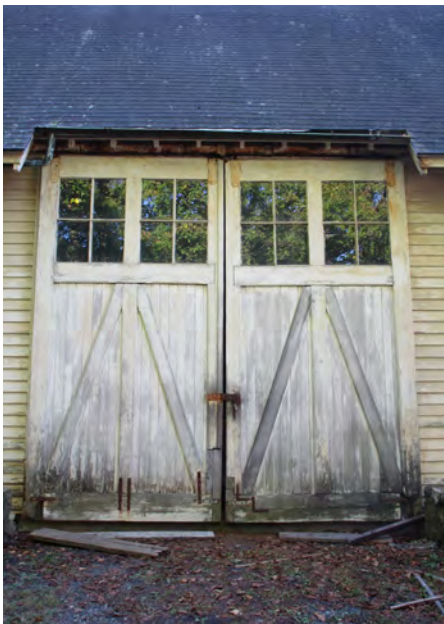
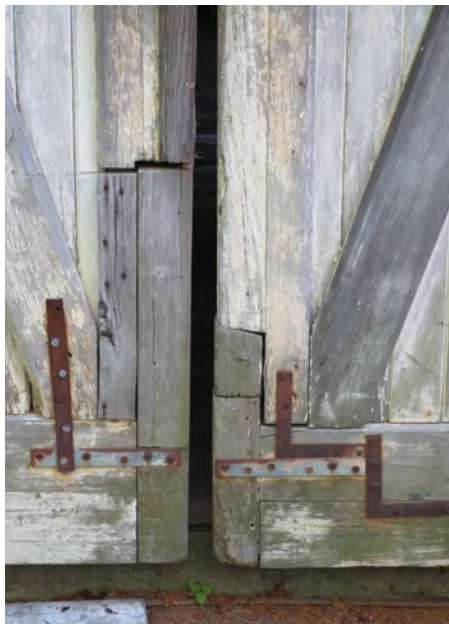
Figure IV-98. Main barn swinging doors on east elevation. (HA, 2015)

Figure IV-99. Metal strap reinforcing at main barn doors. (HA, 2015)

The wagon doors are in poor condition. There is some damage at the bottom of the doors. There are also several metal straps holding parts of the doors together as well as locations of past Dutchman repairs. The paint has significantly faded and peeled. The other doors are in fair condition. Issues include significant soiling, faded and peeling paint, cracked wood elements, and ivy growing on and around the doors and frames.

The doors and windows should all be prepared and painted. Any damaged wood elements on the doors, windows, and frames should be repaired where possible. If damage is too severe, wood elements should be replaced and painted to match the existing adjacent elements. All ivy should be removed from the doors and windows prior to painting. Cracked and broken glass should be replaced with new panes of glass. Loose panes of glass should be removed and reset with new window putty prior to painting the doors and windows.

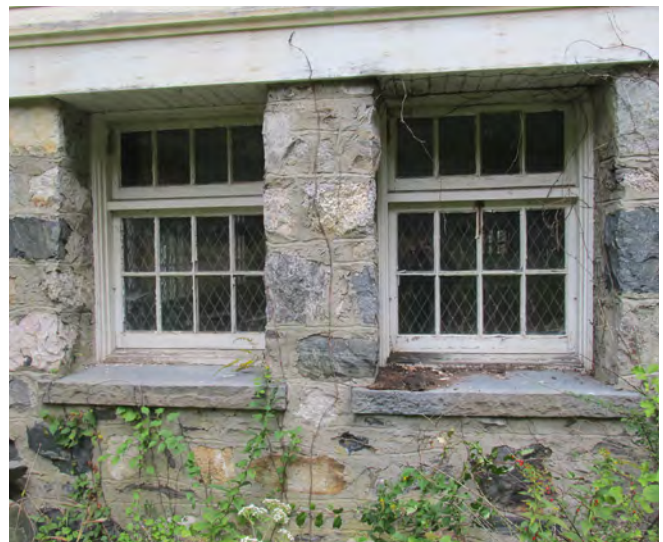
Figure IV-102. Multi-lite windows to the lower level. (HA, 2015)

The windows are in poor/fair condition. Issues include significant soiling, faded and peeling paint, cracked wood elements, damaged mullions, missing window putty, and ivy growing on and around the windows and frames. There are also a couple locations where glass panes are cracked or broken. The stone sills are in fair to good condition. Some of the sills have some small cracks and spalls.

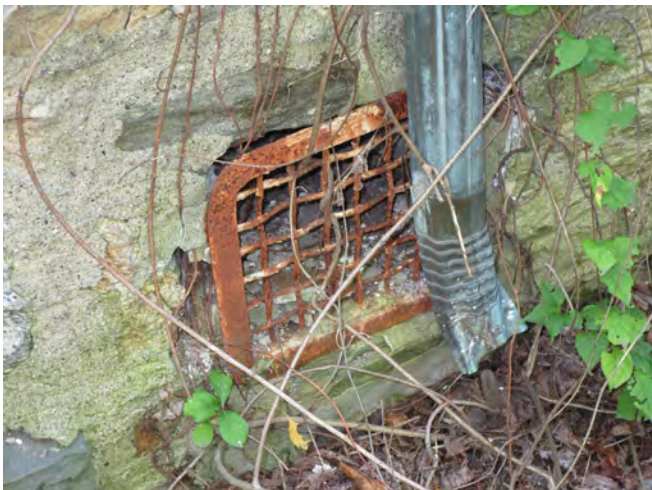
The metal grills are corroded. In some locations the ivy is growing into the vents.

Figure IV-103. Corroded metal vent in fieldstone walls. (HA, 2015)

The metal grills should be removed, cleaned and reinstalled in the walls. All corrosion is to be removed and the grills are to be painted prior to reinstallation.

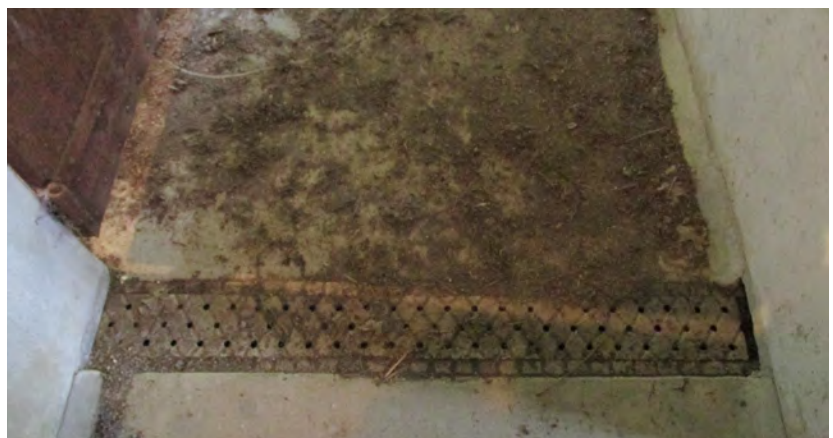
Lower Level: The concrete floor appears to be in good conditions. There is some staining and a few cracks. The most noticeable condition is the significant amount of debris and dirt that has collected on the floor.

Figure IV-112. Concrete floor in lower level. (HA, 2015)

Upper Level: Cracks larger than 1/8" wide should be patched with new concrete and the floor should be cleaned.

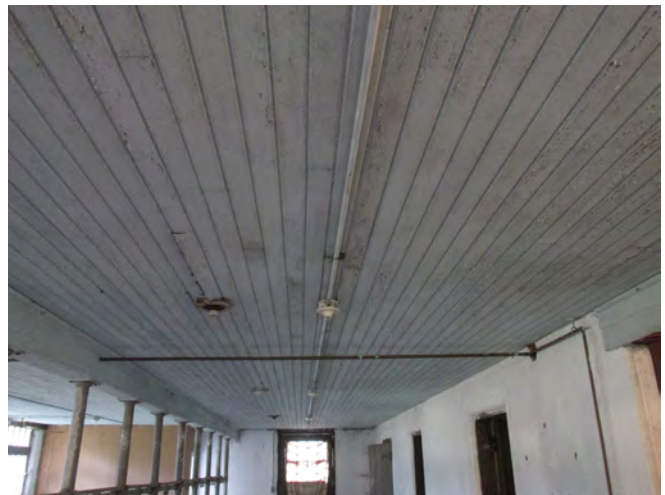
Figure IV-114. Tongue-and-groove wood ceiling in lower level. (HA, 2015)

Lower Level: the tongue-and-groove wood ceiling appears to be in good condition. The paint is severely worn and is starting flake off and there are a few random loose/displaced boards.

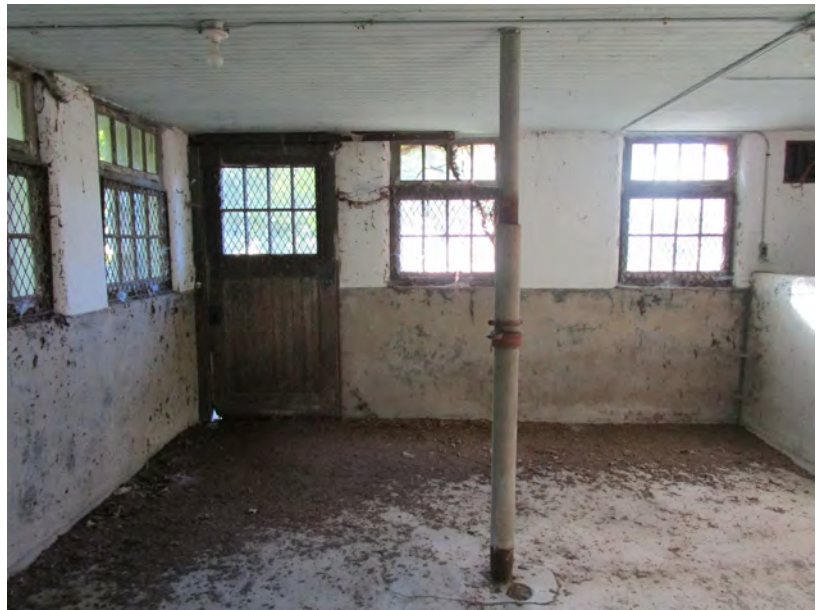
Lower Level: The columns appear to be in good condition. The paint is severely worn and there may be areas of minor surface corrosion.

Figure IV-116. Iron column in lower level. (HA, 2015)

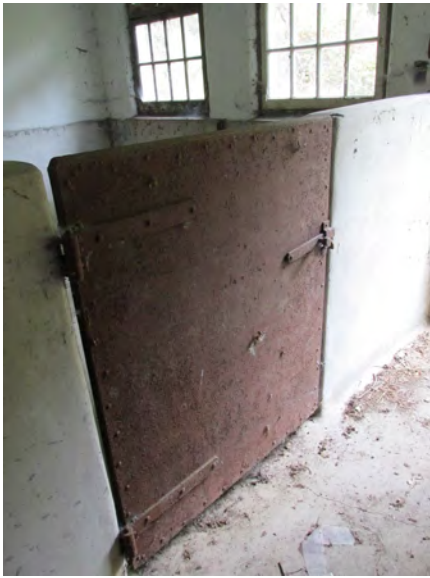
Figure IV-116. Painted metal cow stall door in lower level. (HA, 2015)

The doors all appear to be in fair-to-good condition. There is some surface corrosion and paint failure on the metal pen doors. The wood at the bottom of the beadboard door is split in many locations and the paint is severely worn. The other wood doors are slightly sagging and likewise have significant paint failure.

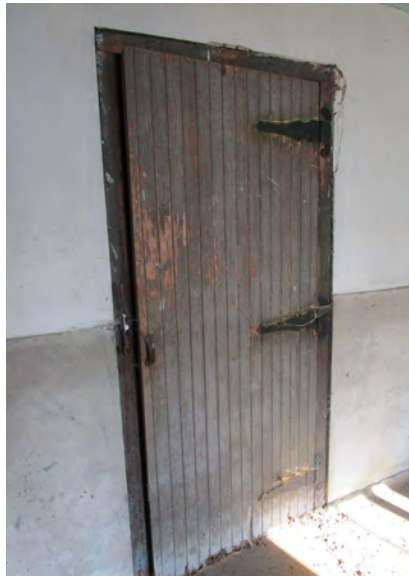
Figure IV-117. Painted bead board wood door in lower level. (HA, 2015)

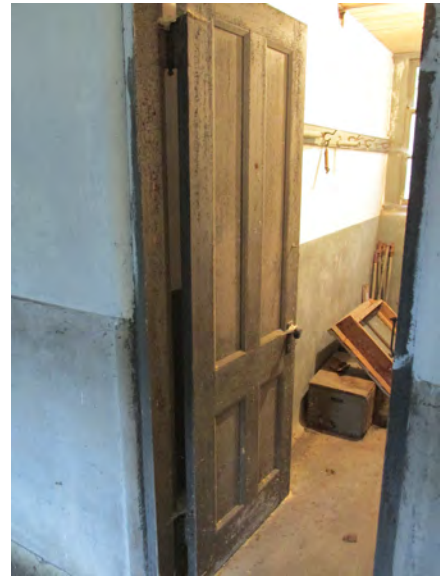
Figure IV-118. Painted four-panel wood door in lower level. (HA, 2015)

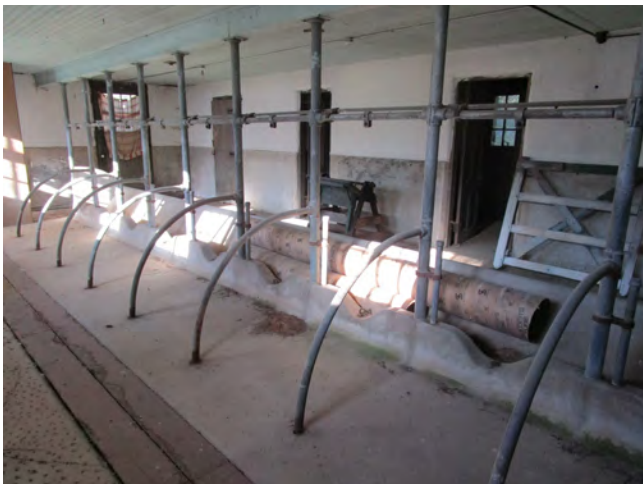
Figure IV-119. Cow stalls in lower level. (HA, 2015)

The cow stalls appear to be in good condition.

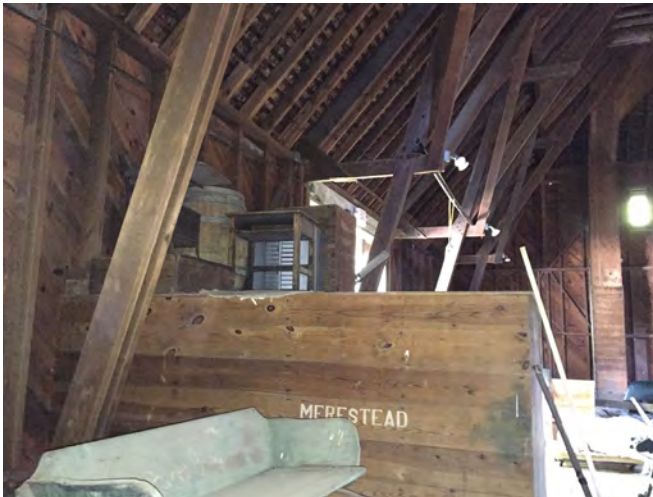
The wood grain bin appears to be in good condition.

Figure IV-121. Wood grain bin on upper level. (HA, 2015)

The wood grain bin should be maintained.

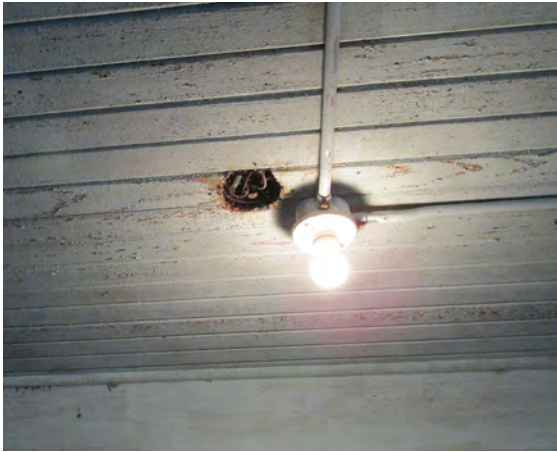
Figure IV-123. Bare bulb ceiling light in lower level. (HA, 2015)

There is currently no electric supplied to the barn and the operation of the light fixtures could not be assessed. Some of the lower level porcelain socket bases are missing there lamps.

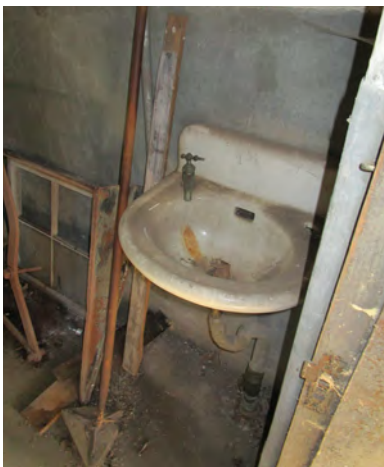
Figure IV-125. Early or original sink in lower level. (HA, 2015)

The large double basin sink appears to be in good condition. There is some surface corrosion around the rim. The small sink in the toilet room is in fair condition and missing half of its faucet. In addition, there are scratches and nicks in the porcelain body.

The sinks should be maintained. If the toilet room is to function, the toilet should be replaced and a new faucet installed on the sink.

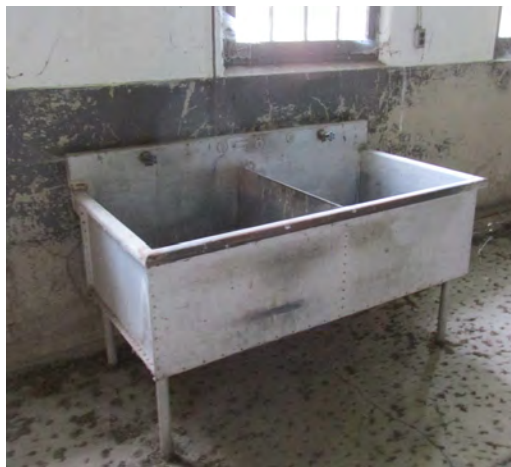
Figure IV-126. Early or original metal utility sink in lower level. (HA, 2015)

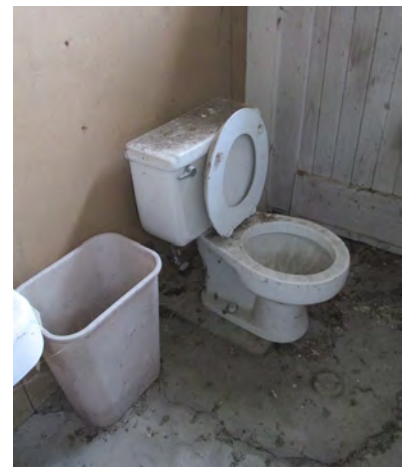
Figure IV-127. Circa 1960s toilet in lower level toilet room. (HA, 2015)

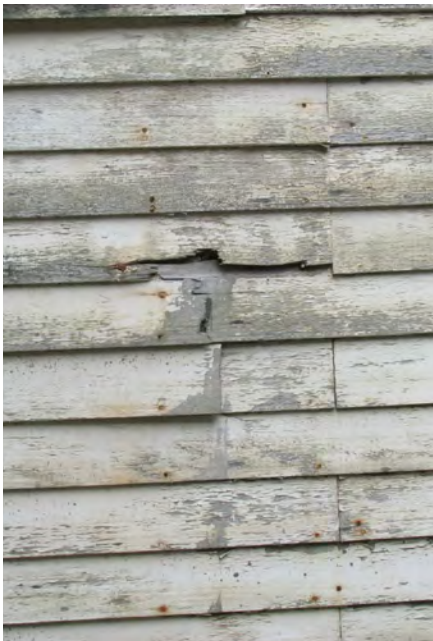
Figure IV-132. Worn paint finish and damaged clapboard. (HA, 2015)

The timber framed walls above are in fair condition. Many of the clapboards are loose, split, or missing. The paint finish is severely worn which has exposed many of the ferrous nail heads that have since corroded. At the southeast corner, the wood corner boards are completely missing and many of the adjacent clapboards are loose or missing. The missing corner boards reveal the timber post which appears to have had significant termite damage and wood rot to the point where there is a loss of section. Ivy is also growing on the clapboard walls. This ivy penetrates gaps in the wood siding, holds moisture close to the building, and serves as a conduit for water to move into the walls. The excess moisture can cause paint failure, wood rot, and potential freeze/thaw damage.

Missing severely damaged clapboards should be replaced with new and all loose boards should be re-secured. The damaged section of the timber corner post should cut-out and a new post section spliced on. New corner boards should be installed to cover the timber post. All of the ivy should be removed and all the wood painted to protect both the wood and fasteners. The entire façade should be made as water tight as feasible to prevent water infiltration.

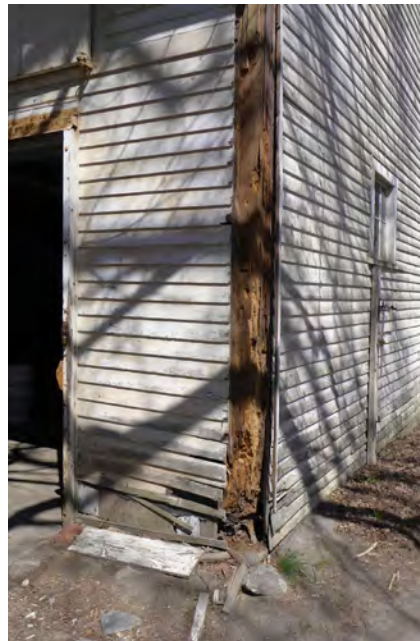
Figure IV-133. Missing corner board and clapboard siding at southeast corner. The corner post also has significant termite damage. (HA, 2015)

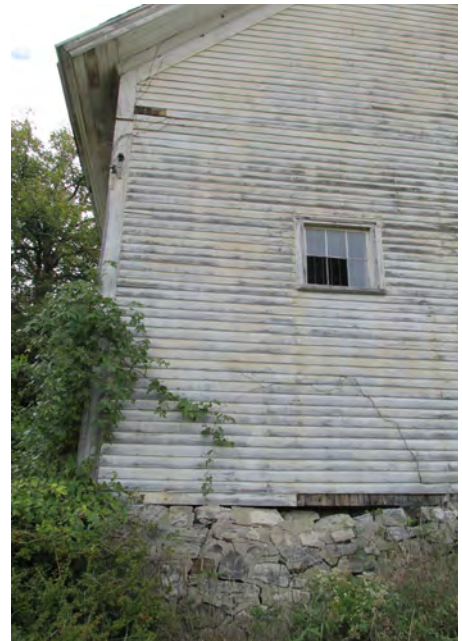
Figure IV-134. Displaced foundation stones. (HA, 2015)

The stone foundation walls appear to be in fair-to-good condition. The ground slopes so the foundation walls are more exposed on north and west ends than south and east. These more exposed faces appear to be in poorer condition since they are subject weather and the elements. On the west elevation, the foundation wall appears to have partly fallen in one area and there is a gap between the stone wall and timber framed wall above. Ivy is likewise growing on and into the stone foundation walls, particularly on the north and west sides. The ivy hold and is a conduit for moisture which can penetrate the wall and cause damage when it freezes.

The fieldstone foundation walls should first be assessed by a structural engineer and then partly rebuilt to correct areas which have become displaced. All of the ivy should be removed and the walls should be re-parged with cement to make watertight.

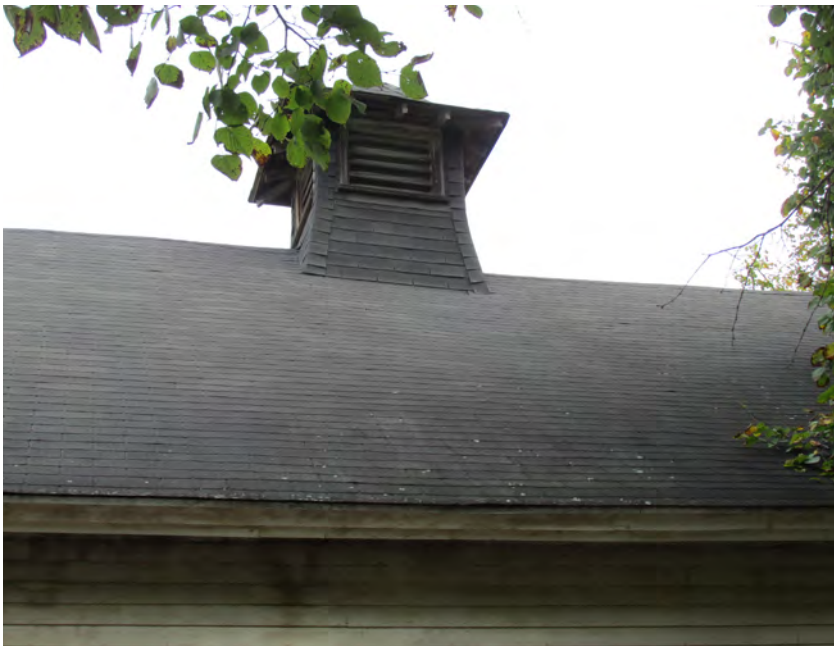
Figure IV-135. Roof and cupola. (HA, 2015)

The roof appears to be in fair condition. The shingles appear to be worn and there are select areas where they are displaced. Given that the asphalt shingles are over twenty years old, they are beyond their expected serviceable life.

The existing roof should be removed and the wood deck inspected and either repaired or replaced. A new wood shingle roof should be installed. New fascia boards should be installed where missing and loose boards reattached. All of the wood should be prepared and painted.

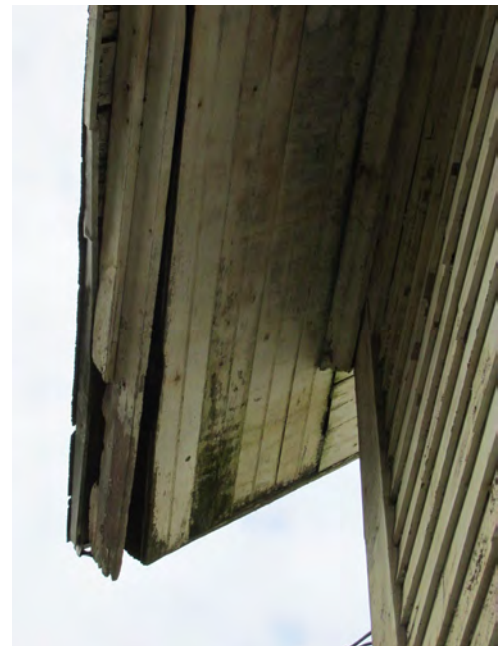
Figure IV-136. Damaged and rotted wood fascia and soffit boards. (HA, 2015)

Some of the wood fascia boards are loose or missing and the paint has typically failed.

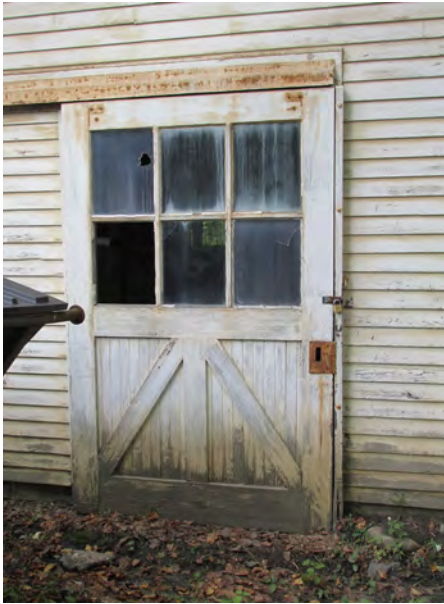
Figure IV-137. Painted wood board-and-batten sliding door. (HA, 2015)

The sliding doors are typically in fair condition. The paint on the sliding doors is severely worn, particularly at the bottom of the stiles and rails of grade level doors where they are most prone to water splash back. There are many broken panes of glass and the glazing putty is very brittle and missing in areas. All of the hardware has surface corrosion.

The sliding doors should be restored since they provide the primary access to the building. New glass should be installed where the existing is missing or broken, the corrosion should be removed from the hardware, the joints reinforced, and the doors prepared and painted.

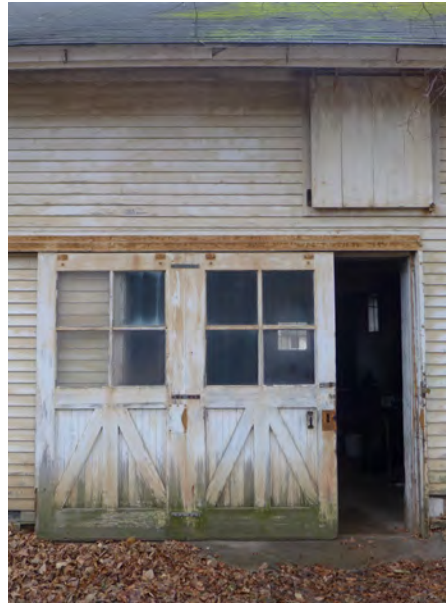
Figure IV-138. Painted wood board-and-batten sliding doors. It appears that the doors were formerly swinging doors but have been joined together and made into sliding doors. (HA, 2015)

The two access doors should likewise be retained and restored. The surface corrosion should be removed from the hardware and doors prepared and painted. Although the conversion of the east door from a swinging to sliding door may have happened long ago, it should be converted back to a swinging door to match the one to the west.

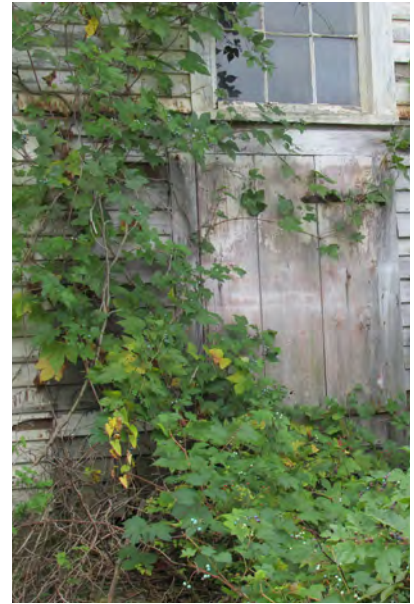
Figure IV-139. Abandoned wood board-and-batten door. (HA, 2015)

The plank door on the north elevation was mostly hidden by foliage. Its paint finish is almost completely worn off and the strap hinges show some signs of surface corrosion.

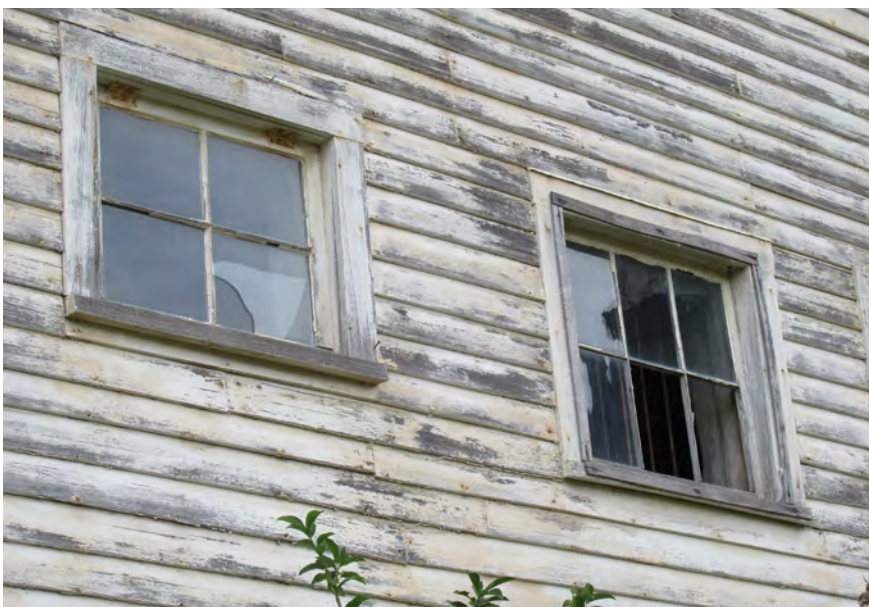
Figure IV-140. Four and six-light painted wood windows. (HA, 2015)

The windows are only in fair condition. Typical conditions include: broken glass, brittle or missing glazing putty, wood rot, loose sash joints, and worn paint finishes.

The windows should be retained and restored. New glass should be installed where the existing is missing or broken, new glazing putty installed, rotted or broken elements repaired or replaced, and all of the wood prepared and painted.

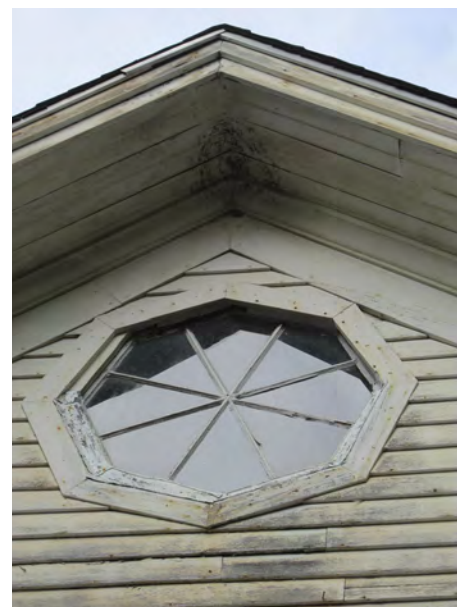
Figure IV-141. Octagonal window below the roof line. (HA, 2015)

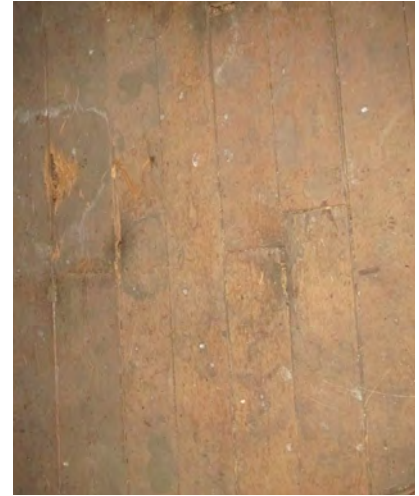
The concrete and wood plank floors generally both appear to be in good condition. In the hay loft, there are a few planks that have termite damage.

Figure IV-148. Wood strip flooring in hayloft. (HA, 2015)

Clean and maintain the flooring.

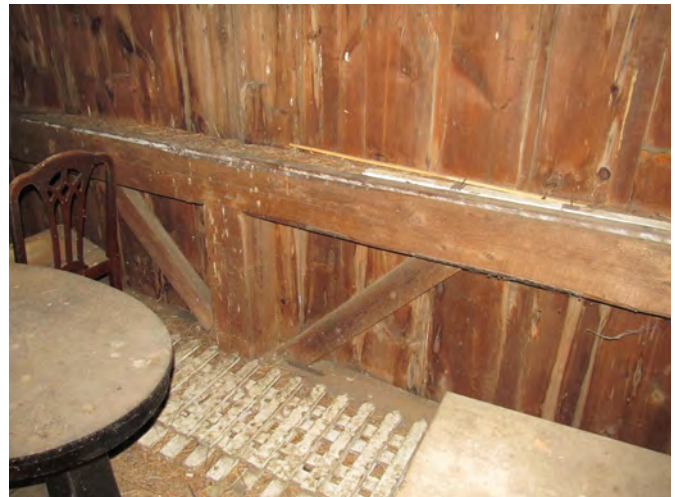
The hay loft walls appear to be in good condition. The most noticeable defect was a small area of termite damage to some of the structural members.

Figure IV-150. Exposed heavy timber framing and wood sheathing in hayloft. (HA, 2015)

The board walls should be prepared and painted. The termite damaged area however, should be assessed to verify if this is an ongoing issue and a structural engineer should ascertain the extent of damage. Damaged timbers should be reinforced or replaced if required by a structural engineer.

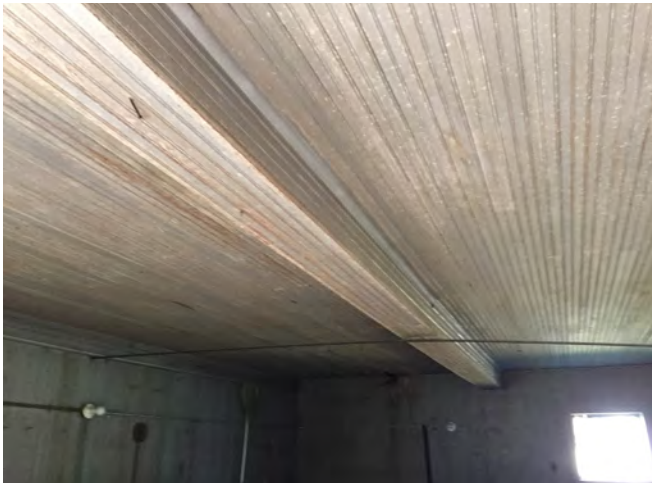
Figure IV-151. Painted tongue-and-groove ceiling boards in garage and horse stall area. (HA, 2015)

The ceilings appear to be in good condition. The paint has failed, particularly in the stable area, and there are a few areas where the boards are displaced or missing.

Repair the broken boards and prepare and paint all the ground floor ceilings.

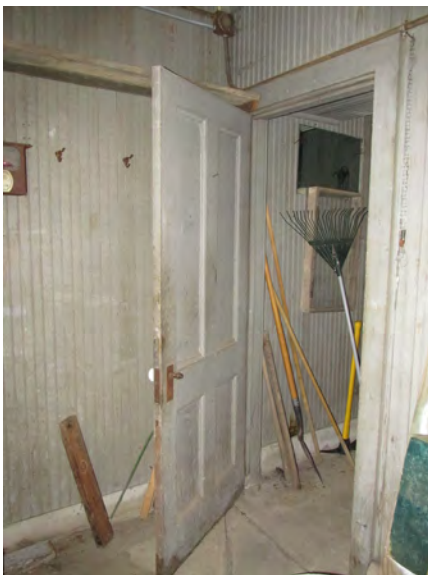
Figure IV-153. Painted four-panel wood door. (HA, 2015)

The four-paneled door is in good condition although the lockset is missing its knobs and the paint is worn.

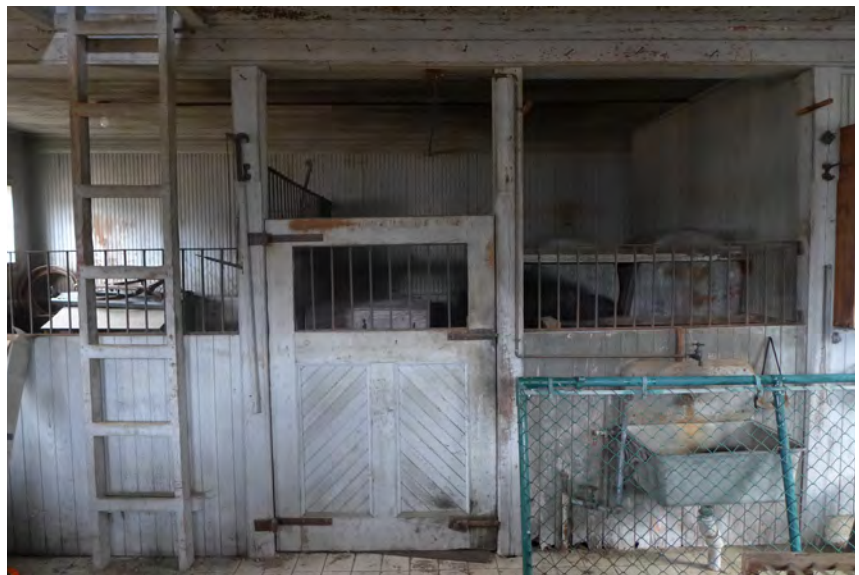
Figure IV-154. Painted board-and-batten wood door with metal grille to horse stall. (HA, 2015)

The box stall doors also appears to be in good condition and has the same worn paint finishes. This door also has many more nicks and scratches.

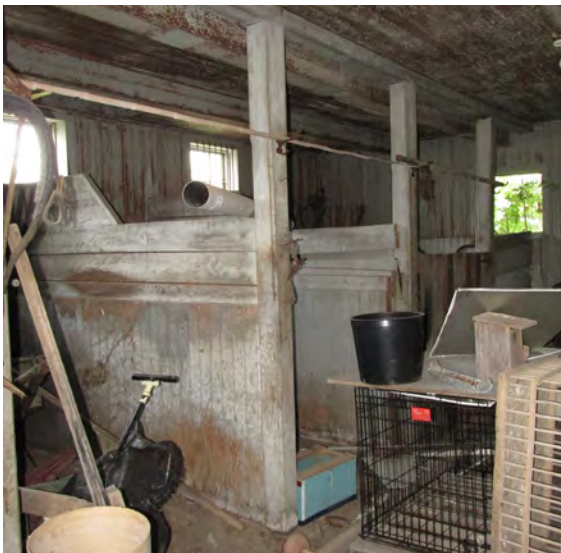
Figure IV-155. Wood horse stall partitions. (HA, 2015)

The horse stalls should be retained for historic interpretation purposes.

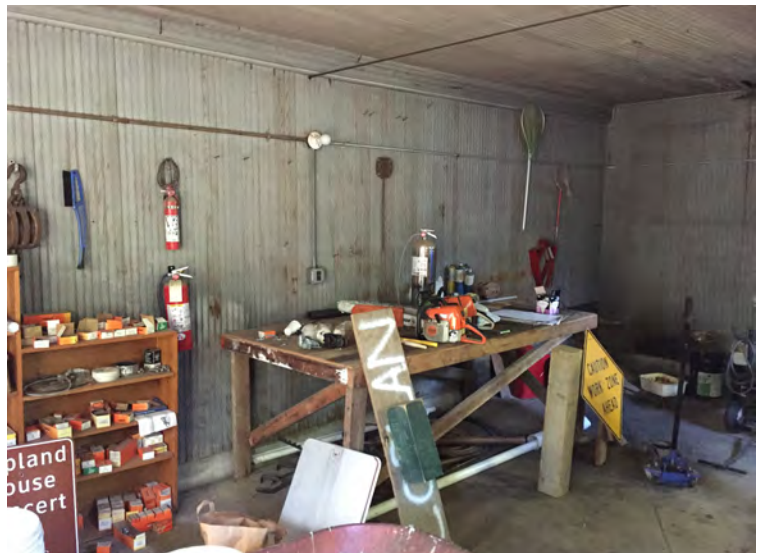
Figure IV-156. Wall mounted porcelain light sockets with exposed conduit in garage area. (HA, 2015)

The lights were not assessed to determine if they all still work and their conditions.

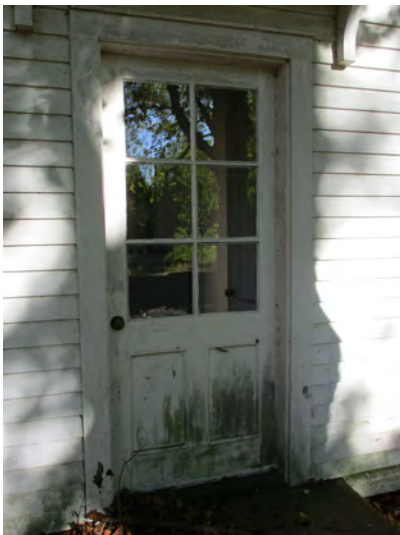
Figure IV-159. Six-lite, two-paneled painted wood door. (HA, 2015)

The doors and frames appear to be in relatively good condition. There is some worn and peeling paint as well as some soiling at the base of the doors and frames. At the time of the survey, all glass was intact and undamaged.

All doors, windows, and frames should be prepared and painted. Loose or missing window putty should be replaced. The damaged meeting rail on the window on the west façade should be repaired.

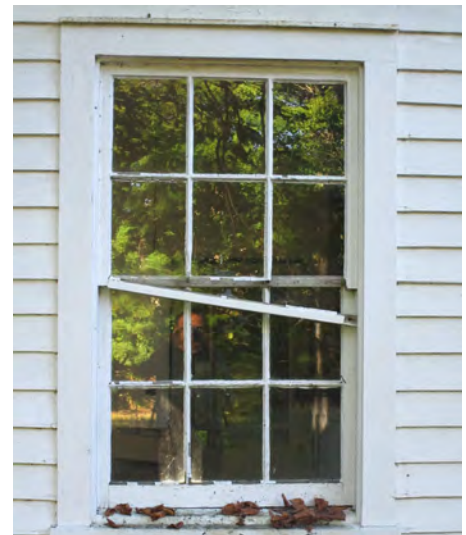
Figure IV-161. Damaged meeting rail. (HA, 2015)

The windows are generally in fair to good condition. The meeting rail on the upper sash of the window on the west side of the Dairy House is broken and coming loose.

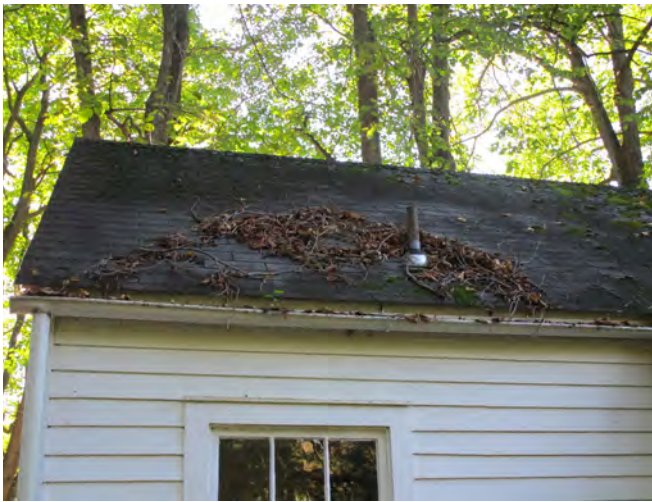
Figure IV-162. Asphalt shingle roof. (HA, 2015)

The roof is in fair condition. There is some biological growth on the asphalt shingles in multiple locations on the roof. The gutter also appears to be coming loose from the eave on the west side of the Dairy House.

All biological growth should be killed and removed from the roof. The displaced gutter should be reattached. The current asphalt shingle roof was installed in 1998 and is near the end of its useful life. It will likely need to be replaced in the near future.
