MERESTEAD

HISTORIC STRUCTURE REPORT

Prepared by
Harboe **A**rchitects, PC

AUGUST 2017

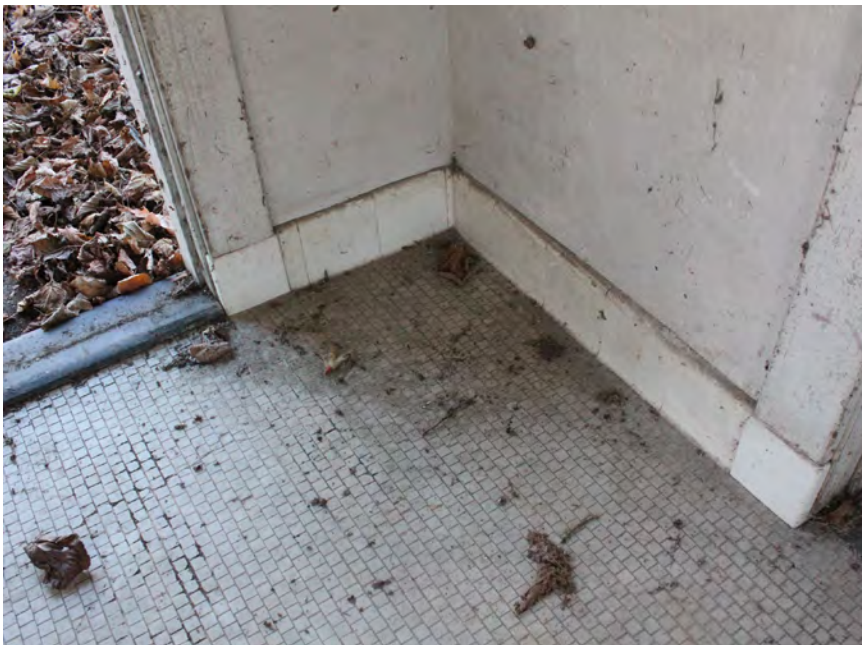
The tile floor appears to be in relatively good condition. There are some cracked tiles. The concrete floors are in good condition. The floors are soiled and there is some staining.

The plaster walls are in fair to good condition. The walls are moderately soiled. There is some damage to the plaster including cracks and delamination of the top coat of plaster.

Figure IV-166. Ceramic tile floor and base tiles with plaster walls above. The doors and windows have wood casing. (HA, 2015)

The floors should be cleaned. All damaged tile should be replaced with new tiles to match the color, finish, and dimensions of the original tiles.

All damaged plaster should be repaired and the walls should be cleaned and painted.

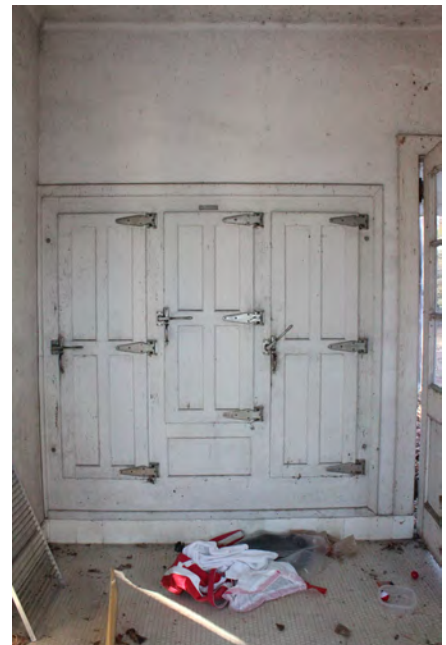
The iceboxes appear to be in good condition. The doors all function properly and there does not appear to be any significant damage. There are some missing shelves.

Figure IV-167. Large ice-box made by the Lorillard Refrigerator Company of New York. (HA, 2015)

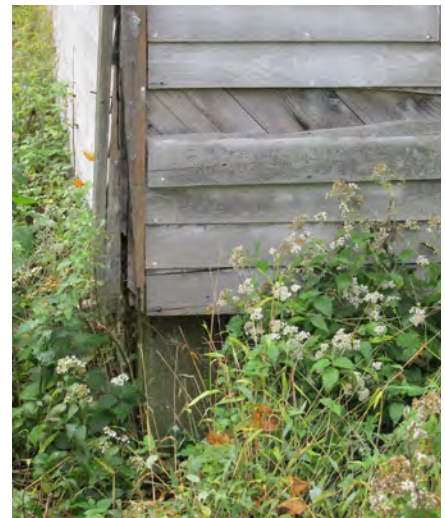
Figure IV-171. Damaged clapboard siding. (HA, 2015)

The wood clapboards are in fair condition. There are some damaged clapboards, especially on the north side of the shed near the bottom of the wall. Some of the clapboards near the base of the wall are missing and the wood sheathing behind is exposed and damaged. The paint finish on the siding is significantly faded and there is biological staining on the clapboards.

Replace damaged clapboard siding and wood sheathing behind is exposed and damaged. Kill and remove all biological growth and prepare and paint the exterior walls.

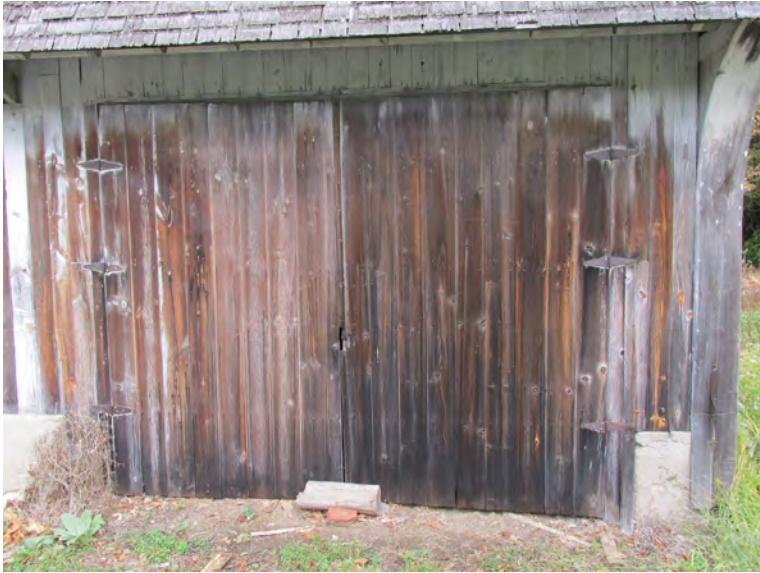
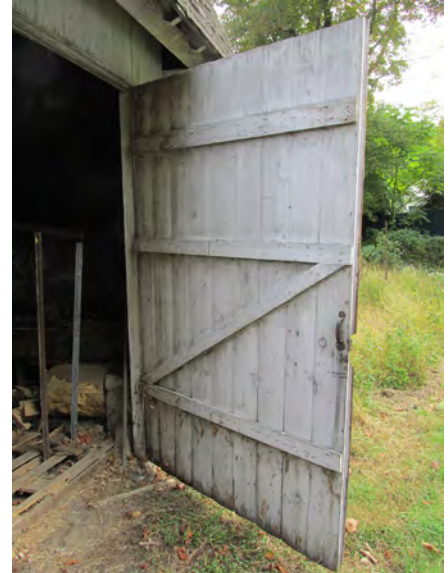
The doors are in fair condition. Some of the wood boards are cracked and damaged, especially at the bottom of the doors. A small section is missing on the east leaf of the door to the tool shed.

Figure IV-174. Exterior of board-and-batten swinging doors. (HA, 2015)

Figure IV-175. Interior of board-and-batten swinging door. (HA, 2015)

Repair damaged sections of the doors. Prepare and paint the exterior side of the doors.

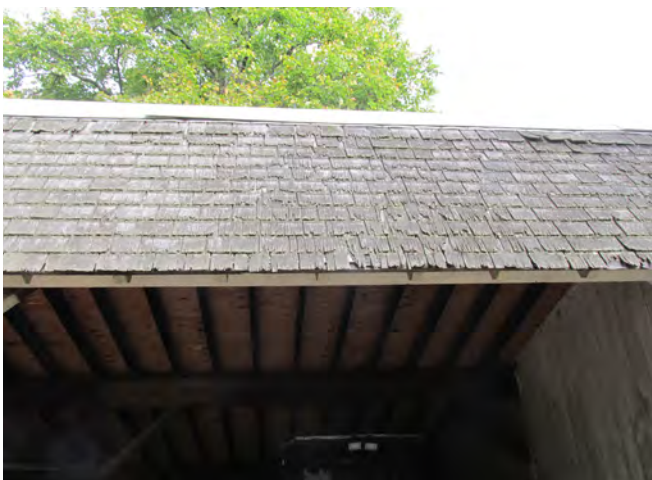
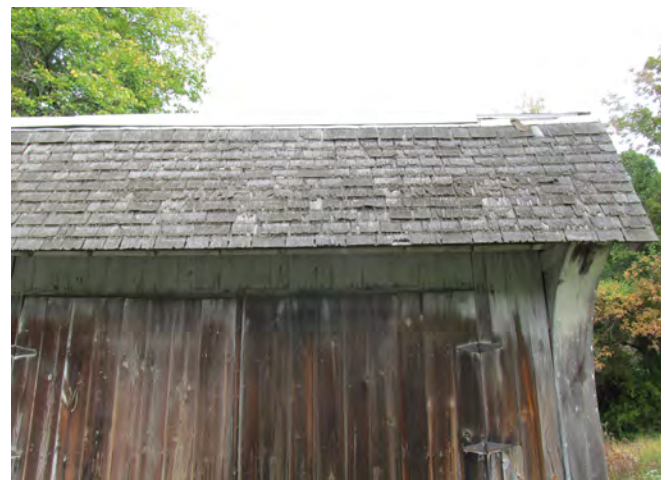
The north slope of the roof appears to be in fair condition. The south slope is in poor condition. Many of the cedar shingles on the south face of the roof are significantly damaged or missing.

Figure IV-176. Worn and displaced roof shingles on south slope. (HA, 2015)

Figure IV-177. Worn and displaced roof shingles on south slope. (HA, 2015)

Replace damaged and missing shingles with new shingles to match the existing.

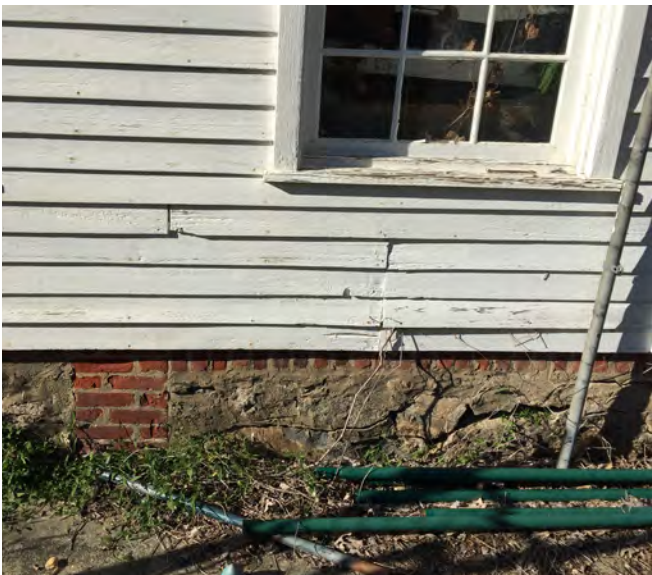
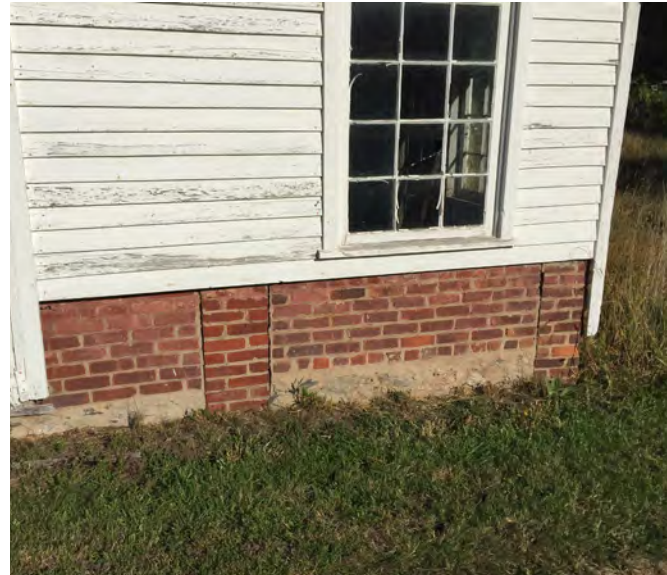
Figure IV-184. Brick and stone foundation wall and painted clapboard siding above. (HA, 2015)

Figure IV-185. Brick piers with later brick infill at foundation. (HA, 2015)

The foundation wall appears to be in relatively good condition. There are some open mortar joints and cracks that need to be addressed. The clapboard siding is in fair to good condition. There is ivy growing on the north façade that needs to be removed to prevent damage to the wood siding. The paint on the siding is peeling and worn in several locations.

The foundation walls should be maintained. All open mortar joints should be repointed and cracks repaired. The ivy should be removed from the clapboard siding to prevent further damage. The clapboard siding and all wood trim on the exterior should be prepared and painted.

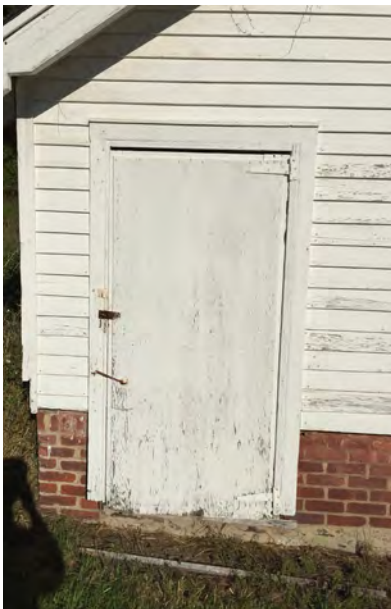
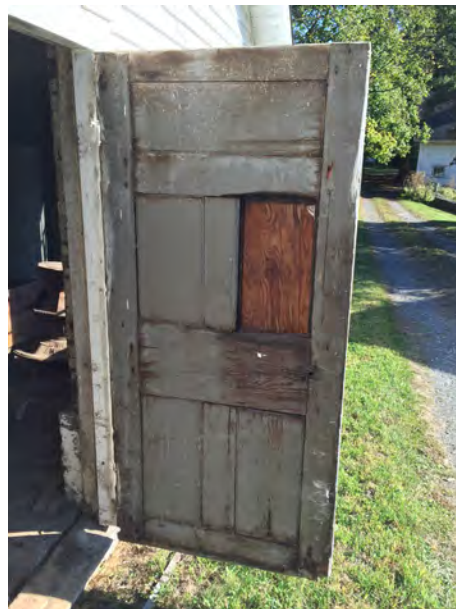
The Chicken House door is in poor condition. One of the panels is missing. The plywood on the exterior face of the door is splintering at the bottom. There are also cracks and gouges in the door stiles and rails. The paint is significantly worn and peeling.

Figure IV-186. Painted plywood has been installed over the exterior of the stile and rail door. (HA, 2015)

Figure IV-187. Interior face of the stile and rail door. (HA, 2015)

The Chicken House door should be demounted, the plywood panel on the exterior side removed, and undamaged wood stiles, rails, and panels salvaged to be stripped and reused. Damaged stiles, rails, and panels are to be replaced with new wood parts that match the dimensions, profiles, and species of the existing wood elements. The reconstructed door is to be repainted and mounted in place.

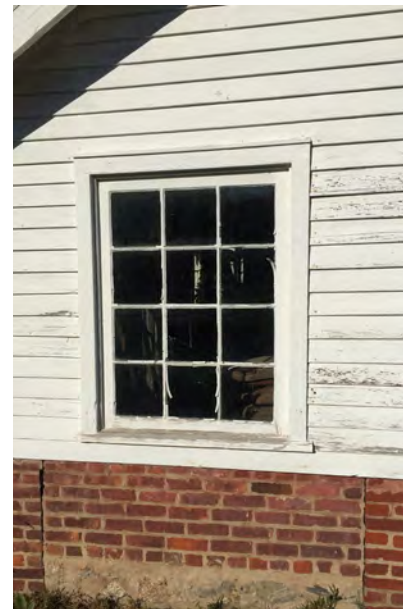
The windows are in fair condition. There are a few glass window panes that are cracked or broken. There is also missing window putty and the paint is significantly worn and peeling. The window on the east side of the Chicken House has been boarded up.

Figure IV-188. Twelve-lite casement window. (HA, 2015)

All damaged wood elements on the windows should be repaired. All Dutchman repairs are to match the dimensions, profiles and species of the existing wood window elements. Damaged glass panes are to be replaced with new glass. The window frames and sashes should be prepared and painted.

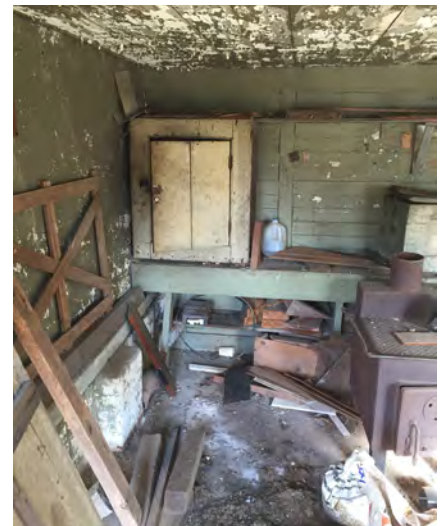
Figure IV-192. Peeling paint at plaster walls and wood ceiling. (HA, 2015)

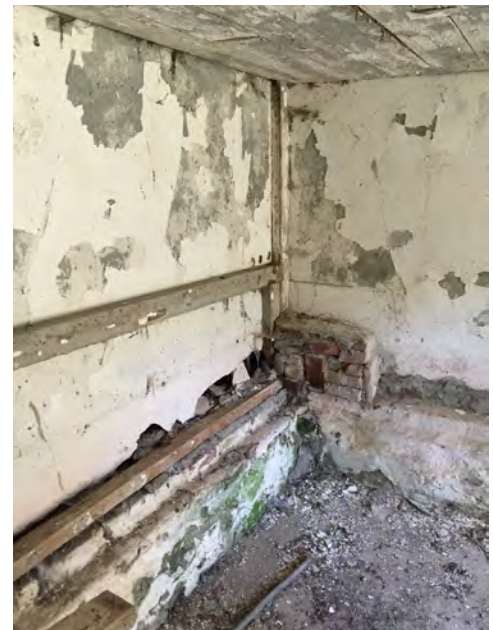
Figure IV-194. Delaminated and spalled plaster walls.. (HA, 2015)

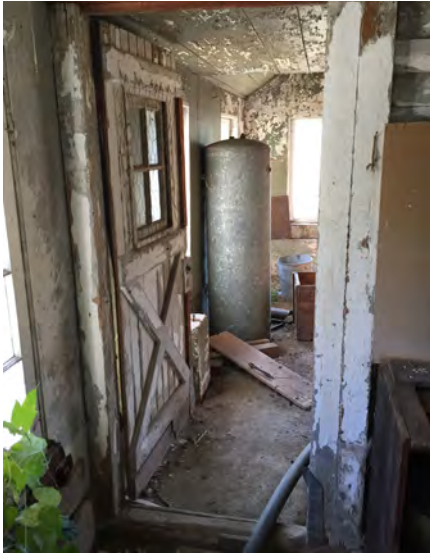
Figure IV-195. Four-lite wood board-and-batten door. (HA, 2015)

The door should be prepared and painted. Any damaged wood or glass elements should be repaired or replaced.

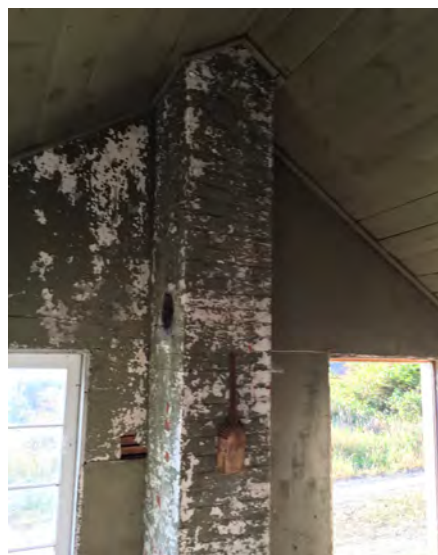
Figure IV-198. Top half of brick chimney at west end of chicken house. (HA, 2015)

The chimney appears to be in fair to good condition on the interior of the Chicken House. The paint is peeling off of the brick.

The paint layers should be removed from the chimney. All loose mortar should be removed and mortar joints should be repointed.

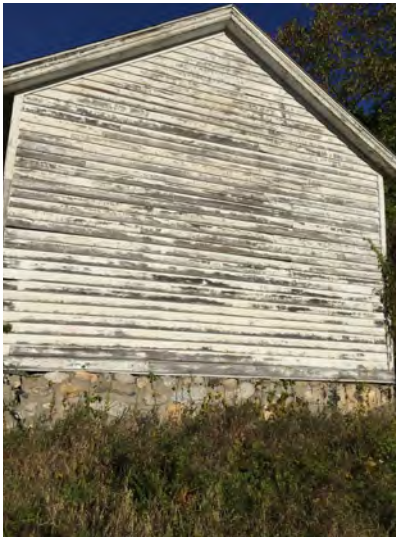
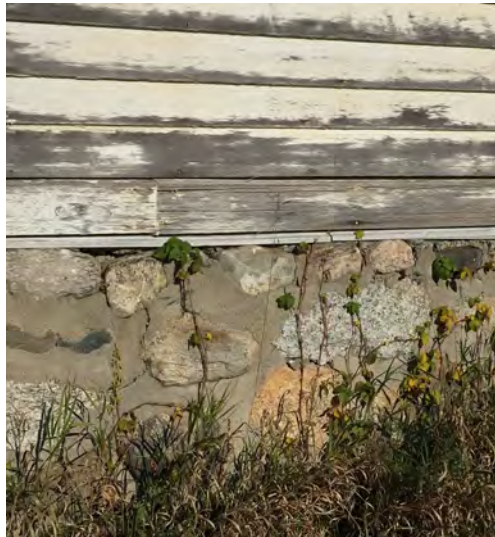
The foundation wall appears to be in relatively good condition. There are some open mortar joints and cracks that need to be addressed. The clapboard siding is in fair to good condition. There is ivy growing on the north façade that needs to be removed to prevent damage to the wood siding. The paint on the siding is peeling and worn in several locations.

Figure IV-201. Clapboard siding and fieldstone foundation wall. (HA, 2015)

Figure IV-202. Close-up photo of clapboard siding and fieldstone foundation wall. (HA, 2015)

The foundation walls should be maintained. All open mortar joints should be repointed and cracks repaired. The ivy should be removed from the clapboard siding to prevent further damage. The clapboard siding and all wood trim on the exterior should be prepared and painted.

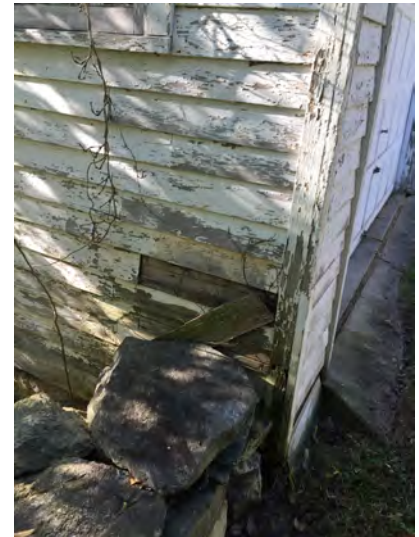
Figure IV-203. Displaced clapboard siding and worn paint finishes. (HA, 2015)

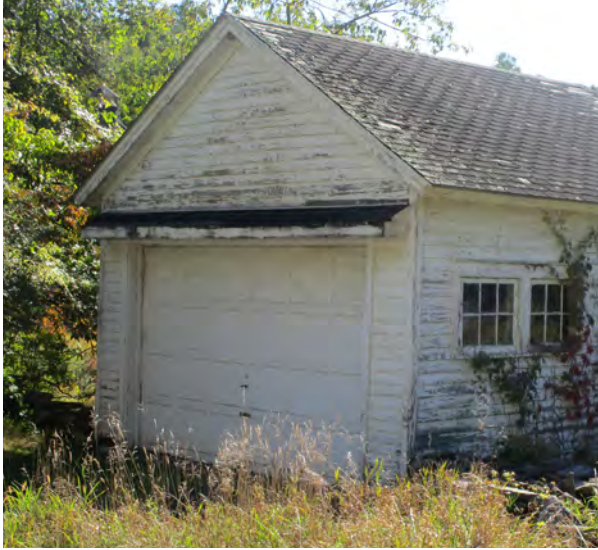
The overhead door appears to be in relatively good condition with the exception of some cracked and peeling paint on the door and frame.

Figure IV-204. Garage door at east elevation. (HA, 2015)

The overhead door and frame should be prepared and painted.

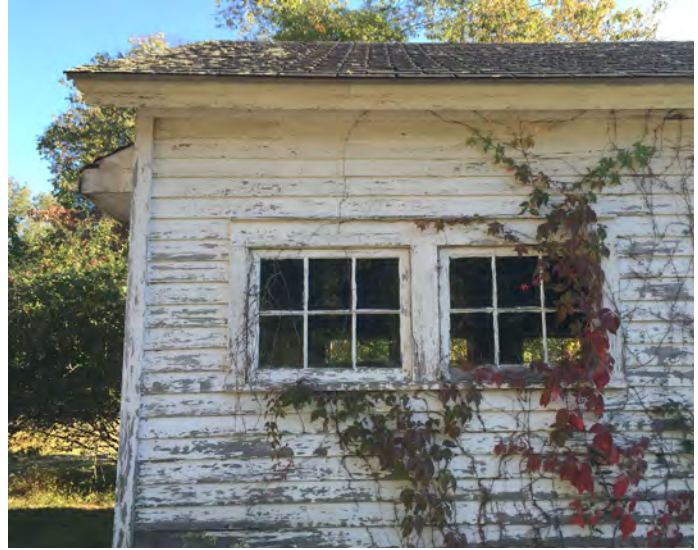
The windows are in fair condition. There is missing window putty and the paint is significantly worn and peeling.

Figure IV-205. Six-lite windows. (HA, 2015)

All damaged wood elements on the windows should be repaired. All Dutchman repairs are to match the dimensions, profiles and species of the existing wood window elements. The window frames and sashes should be prepared and painted.

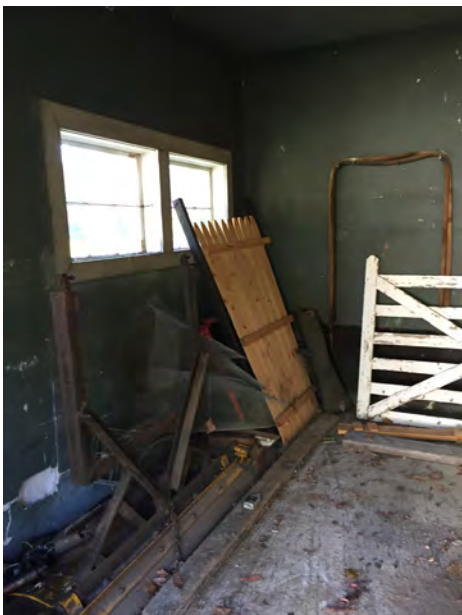
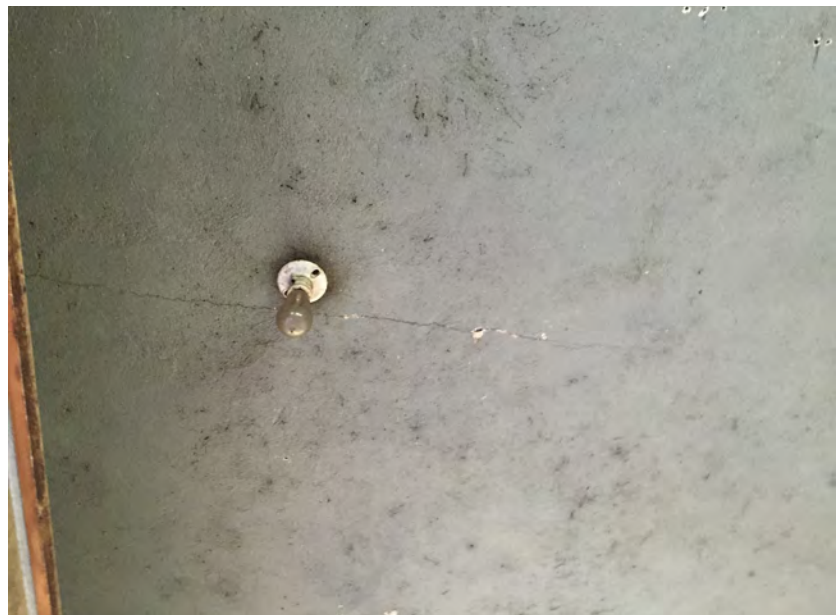
The plaster walls are in fair condition. There are several small holes, gouges, and scuff marks, and stains on the walls.

The plaster ceiling is in fair condition. There are some small holes and stains on the ceiling, as well as some moderate soiling.

Figure IV-206. Interior painted plaster walls and ceiling. (HA, 2015)

Figure IV-207. Painted plaster ceiling and porcelain light fixture with early bulb. (HA, 2015)

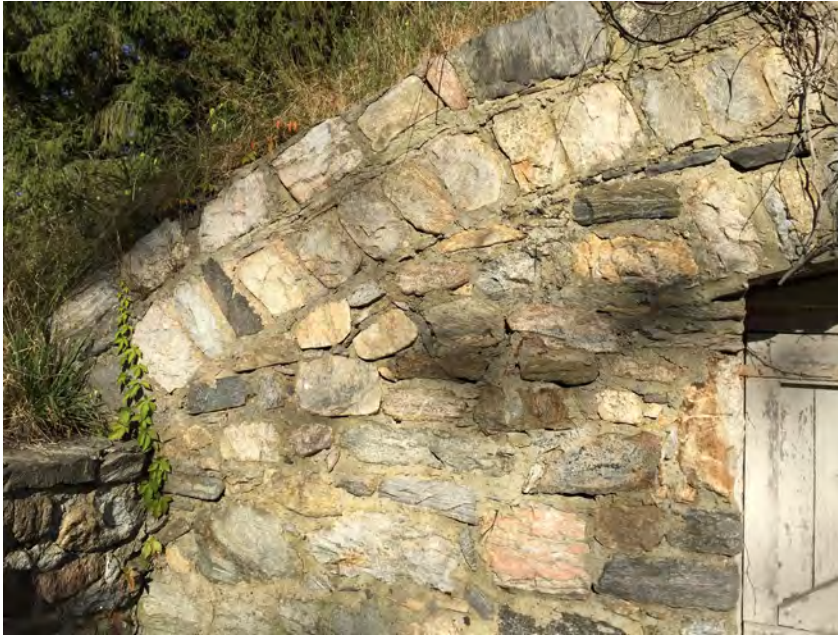
The fieldstone walls appear to be in fairly good condition. There are some small cracks in the mortar joints.

Figure IV-210. Fieldstone root cellar wall. (HA, 2015)

Missing and damaged mortar joints should be repointed.

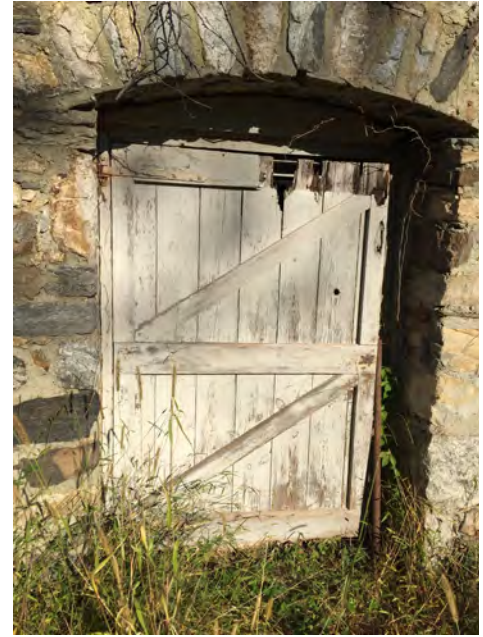
Figure IV-211. Painted board-and-batten door at upper root cellar. (HA, 2015)

The doors are in poor condition. The frames are rotted and significantly damaged. The doors are also damaged, especially at the top and bottom. The doors and frames are also out of alignment and the doors do not close properly. The paint coating on both doors is significantly worn and damaged.

The damaged wood doors and frames should be removed and replaced with new wood doors and frames that match the existing doors.

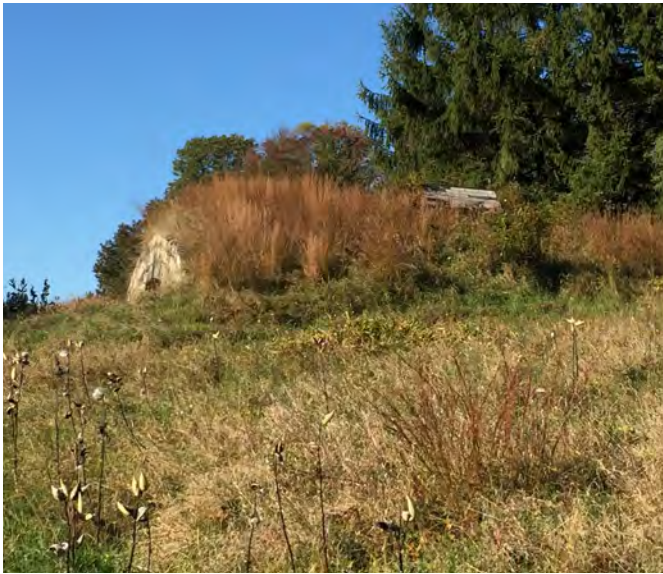
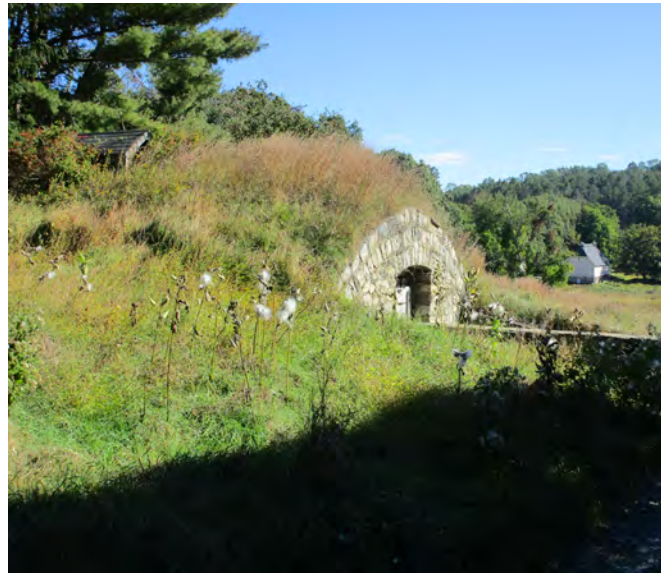
Figure IV-212. Earth roof at upper root cellar. (HA, 2015)

Figure IV-213. Earth roof at upper root cellar. (HA, 2015)

Remove overgrown plantings on the roofs of the root cellars.

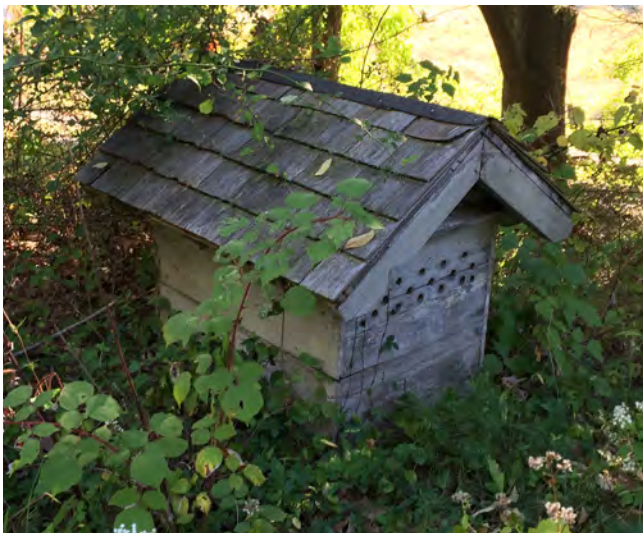
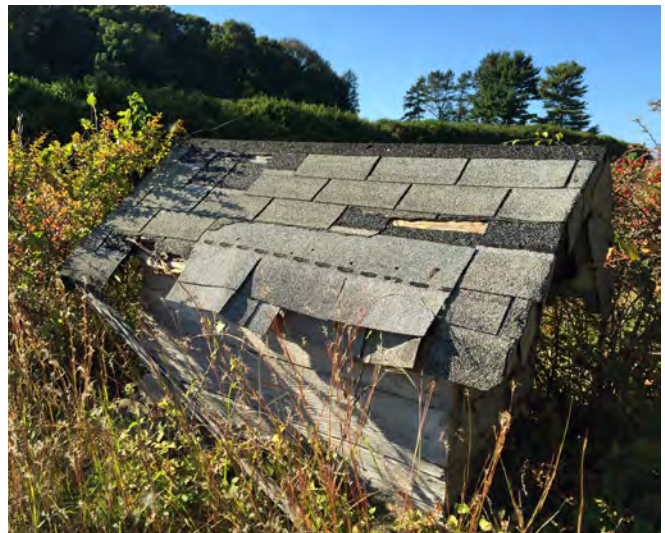
The ventilators are in fair condition. The wood siding is cracked and needs to be painted. There are some damaged asphalt shingles on the ventilator on the root cellar near the garden. According to site superintendent Tom Comito, the ventilator on the lower root cellar was re-done sometime in the 1990s.⁵

Figure IV-214. Earth roof and wood ventilator with wood roof shingles at lower root cellar. (HA, 2015)

Figure IV-215. Asphalt shingles on upper root cellar ventilator. (HA, 2015)

Repair the wood siding on the ventilators as required. Paint all exposed wood elements. Install new shingles to replace damaged and missing shingles.

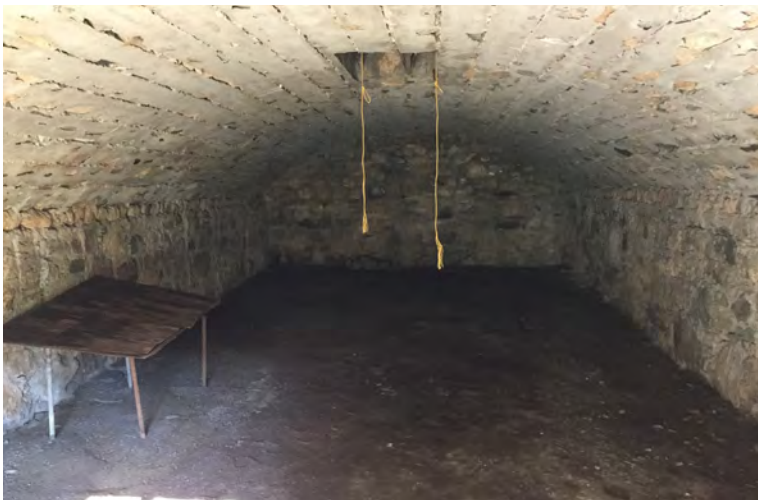
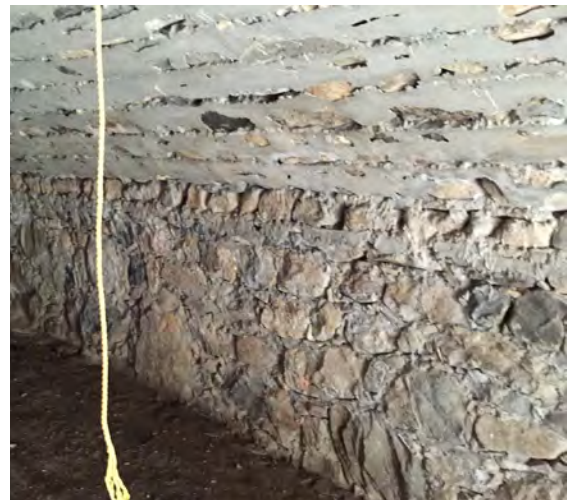
The vaulted ceilings in both root cellars appear to be in relatively good condition. There are some open mortar joints in the brick vault.

Figure IV-216. Fieldstone walls and barrel ceiling. (HA, 2015)

Figure IV-217. Close-up photo of fieldstone walls and barrel ceiling. (HA, 2015)

Repoint all open mortar joints in the vaulted ceiling.

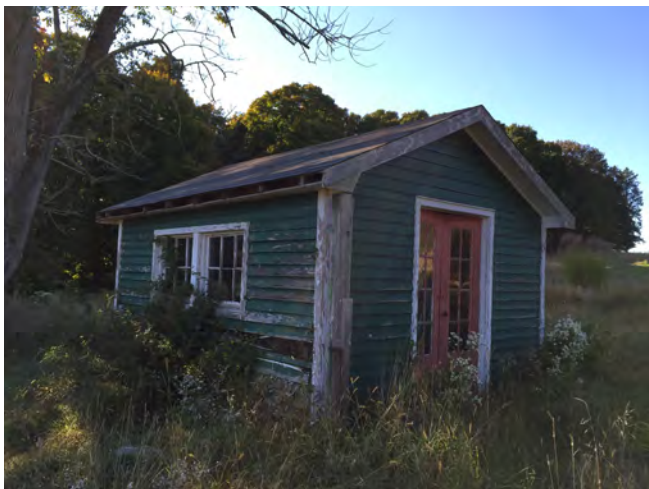
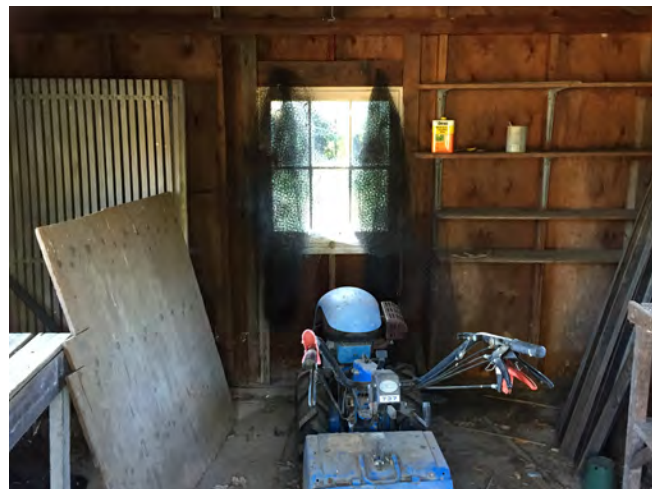
Figure IV-218. Garden shed, looking northwest.. (HA, 2015)

Figure IV-219. Garden shed interior, looking west. (HA, 2015)

The exterior of the garden shed is in fair-to-good condition, with the worst damage on the south elevation. The roof appears to be in good condition but the paint on the clapboards is severely worn and some of the clapboards are loose or missing. Likewise, the paint on the roof fascia boards has mostly failed and the fascia board is entirely missing on the south elevation. The door and windows also have paint failure as well as very brittle glazing putty with some areas where it is missing.

The interior of the building appears to be in good condition although there is quite a bit of debris on the floor.

Restoring the garden shed is not a priority and depends on the future programming for the site. Its purpose was to store garden tools but its current function as a maintenance tool storage building is impractical given its remote location and small size. However, depending on the tenant and use of the site, it may have other applications that are not yet obvious. Restoring the building will essentially require preventing further water infiltration. This would require installing new clapboard siding and fascia boards where missing or badly damaged and performing routine maintenance.
