# **Irrigation Supply/Demand Analysis**

**Maple Moor Golf Course  
1128 North Street  
White Plains, New York**

**Westchester County Department of Public Works and Transportation  
Michaelian Office Building  
148 Martine Avenue  
White Plains, NY 10601**

**March 2018**

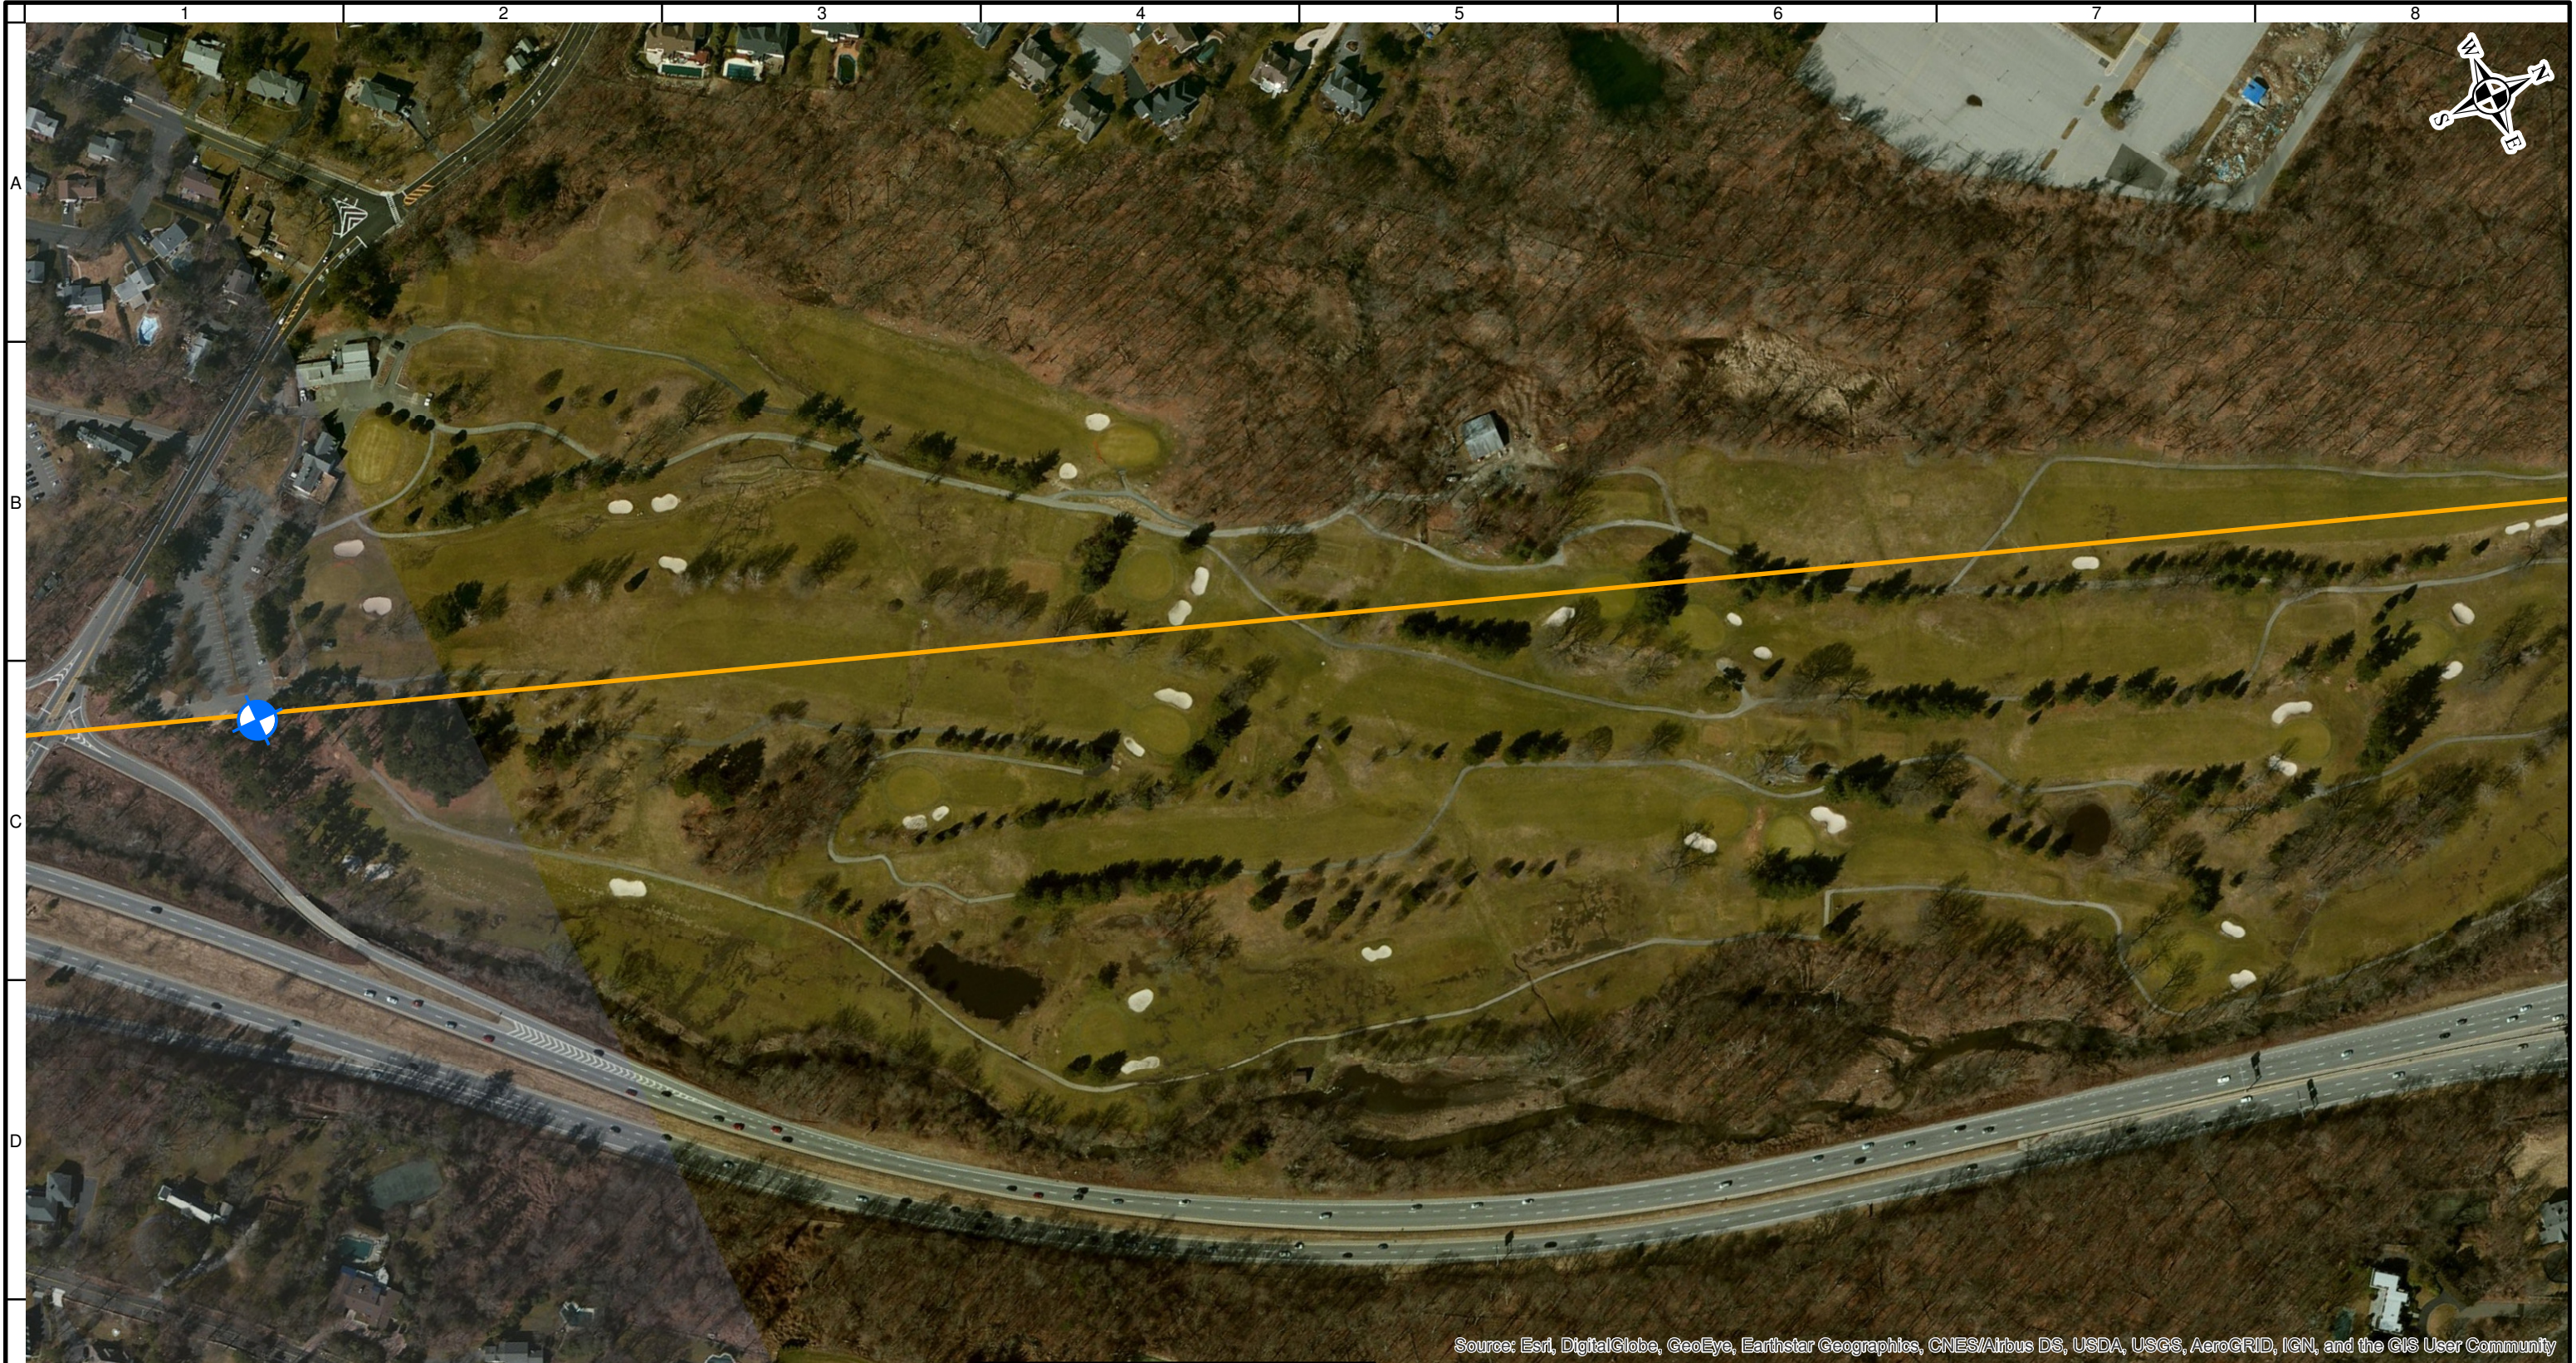
## **Figure 1**

Rock Well Location

Interpreted Fracture

Based on the fracture trace analysis performed as part of this study, there is a fracture that traverses the golf course, refer to Figure 1. If additional wells were installed along this fracture and if the wells produced similar safe yields, it would require 4 additional wells (in addition to the test well) to satisfy the average daily irrigation demand of the course. Assuming each well would cost approximately \$100,000 to install and connect to the system, it would cost an additional \$400,000 to install the additional wells necessary to meet the total average daily irrigation demand. The total cost of the wells would be \$460,000 and the savings per year would be approximately \$62,331, therefore it would take approximately 7.4 years to offset the cost of the wells.

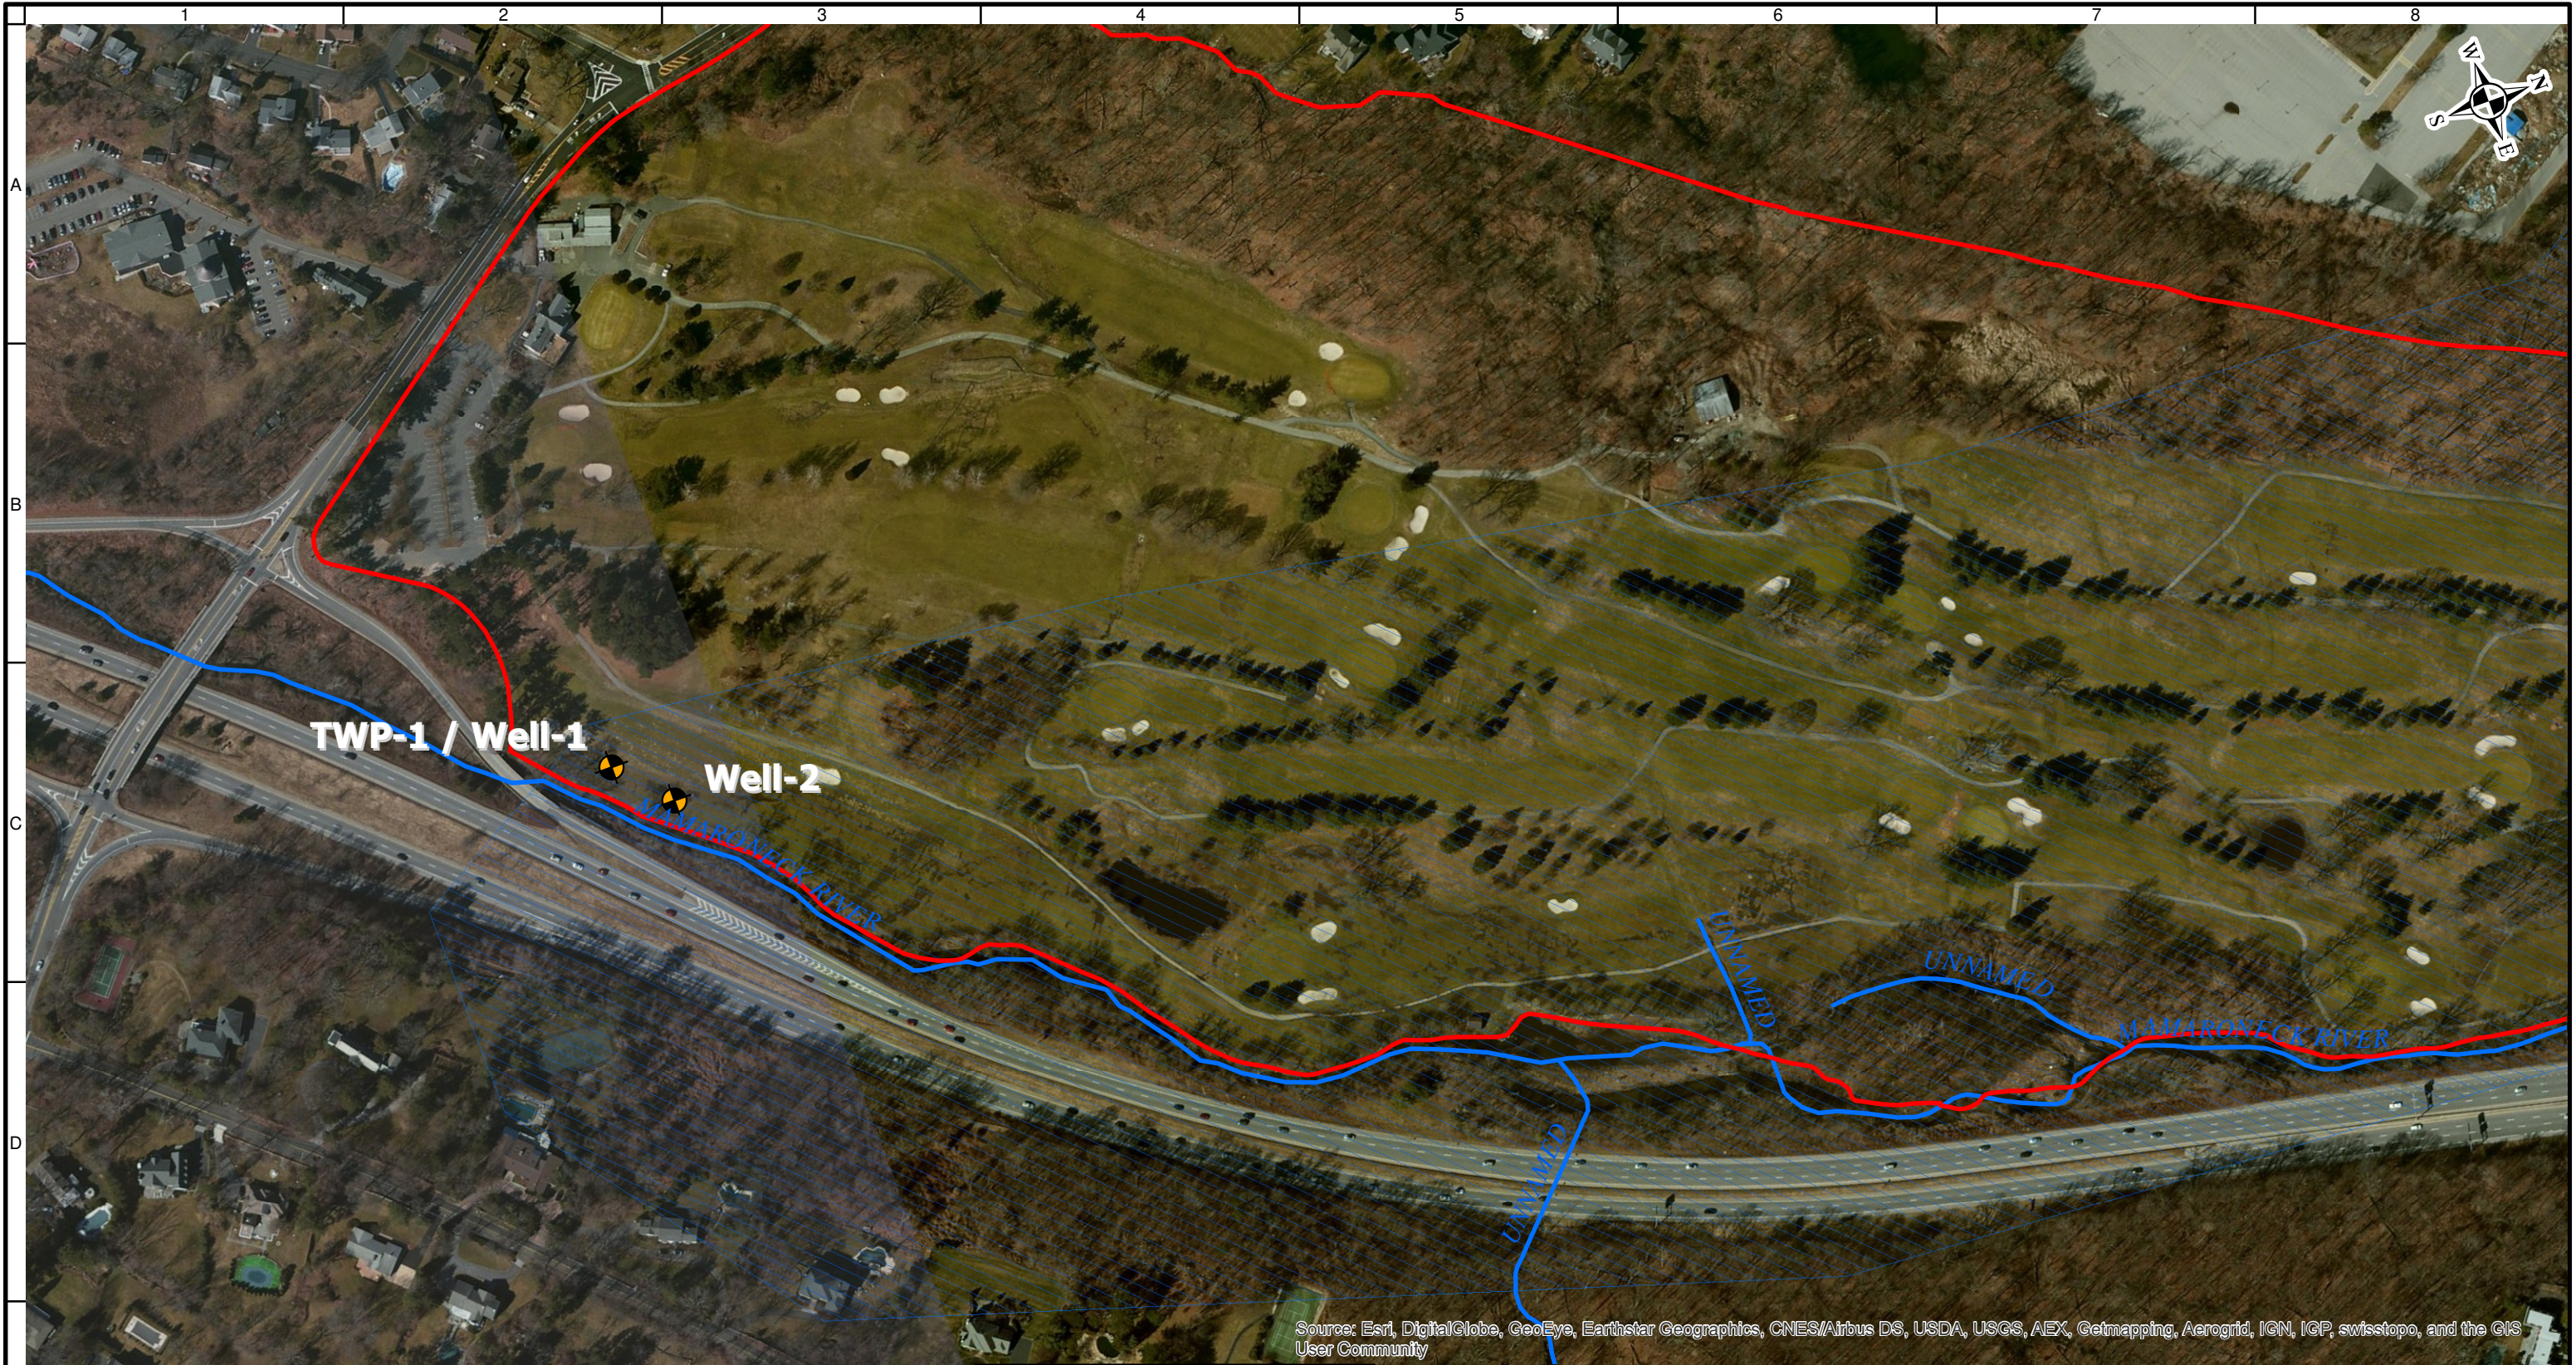
## **Figure 2**

Shallow Groundwater Well Location

- Proposed Temporary Well Point/Irrigation Wells
- Site Boundary
- Surface Water
- Principal Aquifer

depth of 20-feet and 33-feet. The test wells were installed to intercept acceptable water quality levels of the Mamaroneck River. Figure 2 depicts the location of the shallow groundwater well. According to the boring logs, water was encounter 6- and 6.5-feet below grade. The test well boring logs are provided in the tables below:

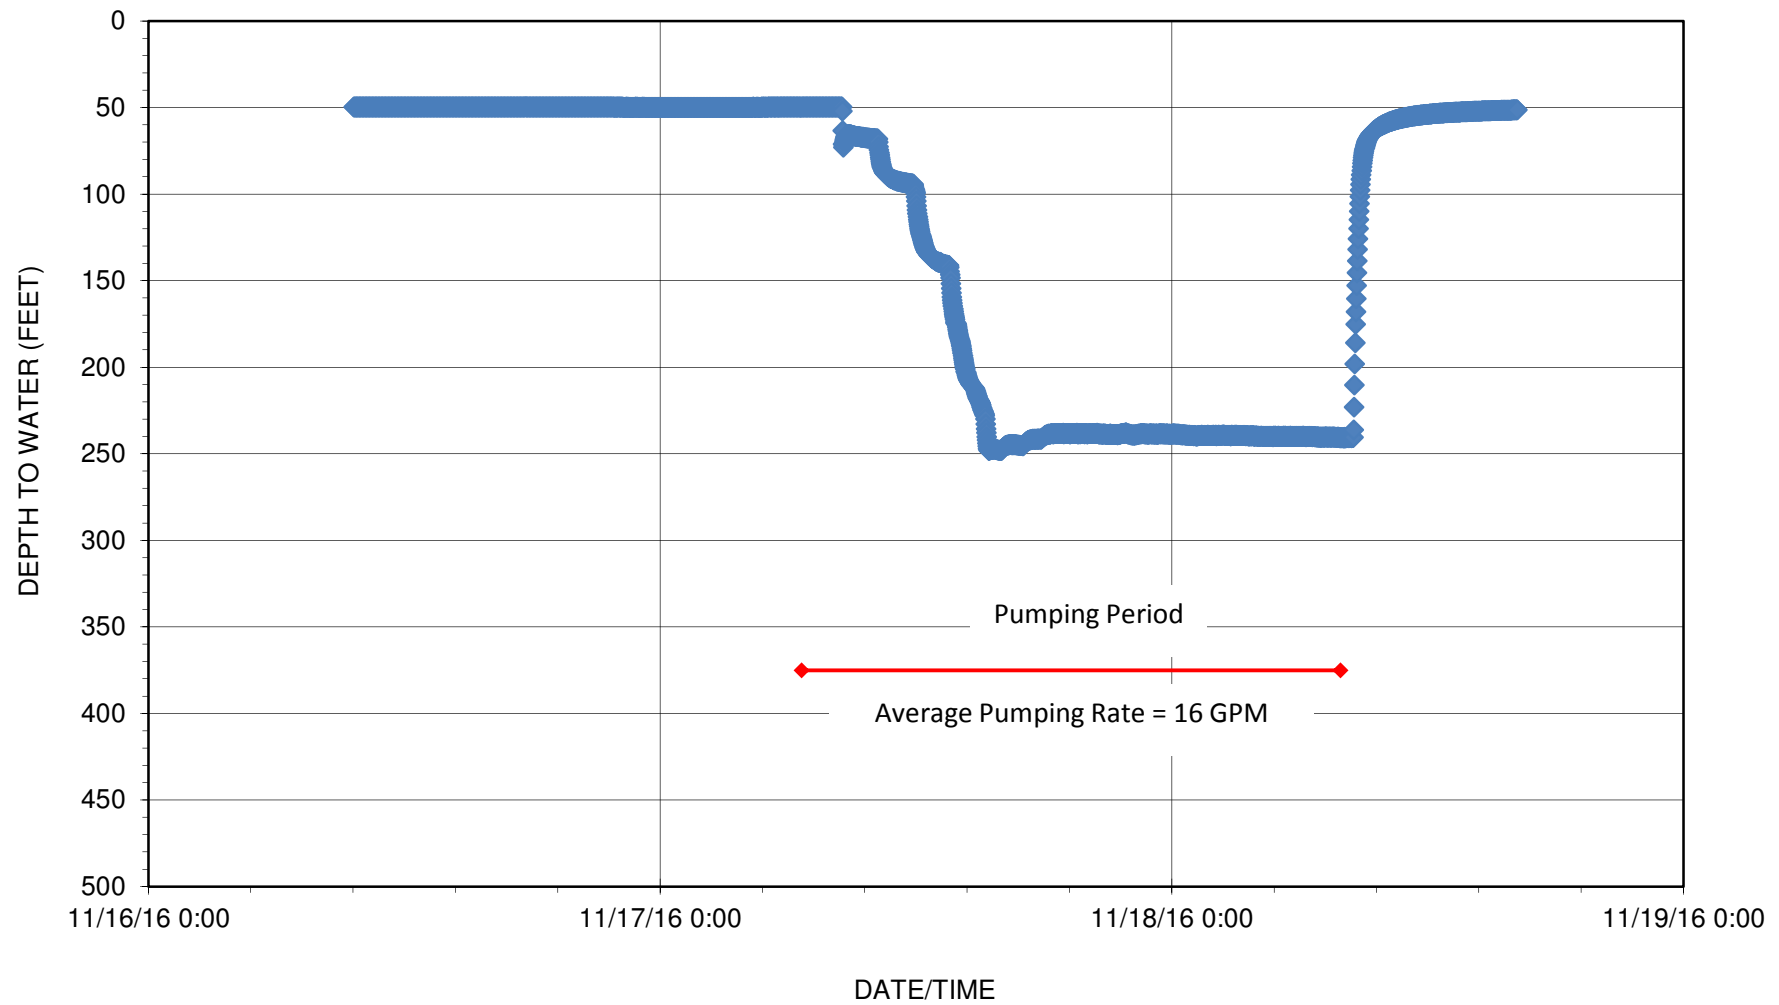
Hydrograph Rock Well Pumping Test

**MAPLE MOOR GOLF COURSE**  
**WHITE PLAINS, NY**  
HYDROGRAPH  
ROCK WELL PUMPING TEST  
11/16/16- 11/18/16

Prior to implementing the pumping test, background conditions were monitored in the bedrock well from 16 November 2016 to 17 November 2016. Aquifer conditions appear to have remained consistent over the course of the background period. Water levels fluctuated approximately 0.35 feet.

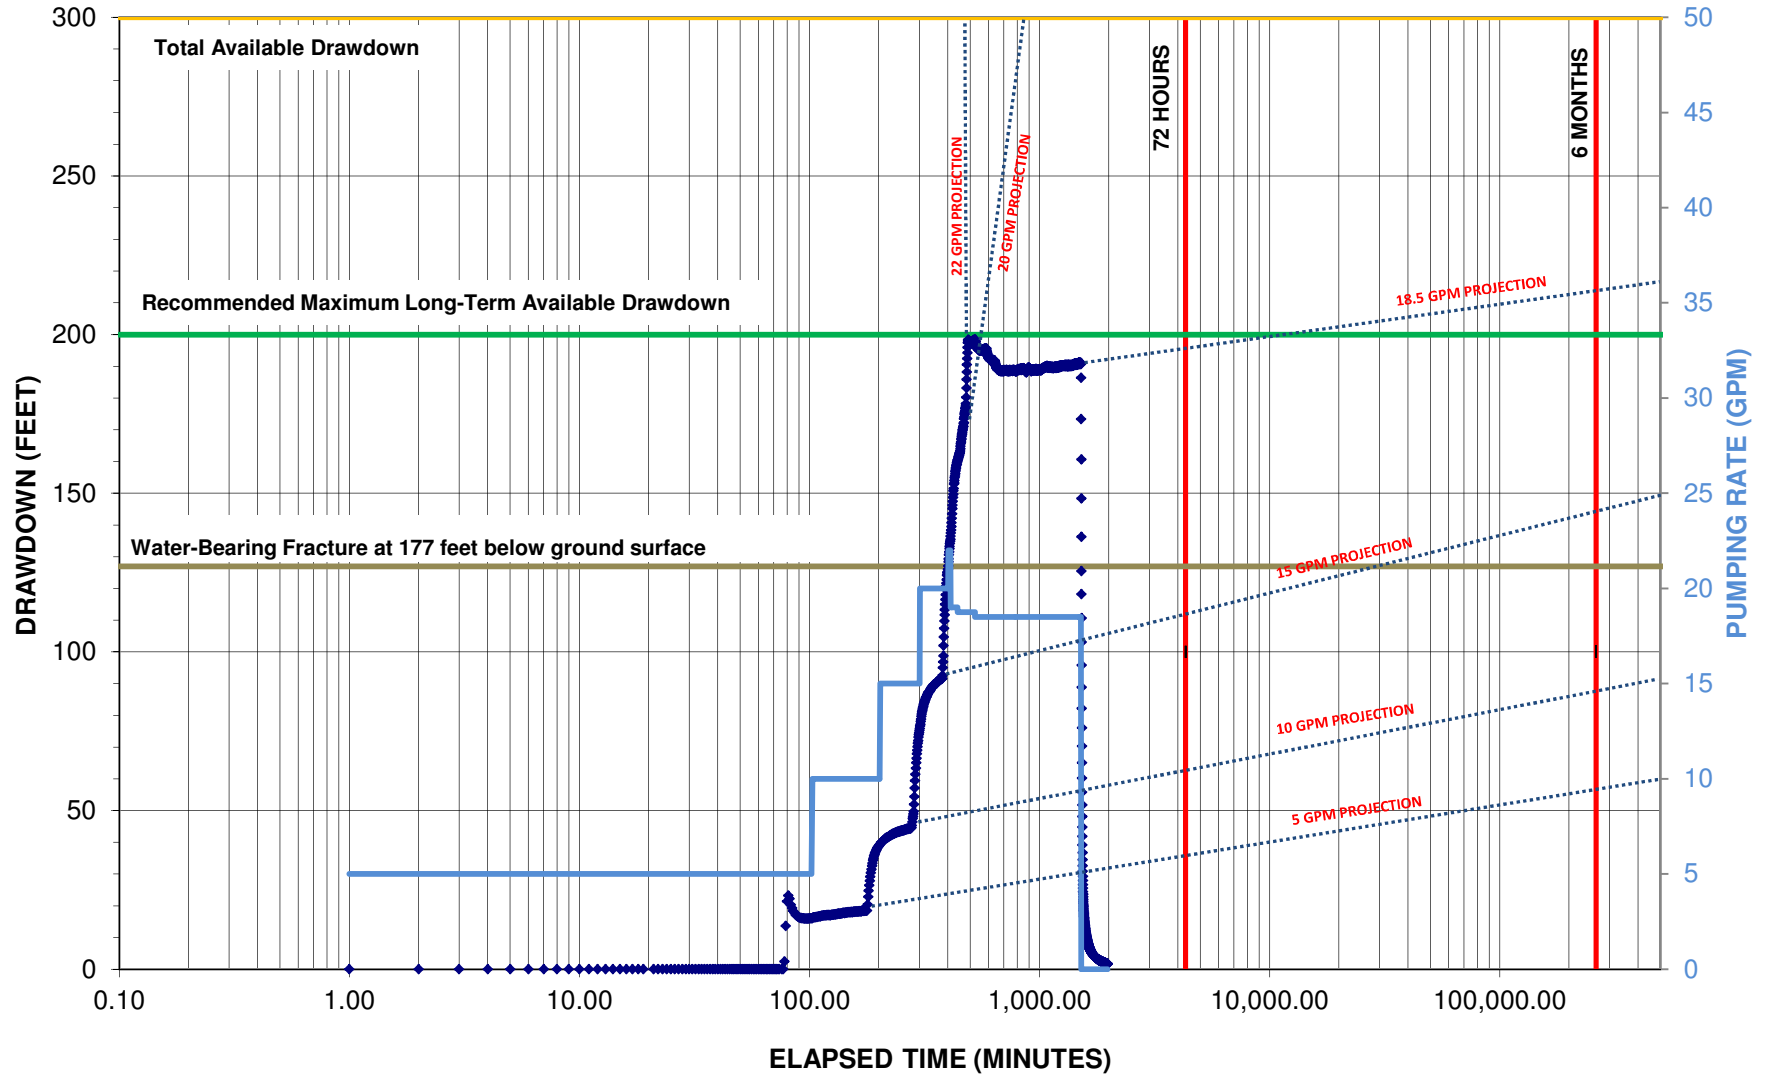
### Pumping Test of Rock Well & Rock Well Drawdown

**MAPLE MOOR GOLF COURSE  
WHITE PLAINS, NY  
PUMPING TEST OF ROCK WELL, 11/17/16 - 11/18/16  
ROCK WELL DRAWDOWN**

Upon completion of pumping, water levels in the well recover to pre-pumping or static conditions. The time in which water-levels equilibrate to static conditions after the pumping ceases is called the "recovery period". The data logger was set to record measurements during the recovery period. The data logger was removed from the bedrock well on 18 November 2016 when 99% recovery had been achieved. [Appendix C](#) presents summarized recovery measurements and logarithmic graphs of elapsed time in minutes vs. recovery for the bedrock well.

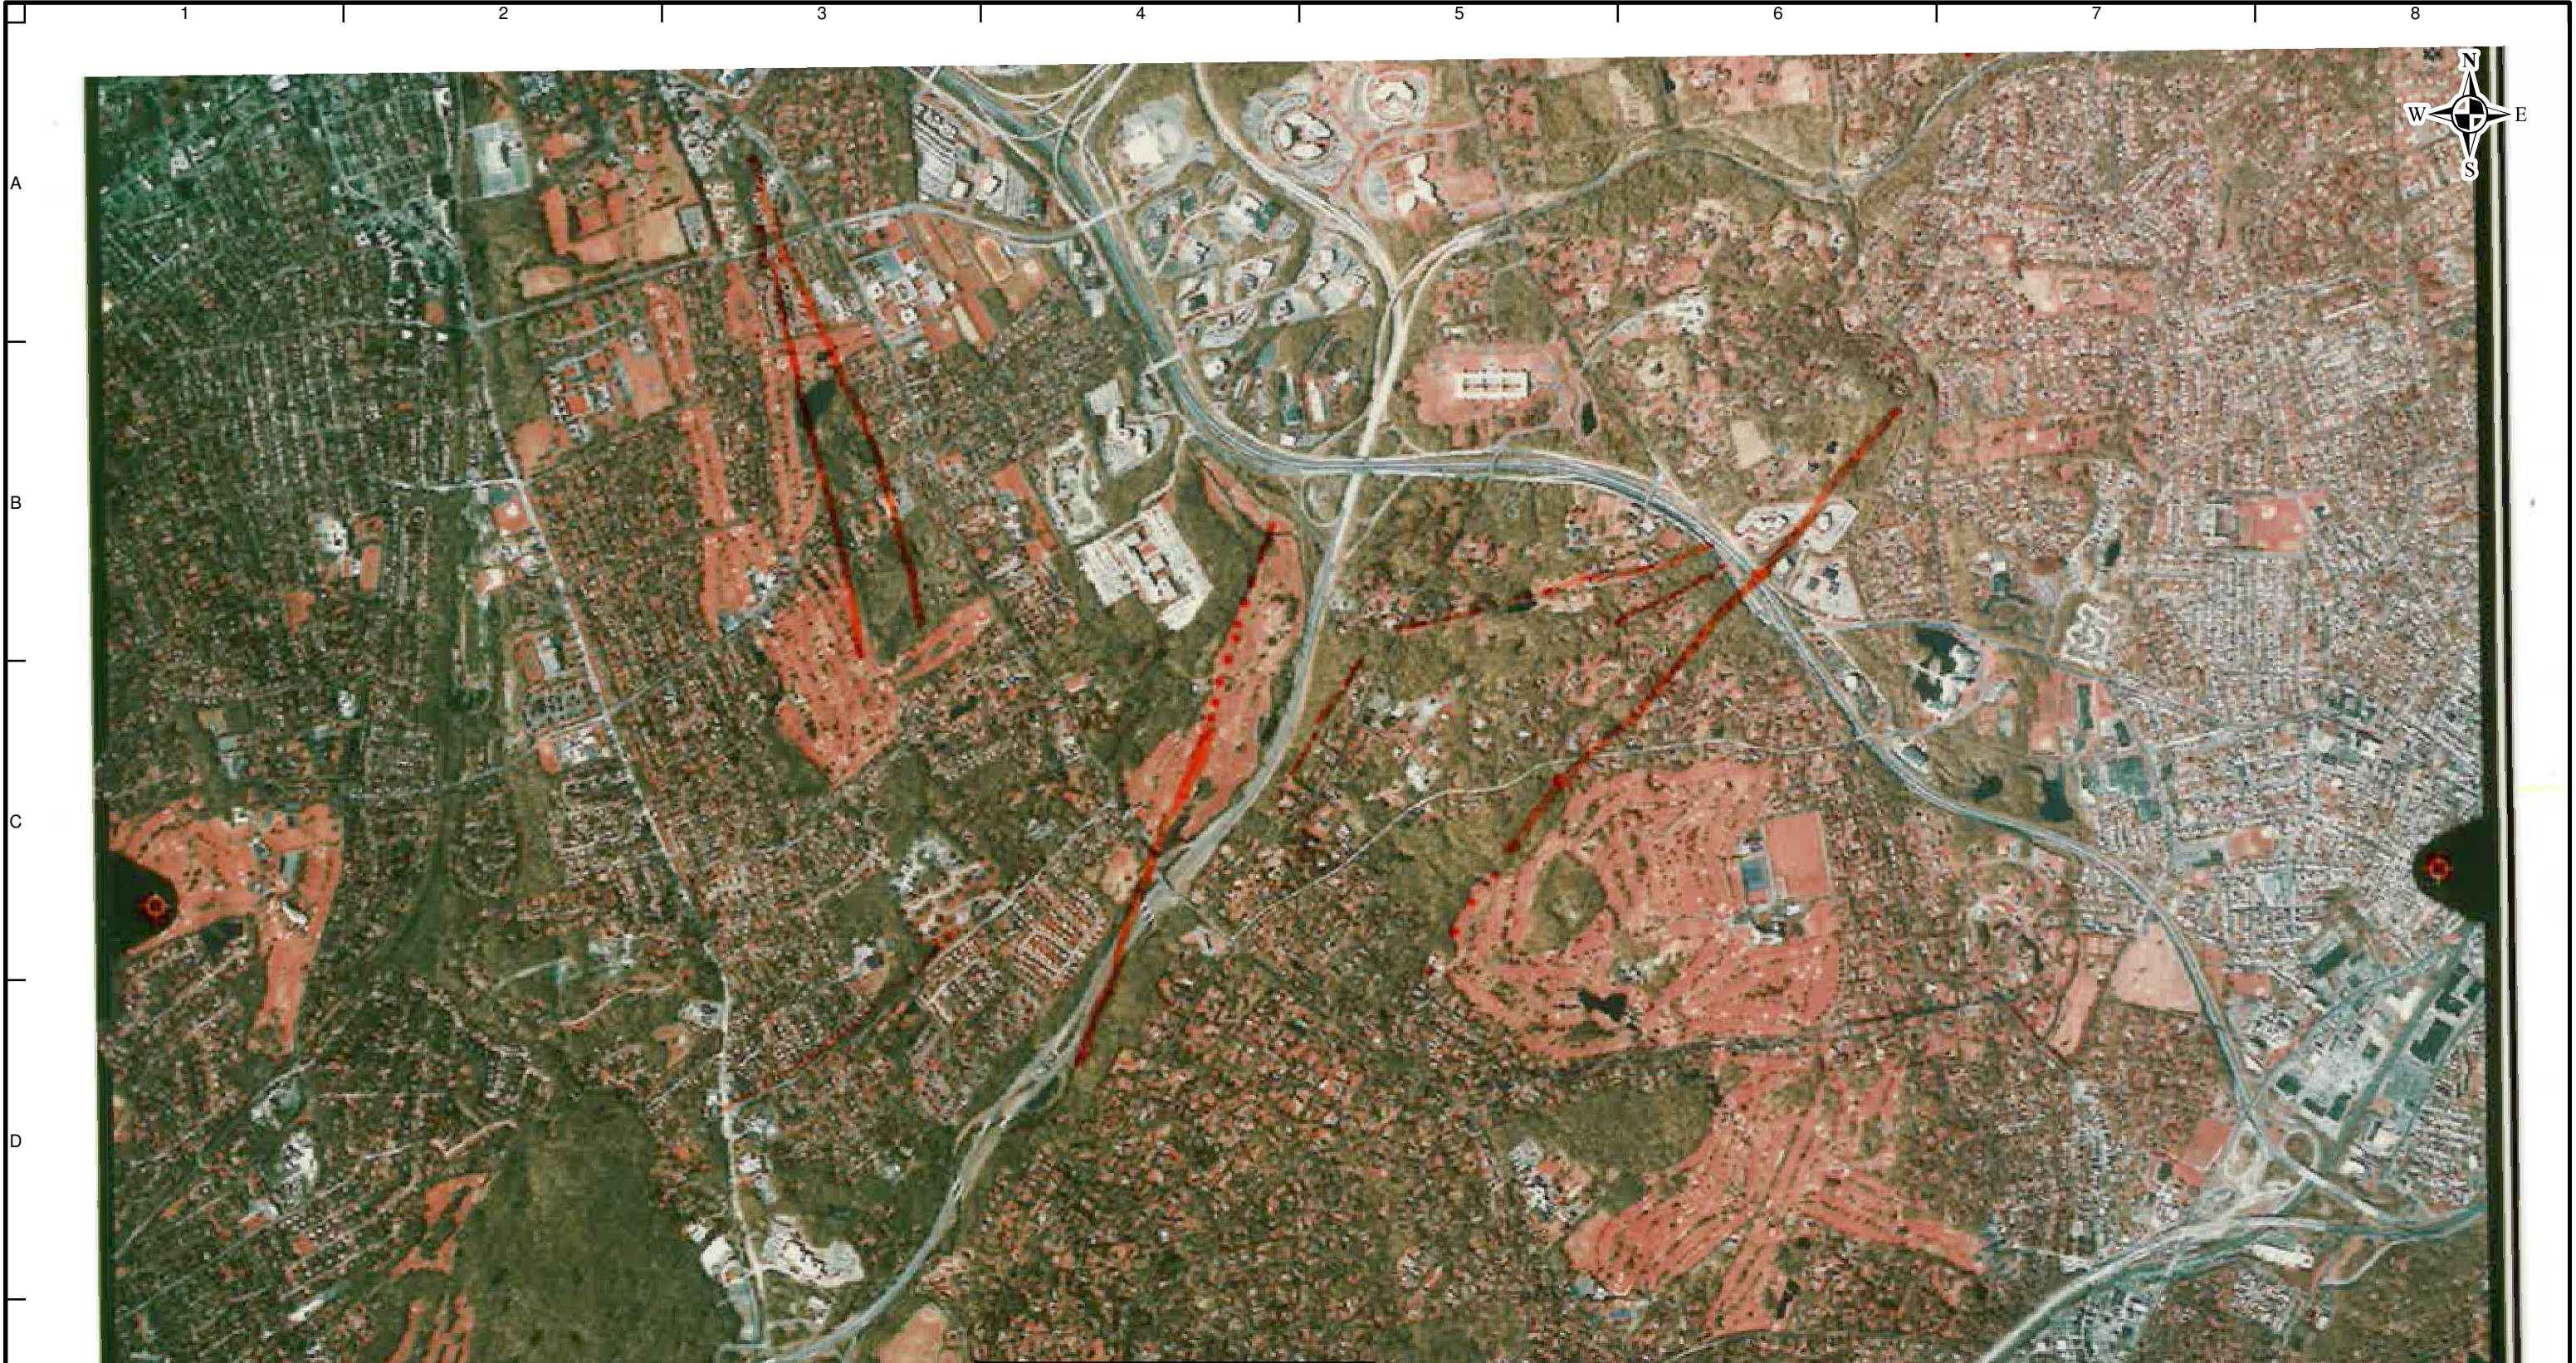
**Notes:**  
Stereo-pair aerial photography provided by  
the United States Department of Agriculture  
Farm Service Agency Aerial Photography  
Field Office of Salt Lake City, Utah.

Potential fractures identified on aerial imagery  
shown as solid and dashed red lines.

Langan performed the fracture trace analysis using stereo-pair aerial photography obtained from the United States Department of Agriculture Farm Service Agency (USDA-FSA) Aerial Photography Field Office of Salt Lake City, Utah (Figure 1). The USDA-FSA aerial photography of the Club was completed in 1994 at a scale of 1 inch equals 3,000 feet. Based on the review of photography, imagery, and maps, one potential fracture trace was identified at the Club (Figure 2). The identified fracture trace is oriented roughly northeast-southwest, consistent with commonly-identified fractures. The identified fracture trace is coincident with surface tonal variations, as evident and interpreted by an experienced hydrogeologist viewing stereographic photography with a stereoscope.
