FIELD REPORT

LOCATION: Wilson Woods Pool

RE: Inspection

An annual inspection of Wilson Woods Pool was conducted by Risk Management for the 2023 season. Grounds and buildings were reviewed as they relate to health, safety and liability.

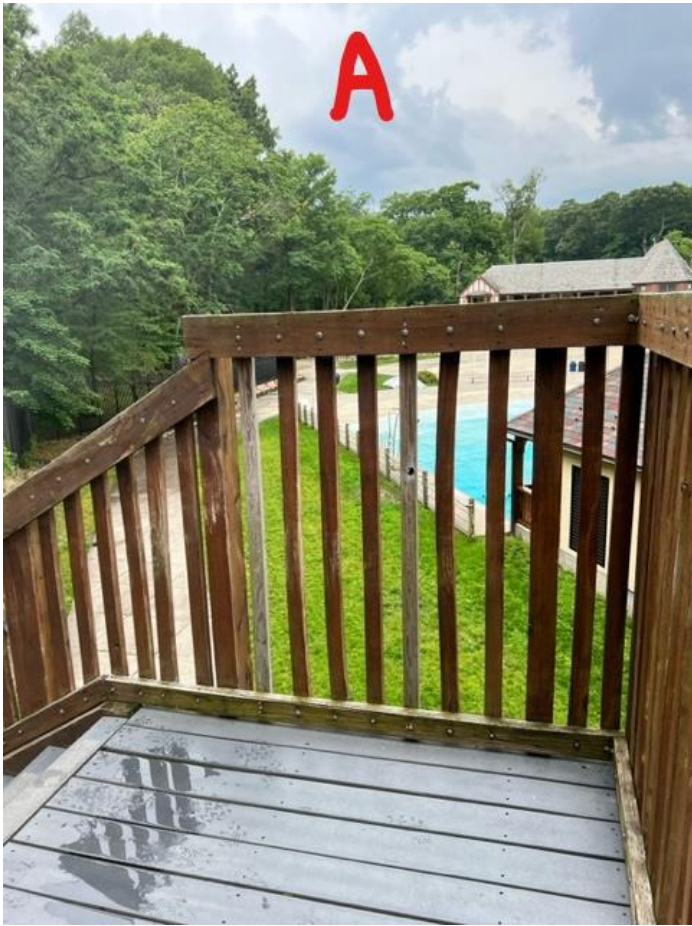
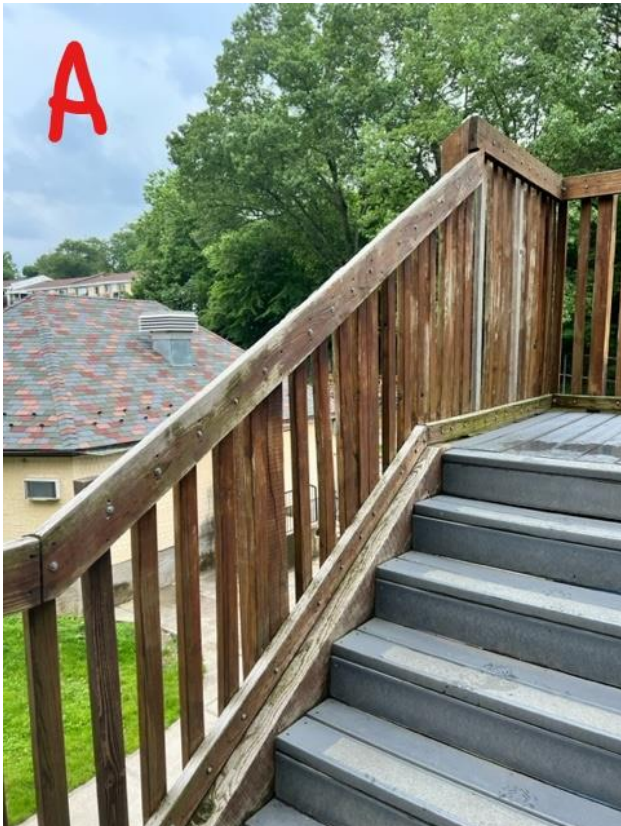
Photos A

-Photos show the same railing front and back along the stairs up to and including the upper landing. The railing is loose and moves laterally 6-8 inches when handled. Vertical support members on outside are split at the connection hardware.

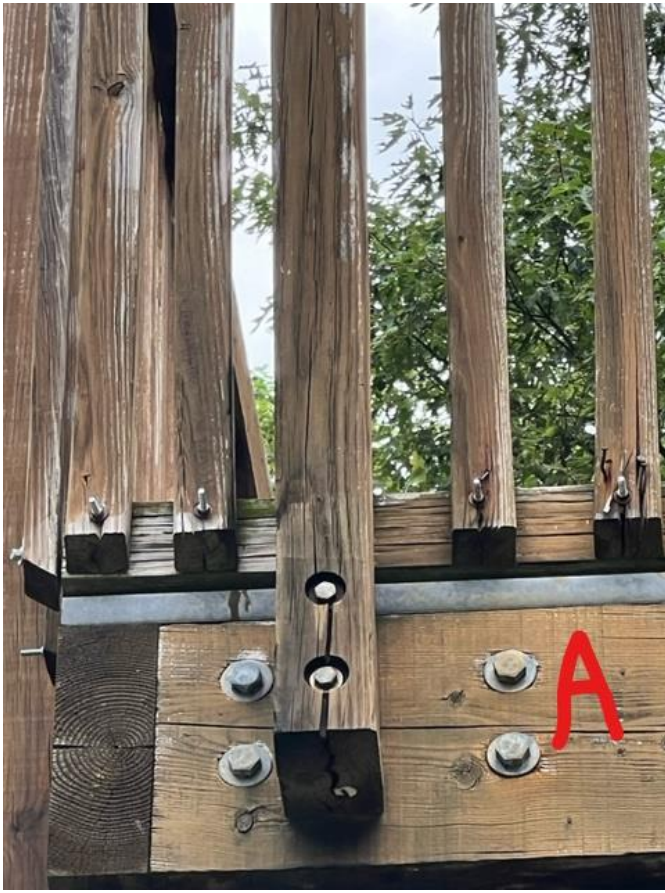
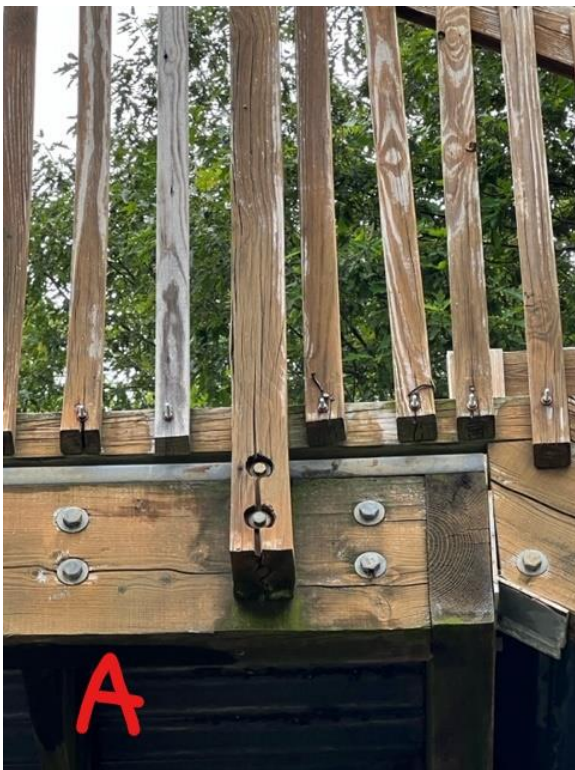
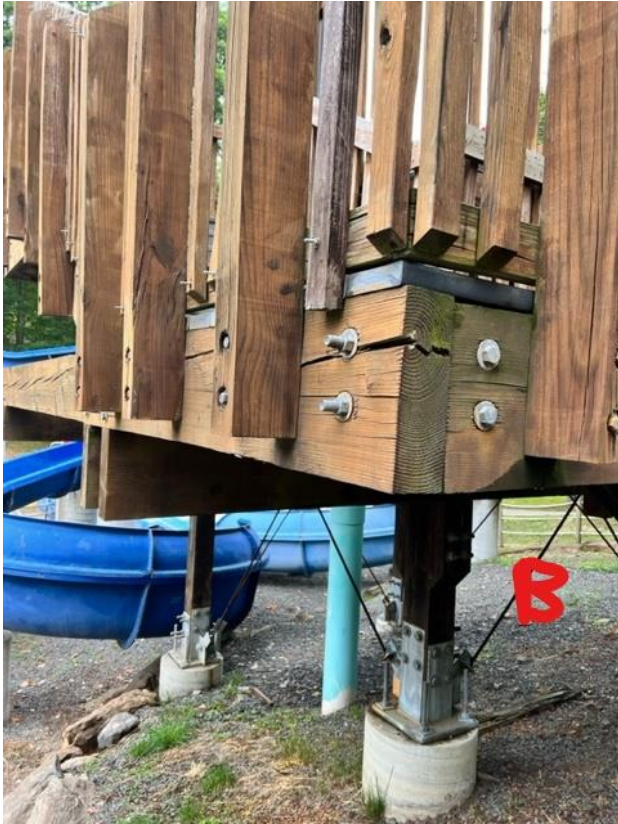
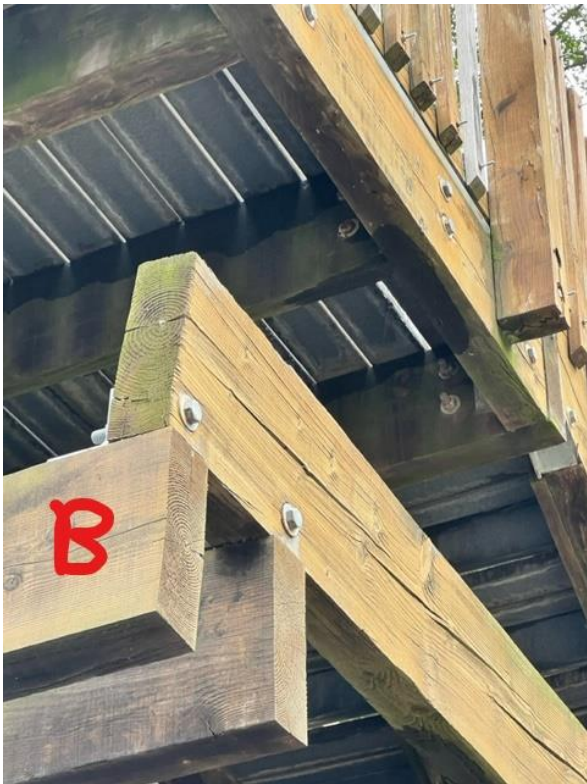
Photos B

-Pictures show the same joist end to end for the lower landing which is directly below the above pics and makes up the lower landing support. The joist is split lengthwise and is twisting away from the connection hardware.

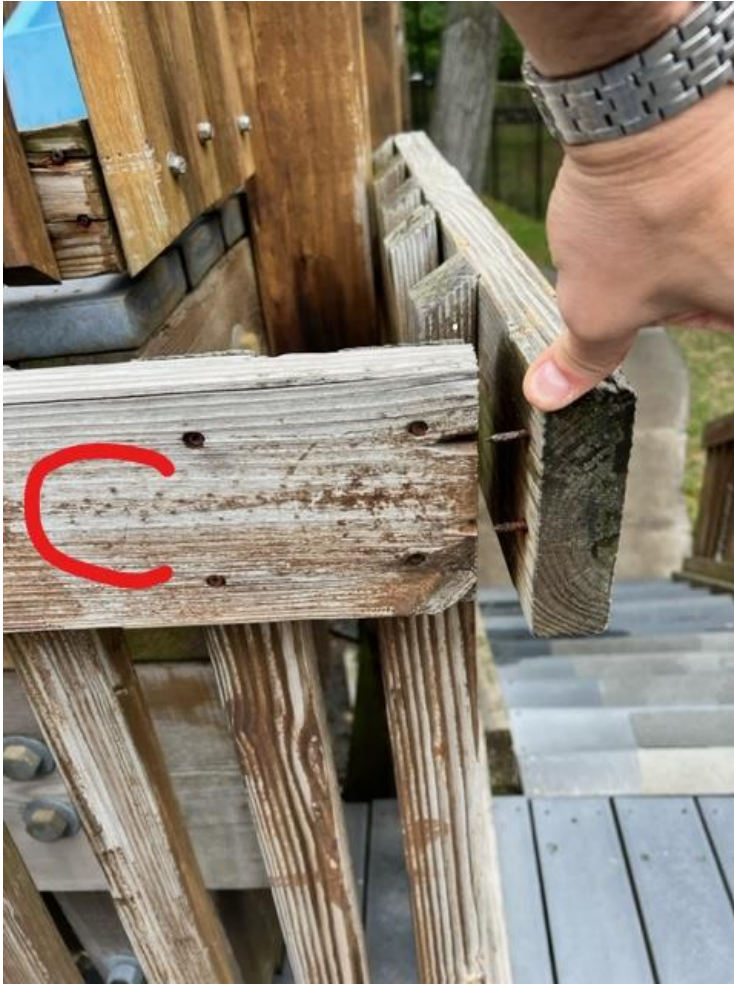
Photo C

-Photo shows the right side railing at the lower landing.
